# Inspection Report

Property Located At:  
Fisher Island Dr, Miami Beach, FL 33109

Inspection Date: 11/20/2021  
Inspected By: Nick Bangor  
FL Home Inspector License #: HI730

**(NOT A FULL INSPECTION OF INTERIOR COMPONENTS; TO BE USED AS  
A SUPPLEMENT FOR MOLD ANALYSIS AT PROPERTY)**

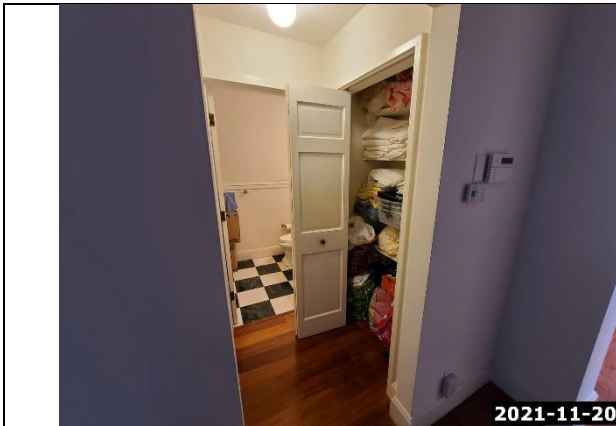
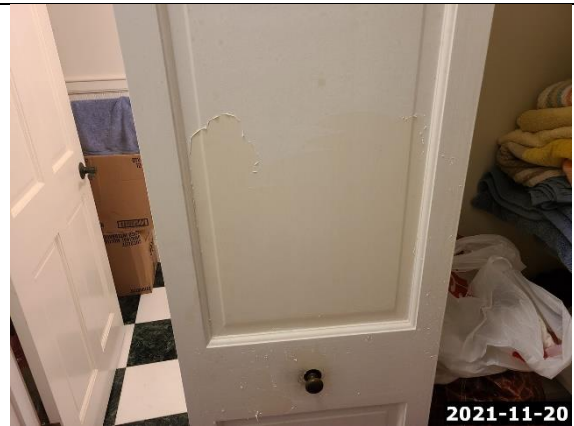
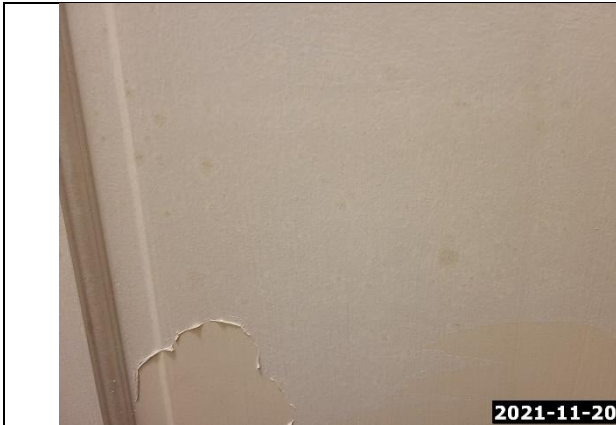
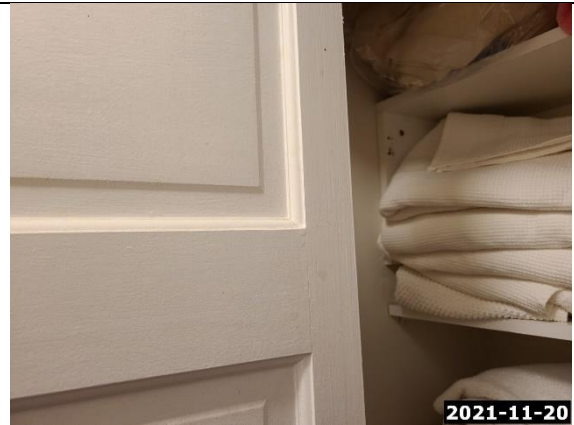
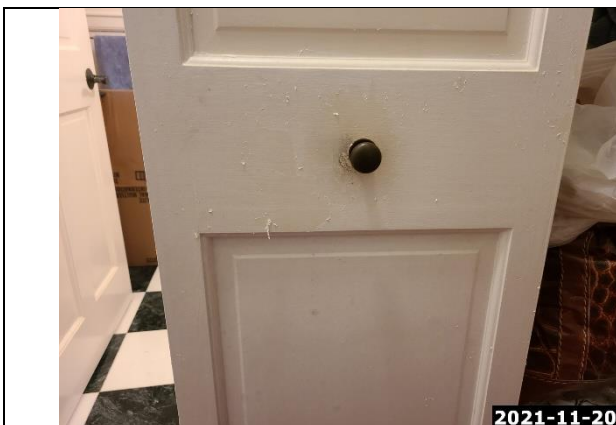
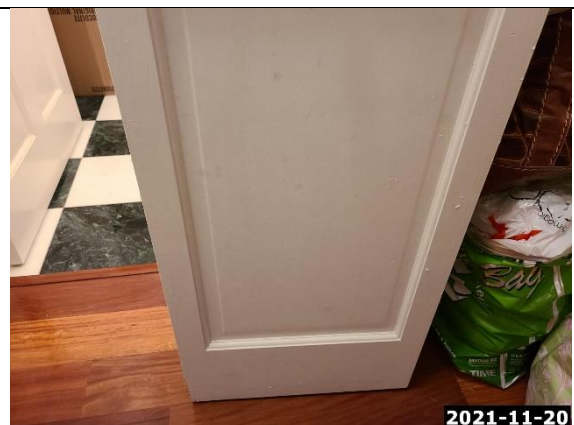
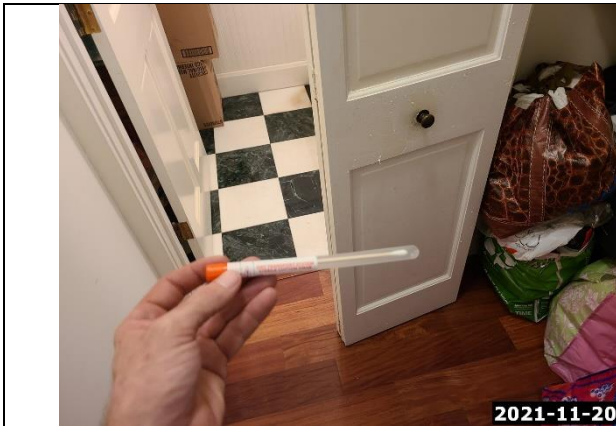
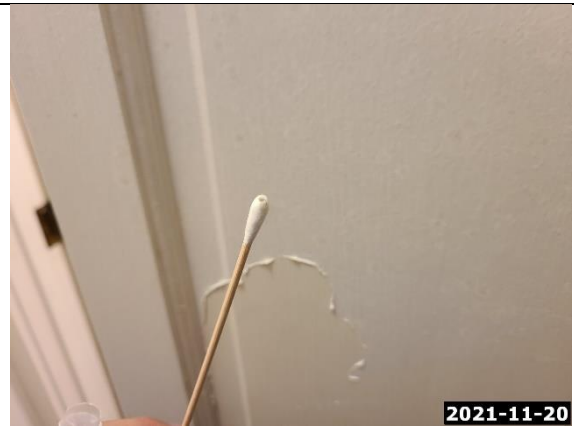
**Hall Bathroom Linen Closet  
(Just Outside Bathroom)**

- Hall Bathroom (Just Outside Bathroom) Linen Closet – Measured Hyphae (signifying active mold) & Penicillium/Aspergillus mold spores; requires remediation.

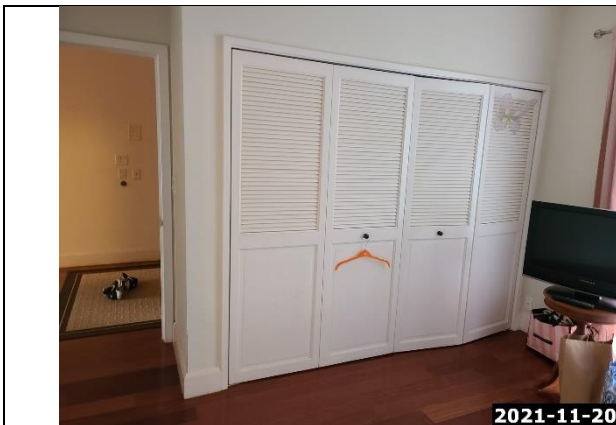
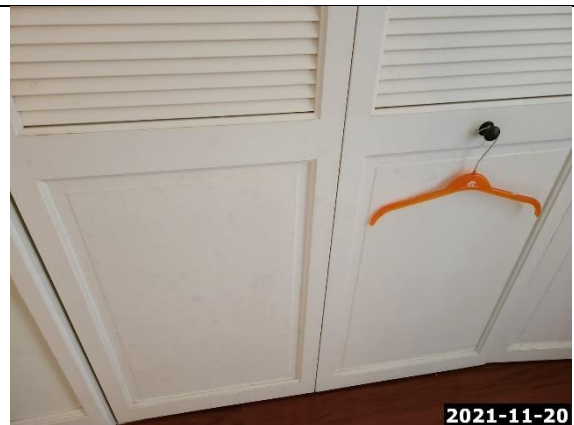
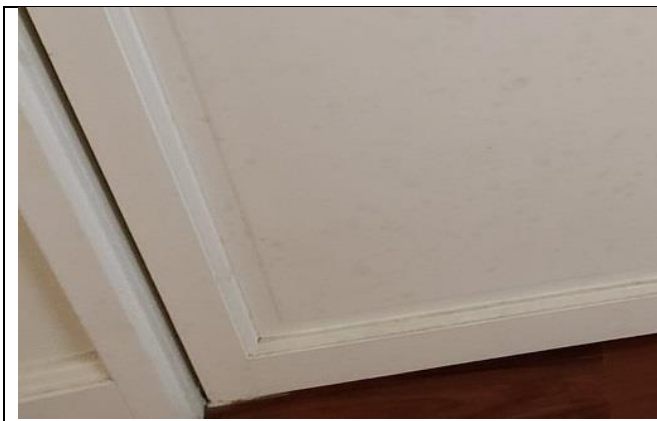
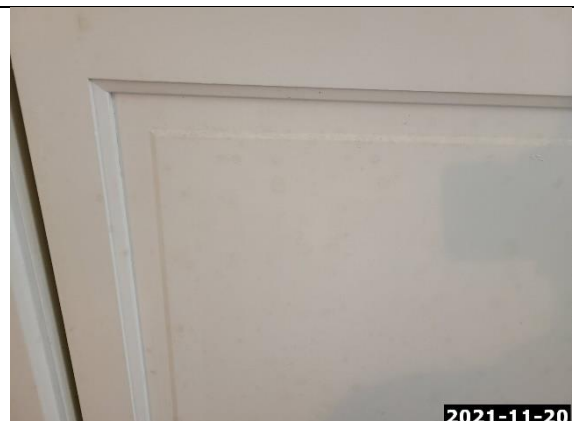
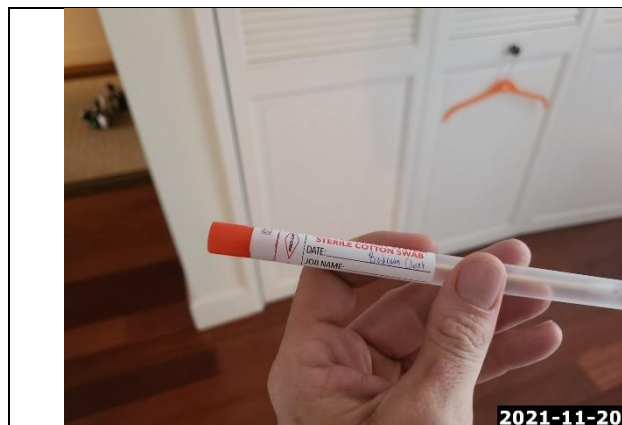
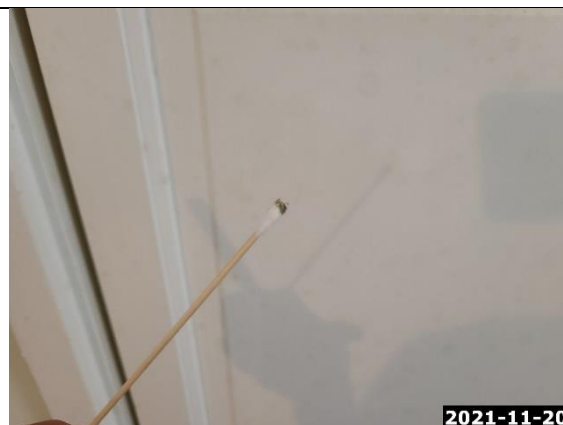
**Bedroom Closet**

- Surface swab testing was conducted at two (2) locations:
  - The front bedroom closet door – Measured Hyphae (signifying active mold) & Penicillium/Aspergillus mold spores; requires remediation.

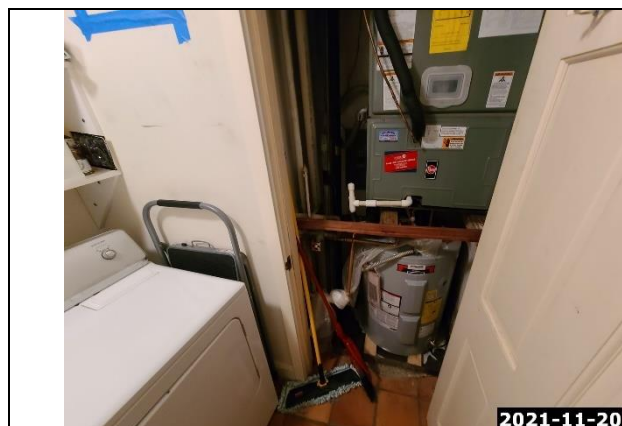
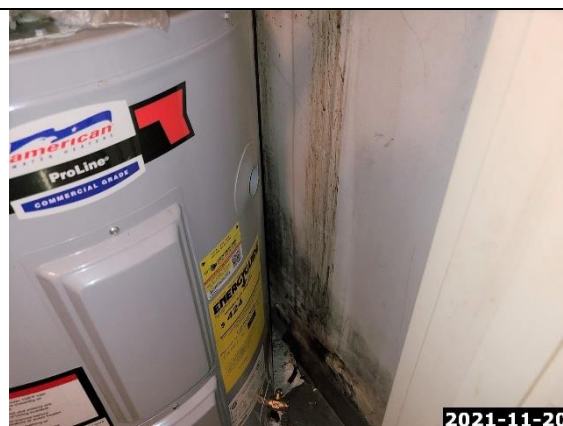
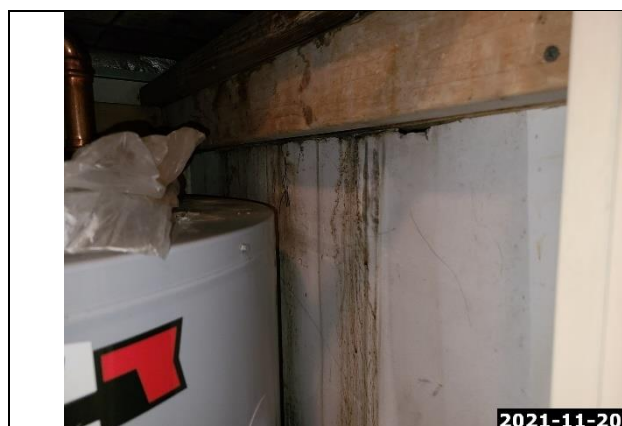
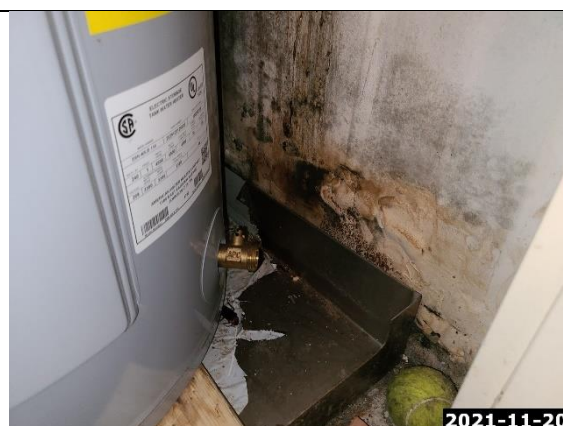
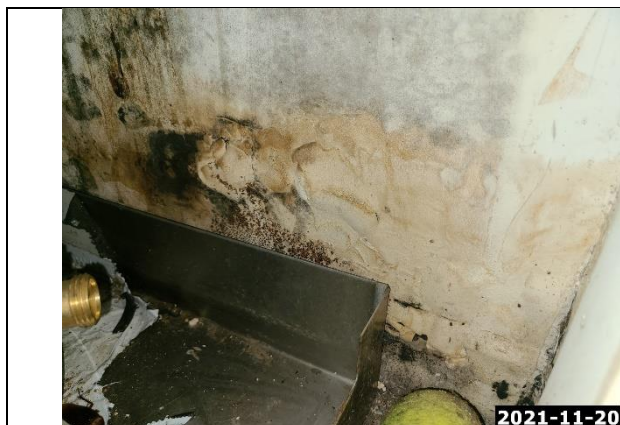
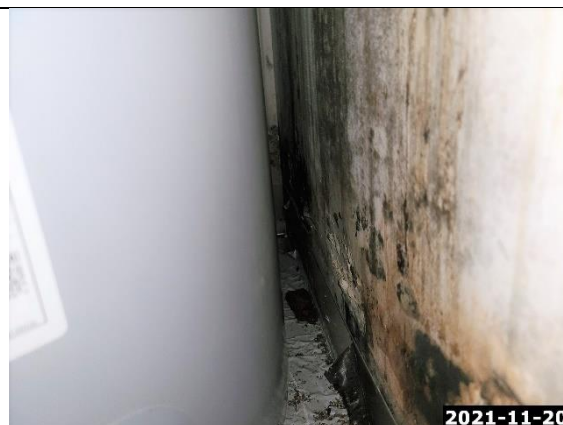
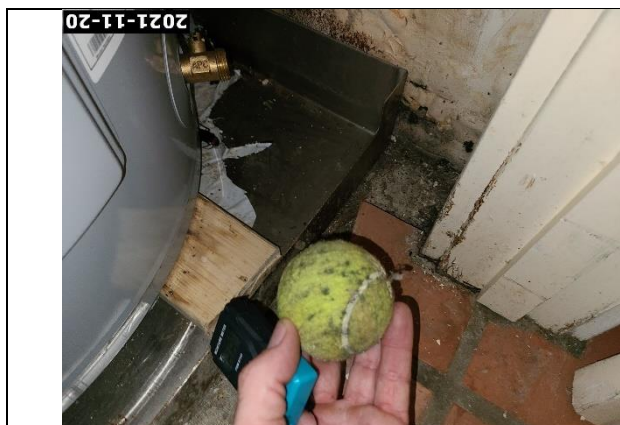
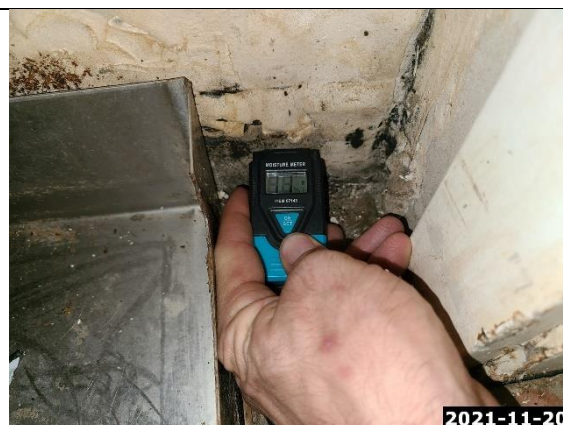
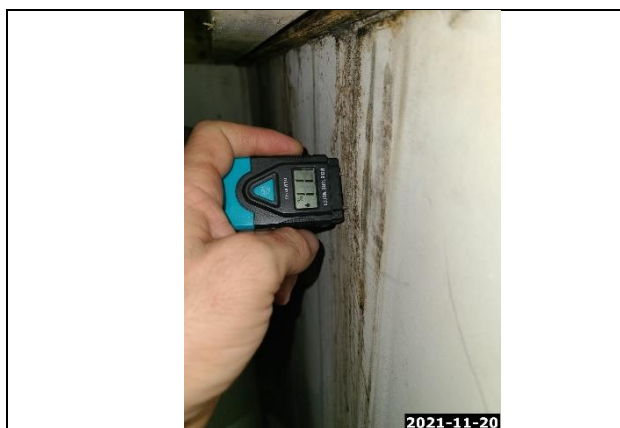
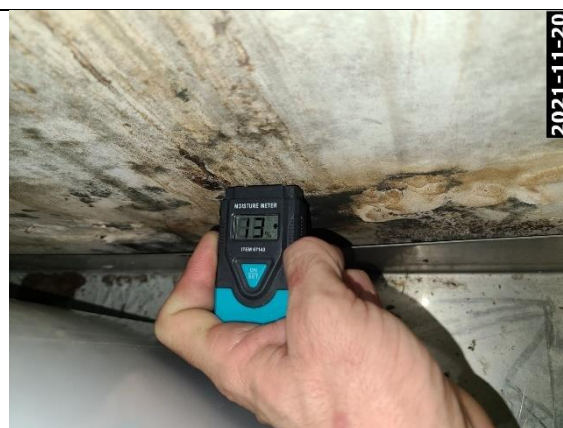
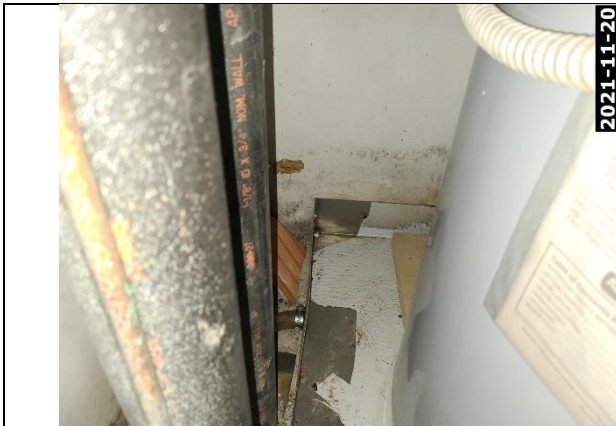
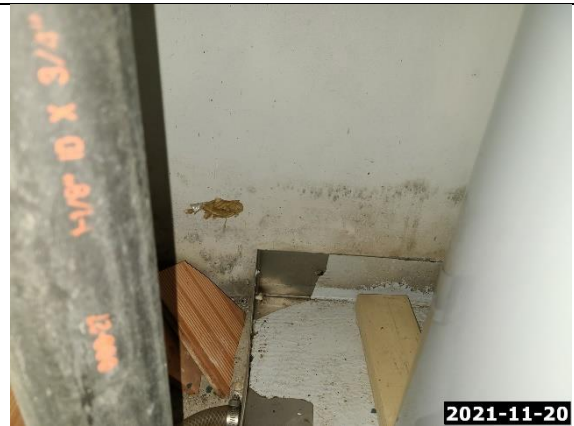
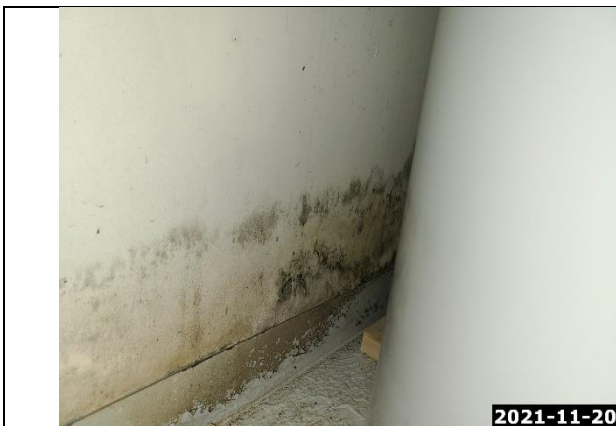
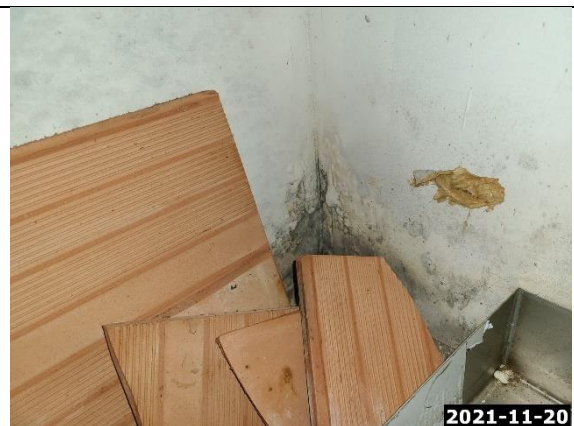
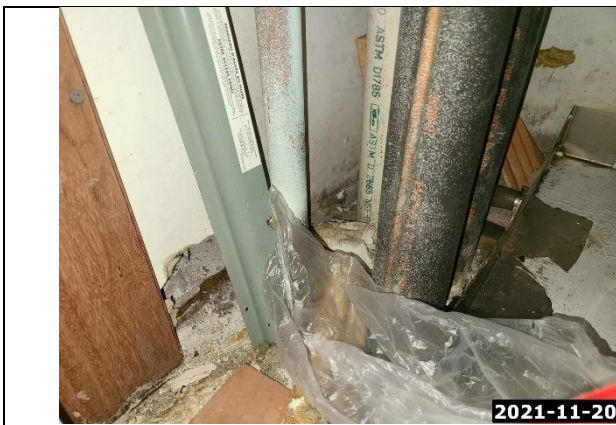
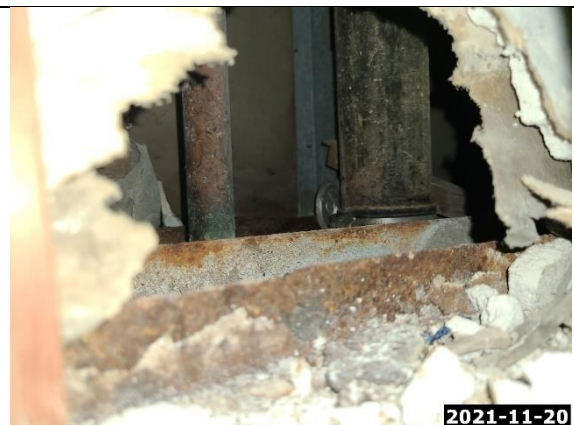
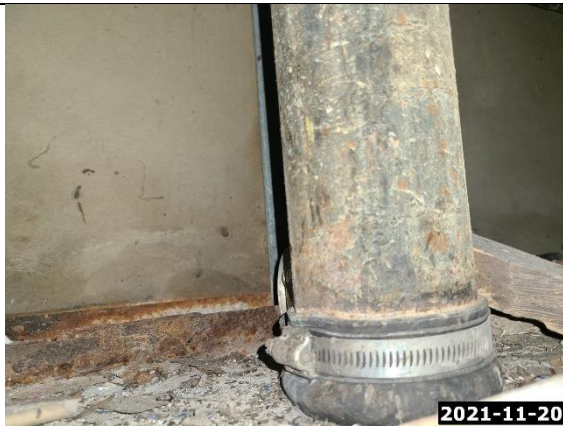
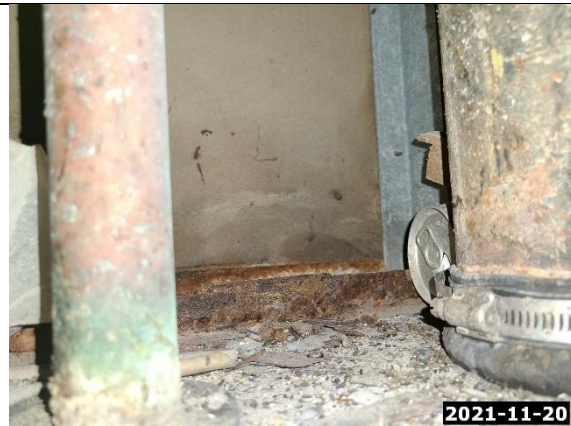
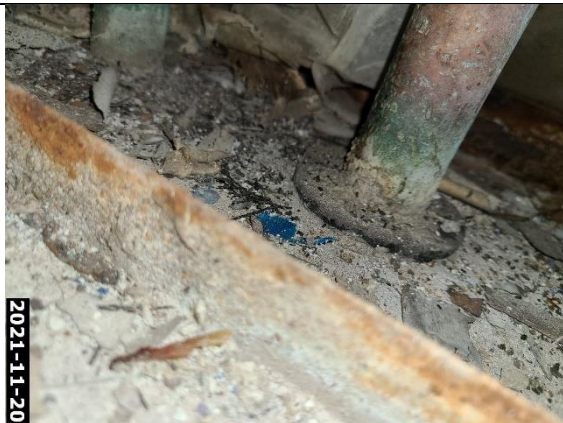
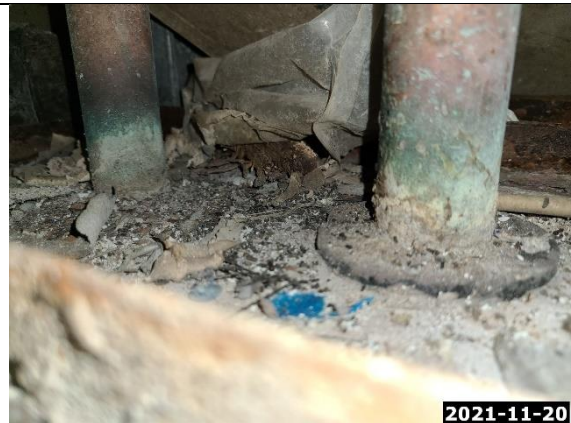
**Laundry Room / AC Closet**

- Air Samples taken at three (3) locations in the home:
  - Laundry Room with Interior AC Closet Open – Cladosporium & Penicillium/Aspergillus measured. The AC room closet has visible mold growth present at all sides of the closet. Evidence present of a previous moisture issue at the closet. There is damage to the wall that has created an opening. Metal components inside the wall show corrosion, which suggests a past or present moisture issue.

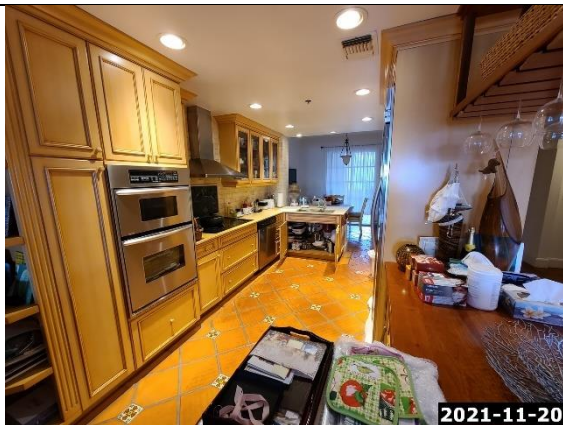
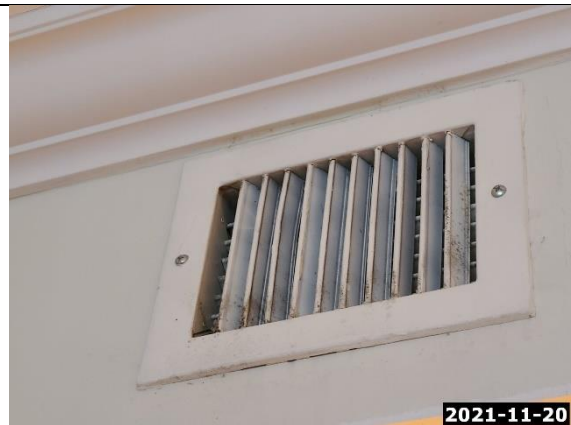
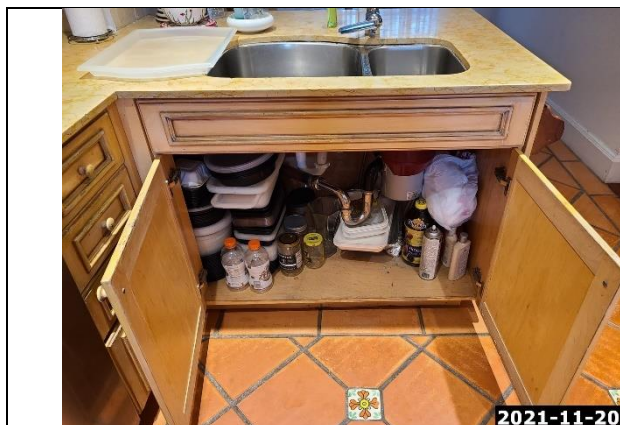
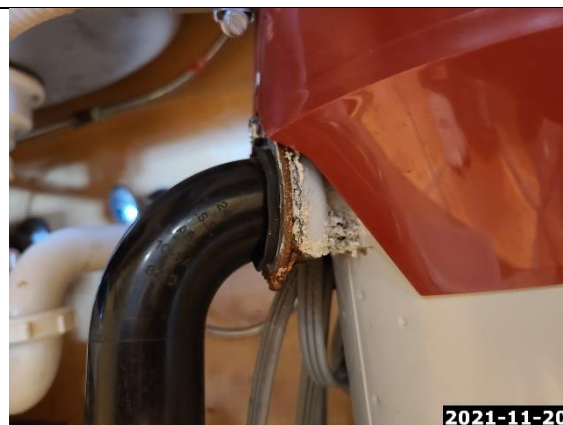
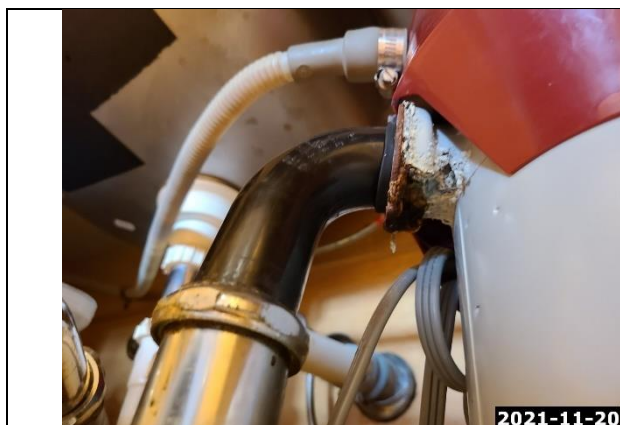
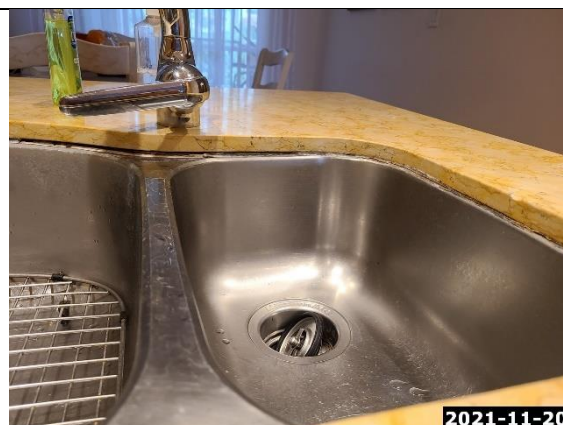
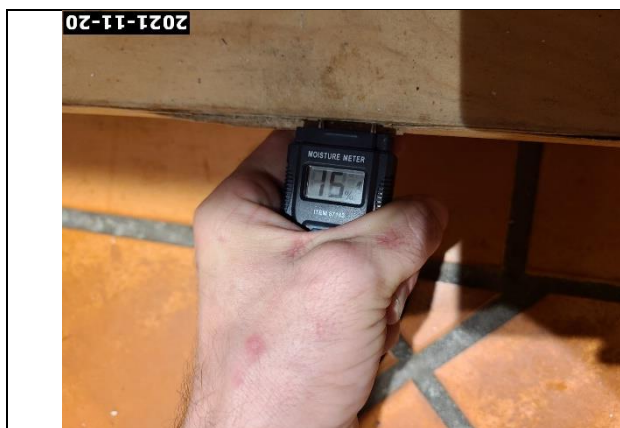
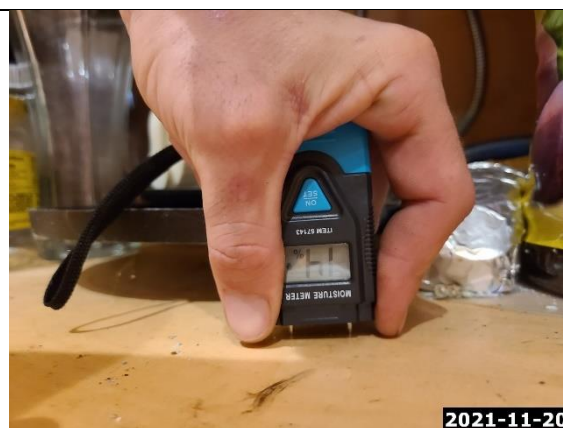
**Kitchen**

- Kitchen: Penicillium/Aspergillus measured. Sink drain is damaged at the kitchen sink, dry at time of inspection, there may underlying damage at the cabinet that is not visible at time of inspection caused by previous leaking.

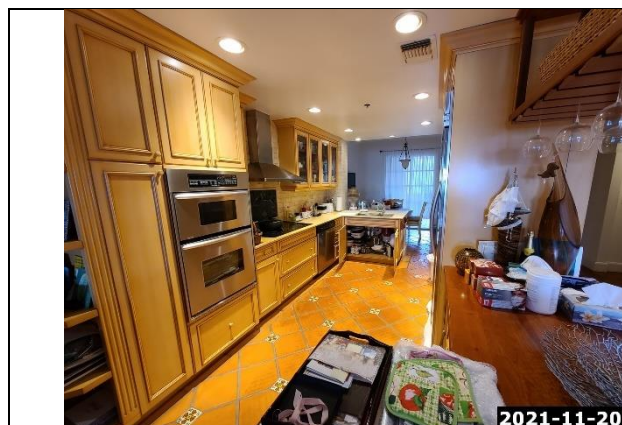
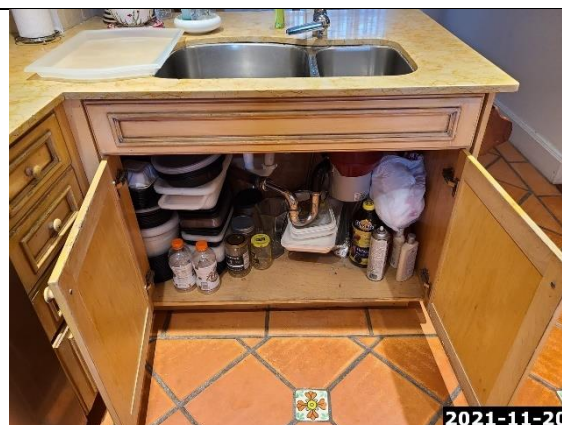
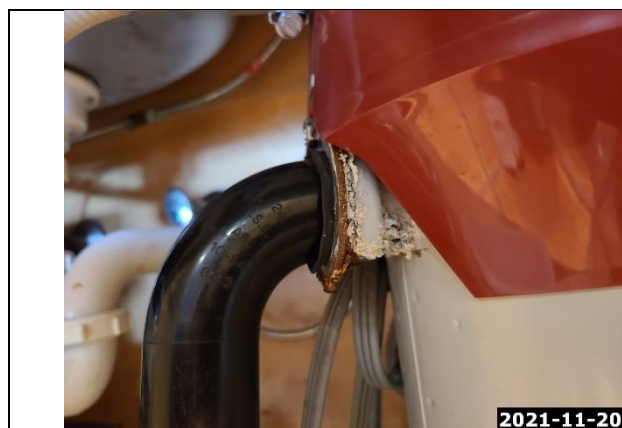
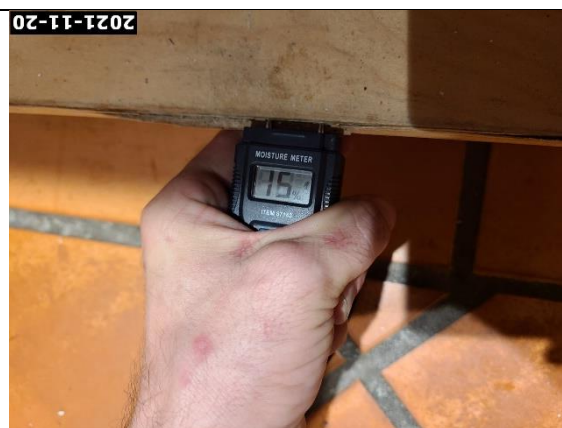
**Kitchen Images**

- Garbage disposal is very damaged (section missing) at connection to sink drain. Replacement of the disposal is required including any required plumbing repairs.
  - No active moisture was measured at the cabinet at time of inspection. Due to the condition of the disposal there was likely past leaking at the sink and there may be underlying damage at the cabinets. (See "Mold Analysis" comment).
  - Undercounter sink; caulk between sink and countertop is damaged and should be replaced.
- Repairs Required at Sink**

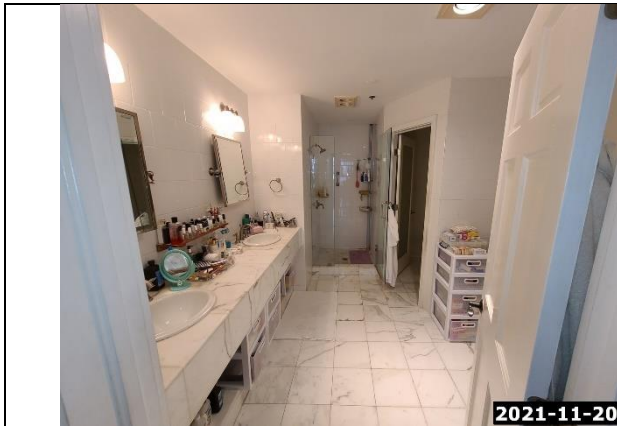
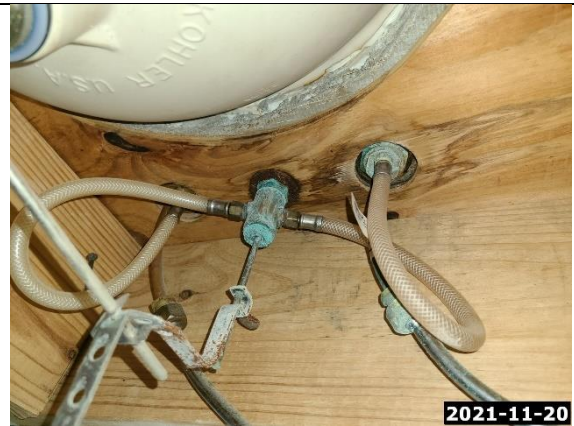
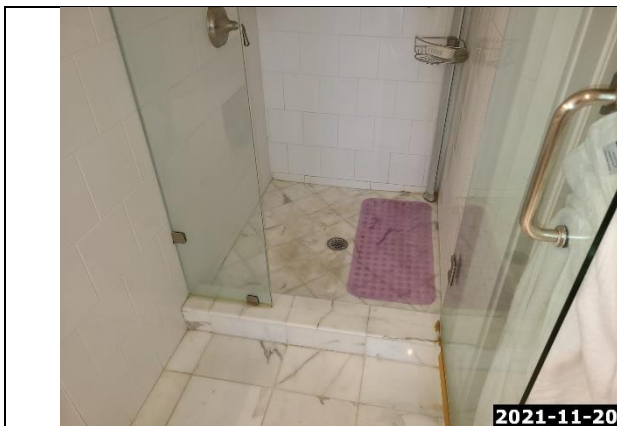
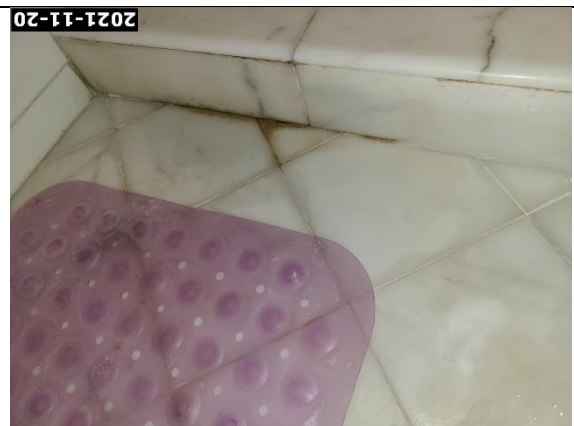
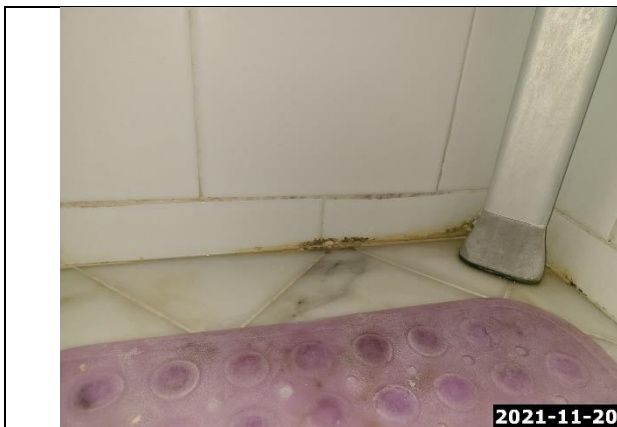
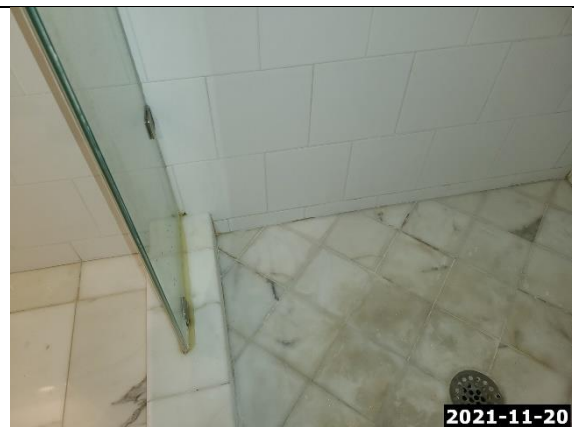
**Bathroom #1 Images**

- Master Bathroom: Penicillium/Aspergillus measured. There is some mildew / mold present at the shower stall grout lines and threshold-step. The shower is close to the Laundry Room / AC closet and may have underlying damage to components behind shower tile. Dinginess at walls in bathroom; due to presence of mold and mold growth noted at bedrooms and hall closet doors, the dinginess at walls may be mold, further testing recommended at time of mold remediation to ensure all areas with mold are remediated.

- **Sink faucet is leaking at faucet body; note age at fixture. Replacement recommended over repairs.**

- **Caulking seals at the shower show mold growth and the caulking seals are deteriorating; caulking showing mold growth should be removed and caulking seals should be reapplied.**
- **Underlying condition of any shower liner is not visible at time of inspection. Note age at the home (1988); age of the shower liner is not known.**
- **Mold noted at the shower threshold; the underlying condition of wallboard under tile is not visible.**
- **See "Mold Analysis" comment.**

**Sink Faucet Est. \$180+**
