# Inspection Report

Prepared Exclusively For:  
Sample Report

Property Located At:  
Delray Beach, FL 33444

Inspection Date: 03/25/2024  
Inspected By: Nick Bangor  
FL Home Inspector License #: HI730

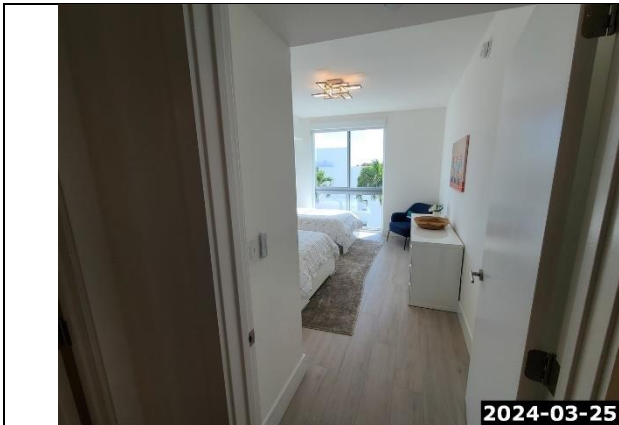
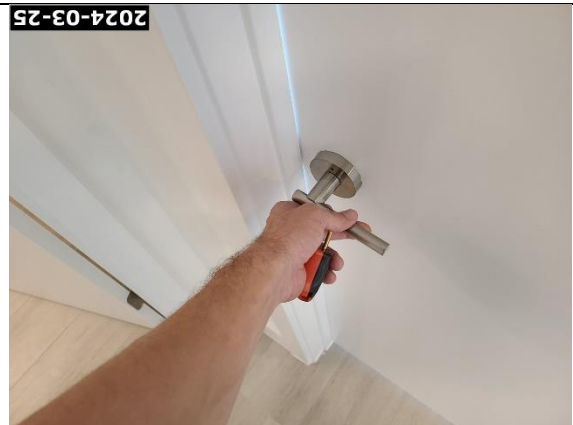
- **Multiple door handles throughout the home have movement noted at the door handles. A couple door handles need to be tightened at the attachment to the door, and most doors require tightening of door handle hardware to prevent movement at the actual door handle mechanism.**
- **One door (northernmost bedroom) is not latching shut at time of inspection; service required.**

**Northern Most Bedroom  
Door Handle Loose; Not Latching**

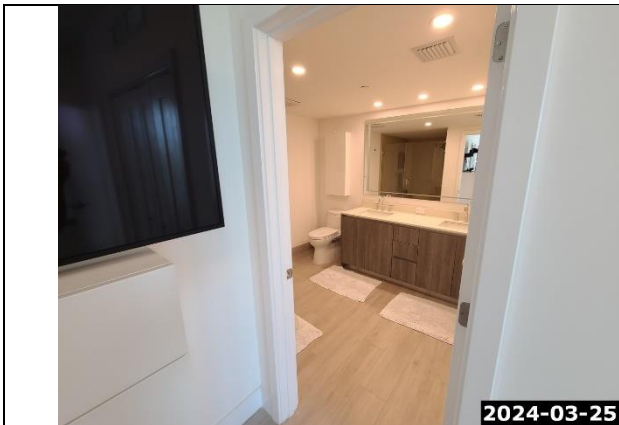
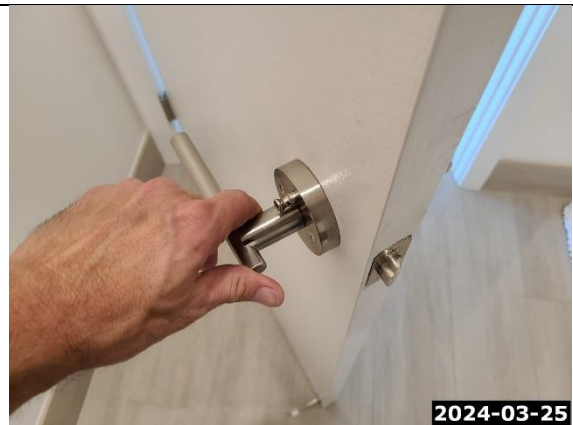
**Loose Door Handle  
(Master Bathroom as Example)**

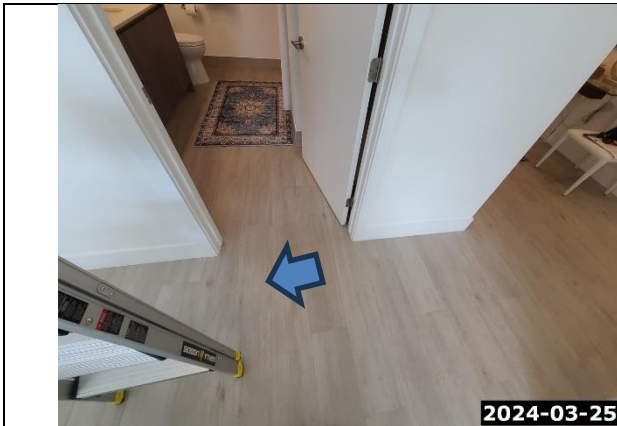
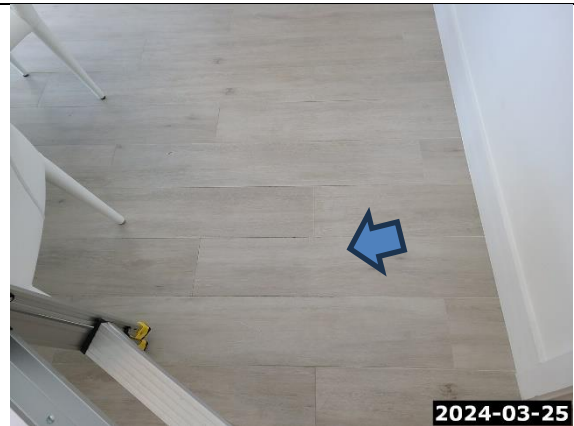
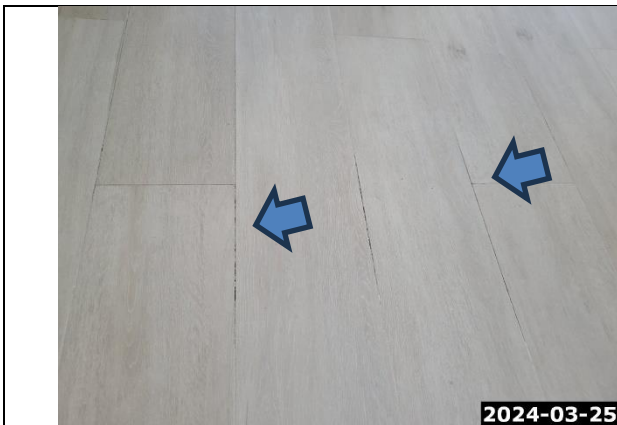
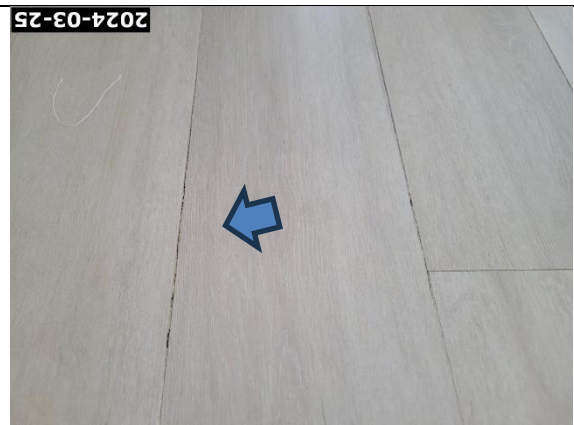
- **Tile grout is deteriorating at locations of high traffic. Areas of grout deterioration are located outside of the hall bathroom (bathroom #2) and in the hall outside of the master bedroom. Install additional grouting at floor tile.**

**Tile Grout Damage at  
Main Walk / Hallway**

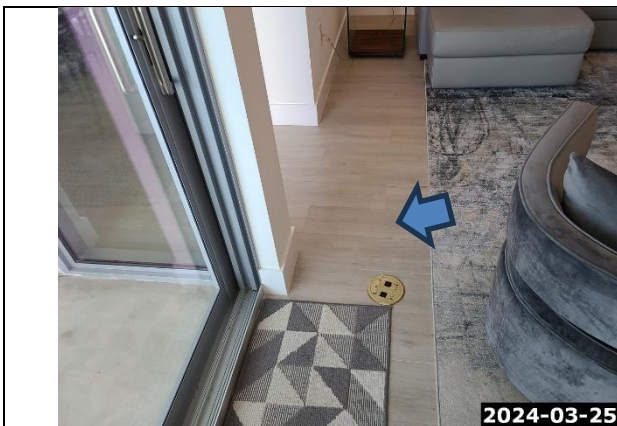
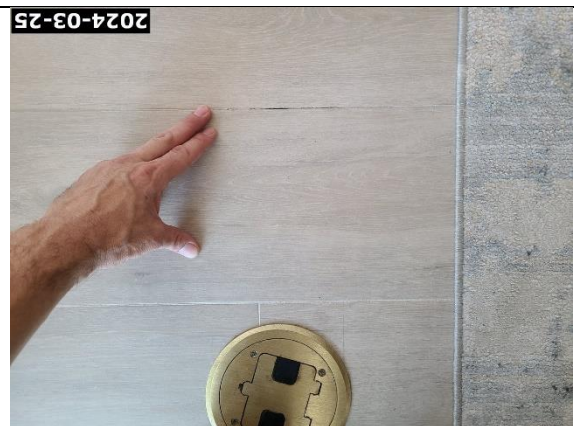
**Tile Grout Damage near**

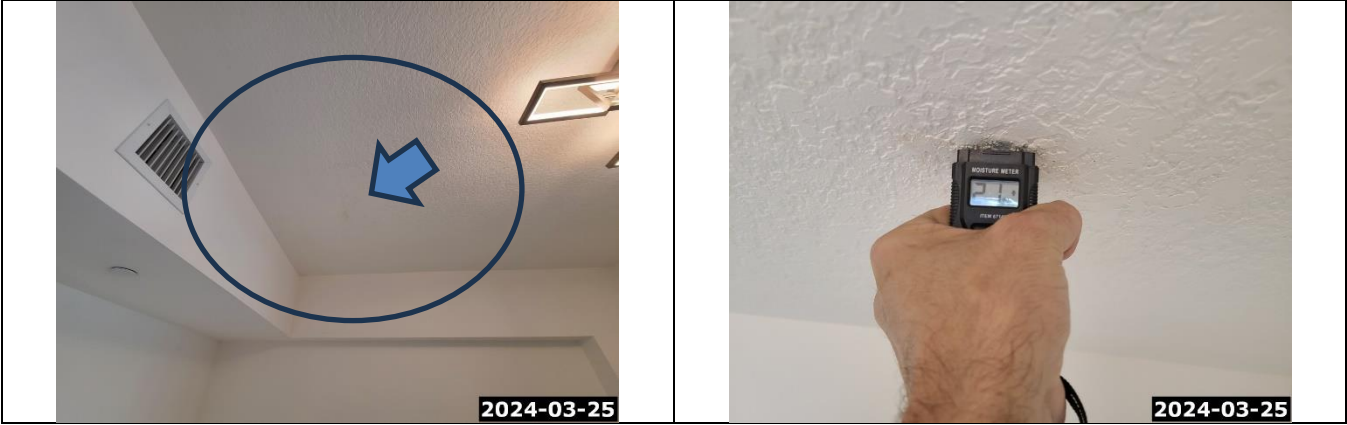
- **There is evidence of an active leak at the office / nursery ceiling. The ceiling has a stained area of around 9 square inches that have active moisture present when measured with a moisture meter.**
- **The condo unit is the top floor and the building roof is about the unit. The roof is maintained by the building HOA (COA); the HOA needs to address the issue immediately to ensure that the leak is stopped as soon as possible.**

| Area of Prior Repairs to Ceiling<br>Arrow: Area of Active Leak / Stain | Active Moisture Measure<br>at Area of Ceiling Stain |

**Contact HOA for Leak Repair / Possible Roof Service**

- **Mold Analysis: Due to the moisture intrusion at the home (staining with active moisture at office), a full mold analysis is scheduled to be performed at the home (03/26/24 9:30am) to determine what species of mold may be present and at what levels. If testing shows that mold levels are elevated, remediation will be required. Obtain detailed quotes for mold remediation from licensed remediation contractors if levels are elevated.**
- **Mold air samples will be delivered to Pro-Lab for analysis on 03/26/2024, results expected end of day between 5pm-6pm, and no later than next day.**

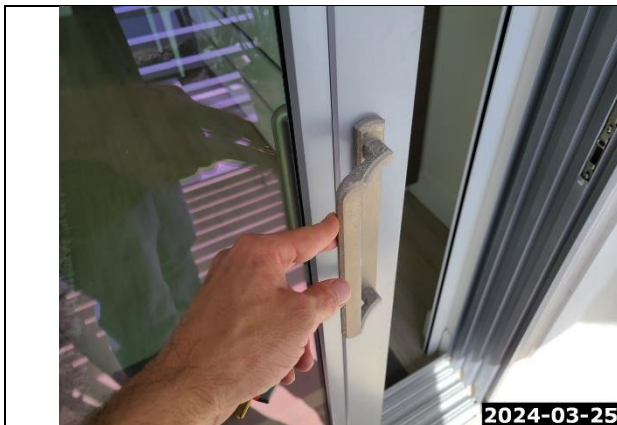
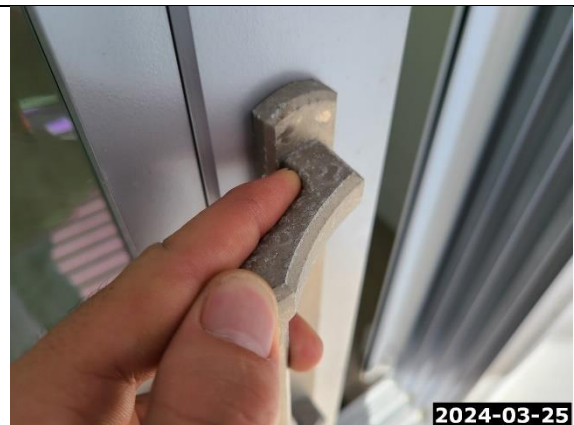
**Visible Corrosion Noted at Exterior  
Door Handles****Visible Corrosion Noted at Exterior  
Door Handles**

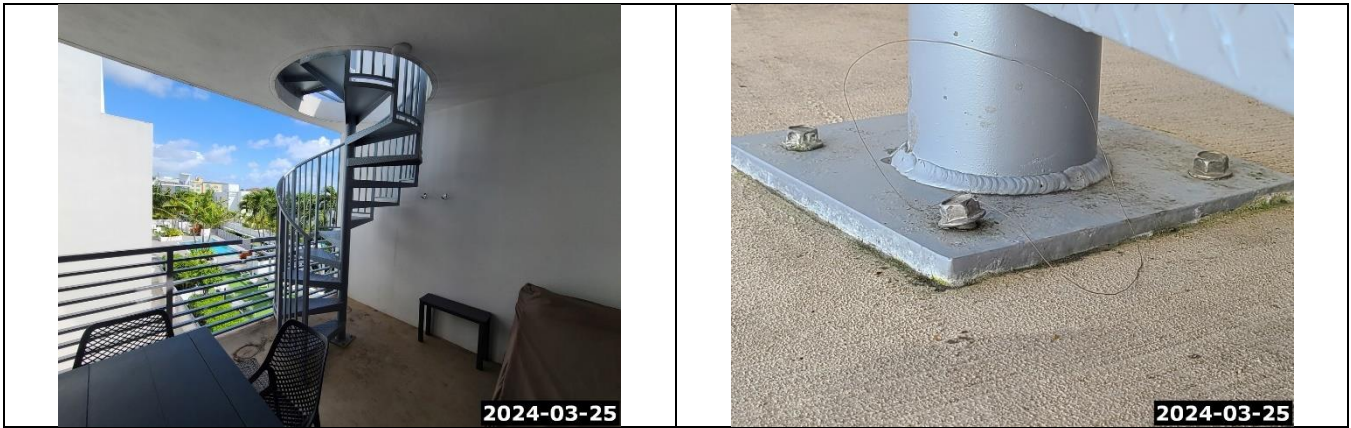
- **There is a metal spiral staircase installed at the exterior balcony of the condo leading to the rooftop balcony.**
- **There are 2 bolts securing the base of the staircase that appear to have been installed at a slight angle that does not allow the bolts to sit flush. Recommend installing a high strength construction adhesive caulking at the bolts to seal bolts from corrosion and strengthen the connection's shear strength.**
- **Metal bolts securing the staircase are showing evidence of corrosion at connection to rooftop balcony; recommend sealing bolts to prevent further corrosion (silicone caulk or other means).**

| Balcony Staircase | Balcony Staircase – Bolt Not Flush |

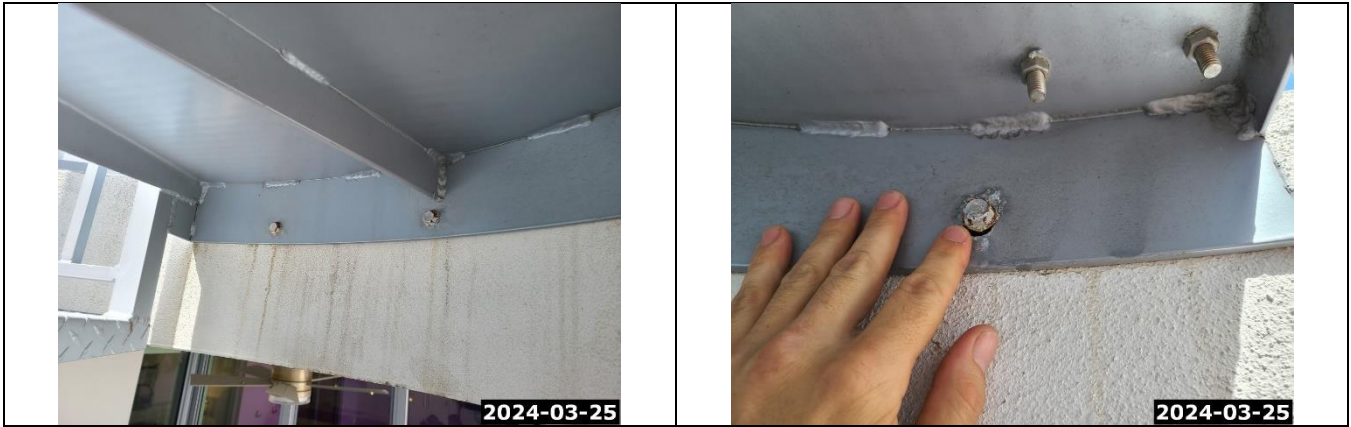
| Balcony Staircase<br>Seal Bolts to Prevent Corrosions | Balcony Staircase<br>Seal Bolts to Prevent Corrosions |

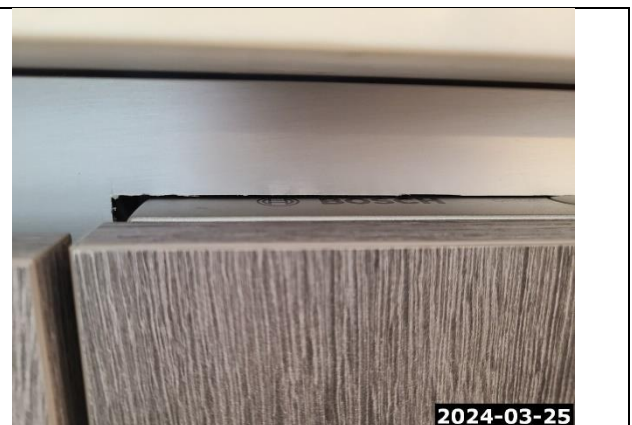
- **Functional at time of inspection. Note age. Unit was run through a cycle at time of inspection, the unit is draining properly. No determination of cleaning capacity is made. (2019)**
- **Dishwasher has an attachment screw securing it to the sink cabinet that was installed improperly; screw is crooked and could damage rubber gasket installed overtop of the screw. Reinstall the attachment screw at dishwasher.**
- **The opening cut into the cabinet for the dishwasher is a very tight fit at areas (not a straight cut). The buttons of the dishwasher appear to come into contact with the cabinet when dishwasher is closed. Recommend extending (slightly) the opening cut into the cabinetry for the dishwasher; ensure opening cuts are straight and square.**

**Dishwasher –  
Opening Larger Towards Left Side**

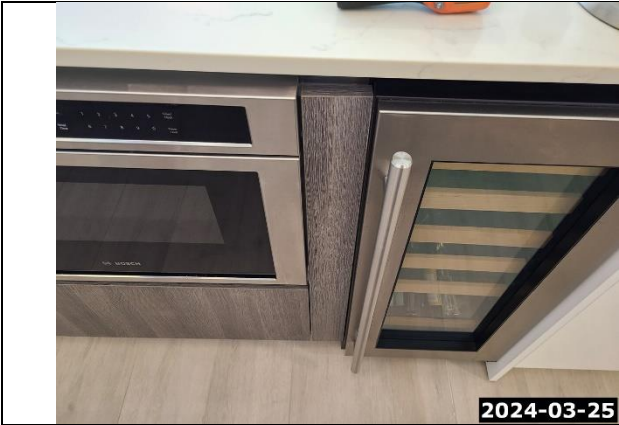
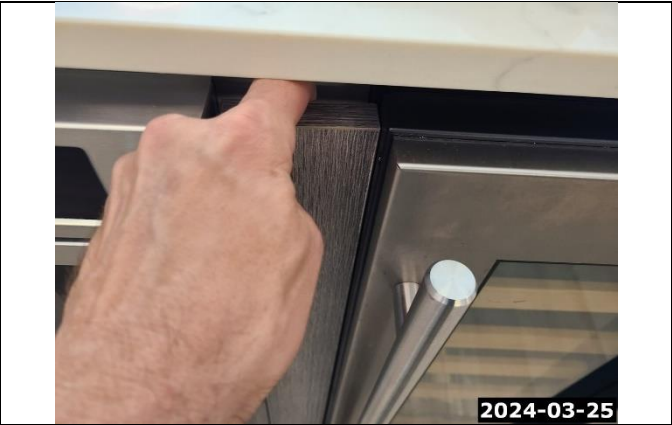
- **Small piece of cabinet trim is loose between the microwave and the wine cooler; secure cabinet trim to prevent movement.**

Small Piece of Loose Cabinet Trim

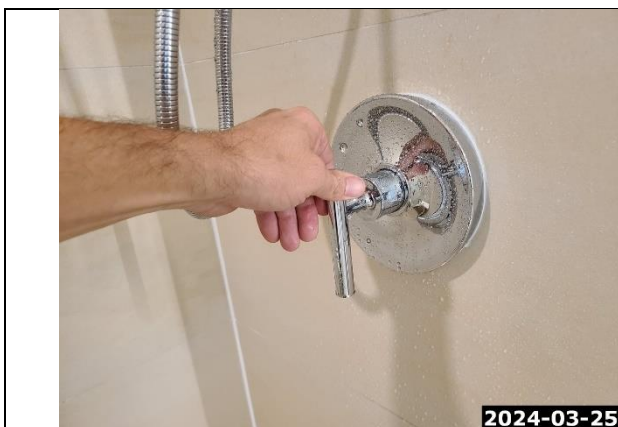
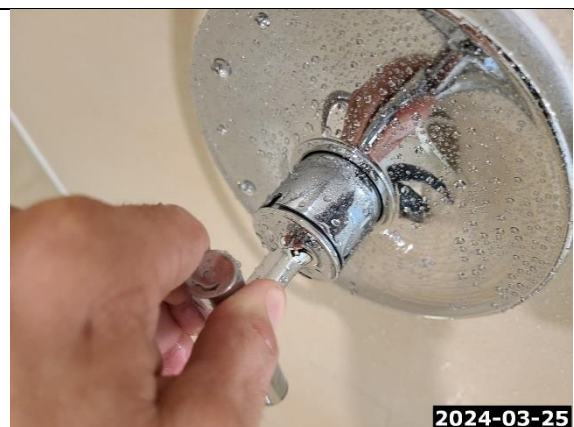
- **Shower fixture handle components are loose (side-to-side movement at handle). Components at the shower handle need to be adjusted to tighten. (shower fixture functional at time of inspection)**

**Bathroom #1  
Loose Shower Handle****Bathroom #1  
Loose Shower Handle**

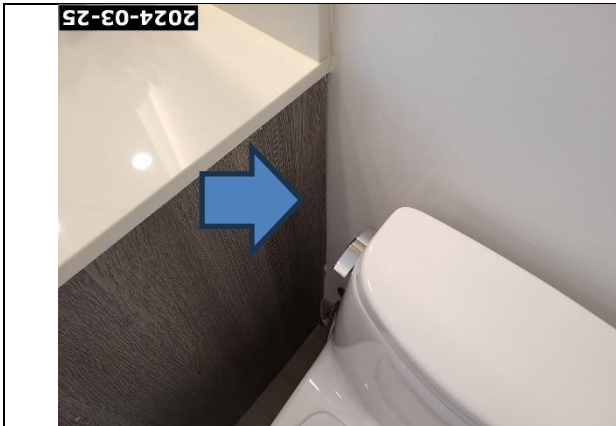
- **Cabinet installed to the right of sink has movement noted; cabinet needs to be better secured to wall to prevent movement. Reapply caulking between wall and cabinet after repairs.**

**Caulking Incomplete at Cabinet**

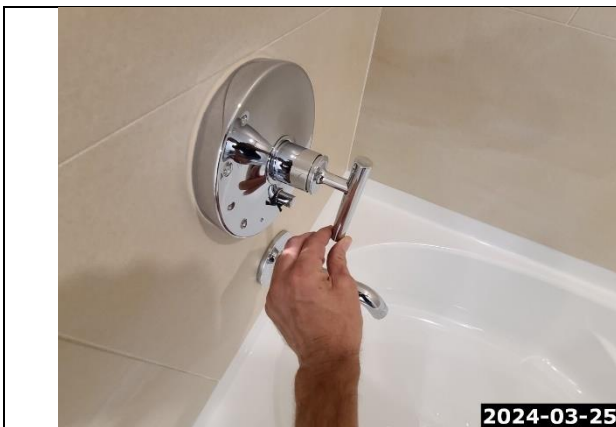
- **Shower fixture handle components are loose (side-to-side movement at handle). Components at the shower handle need to be adjusted to tighten. (shower fixture functional at time of inspection)**

**Bathroom #2  
Shower Handle Loose**

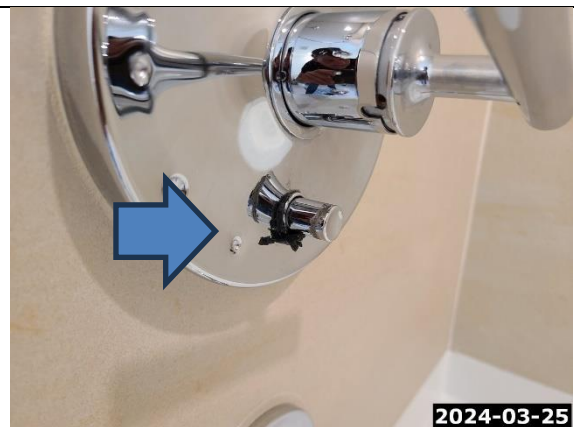
**Material (Gasket?) Visible at Shower  
Diverter Button**

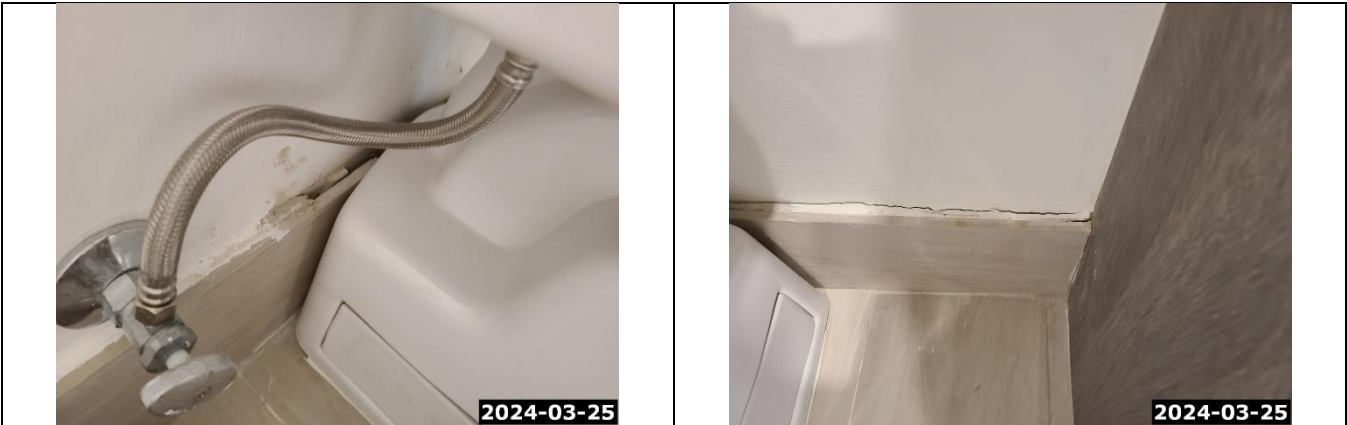
- **Grout / caulking at “baseboard” tile is damaged and / or not installed. Grout appears to have not been installed at tile directly behind the toilet.**
- **Install caulking or grout at the “baseboard” tile behind the toilet.**

| Grout / Caulk Damaged / Incomplete Behind Toilet | Grout / Caulk Damaged / Incomplete Behind Toilet |

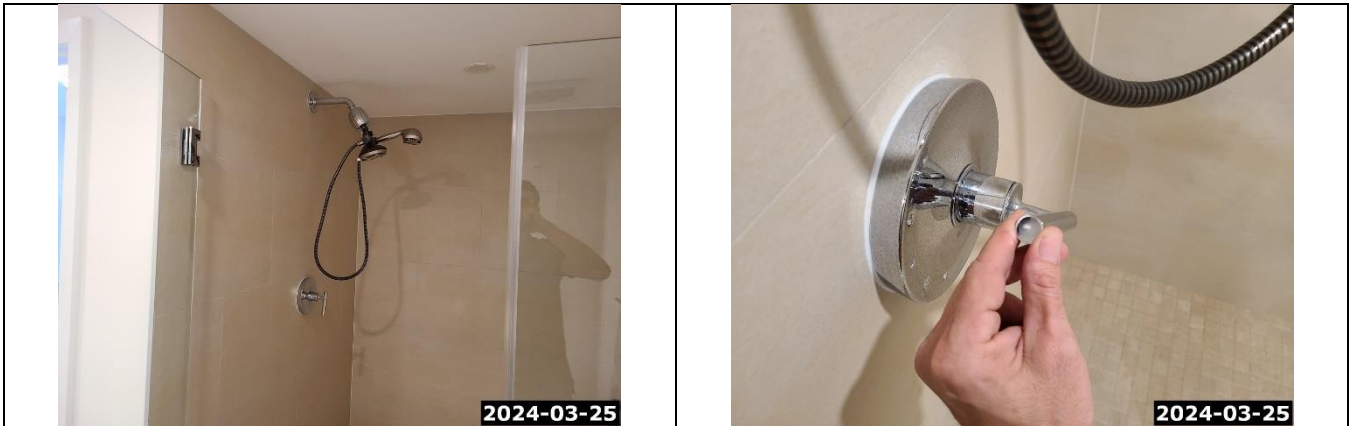
- **Shower fixture handle components are loose (side-to-side movement at handle). Components at the shower handle need to be adjusted to tighten. (shower fixture functional at time of inspection)**

| <b>Bathroom #3 Images</b> | <b>Bathroom #3 Movement at Shower Handle</b> |

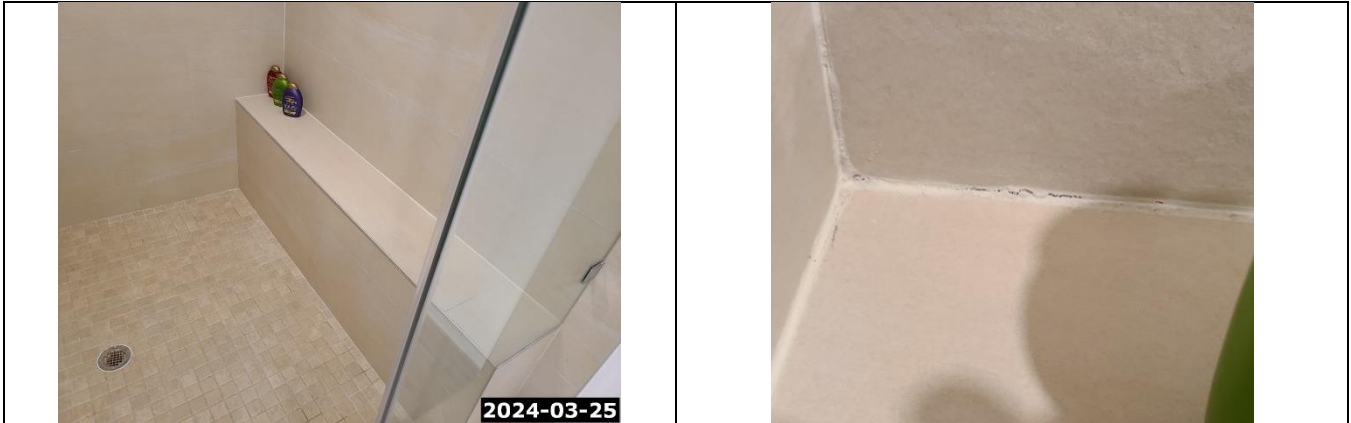
| <b>Bathroom #3<br/>Caulk Cracking at Shower Seat</b> | <b>Bathroom #3<br/>Caulk Cracking at Shower Seat</b> |

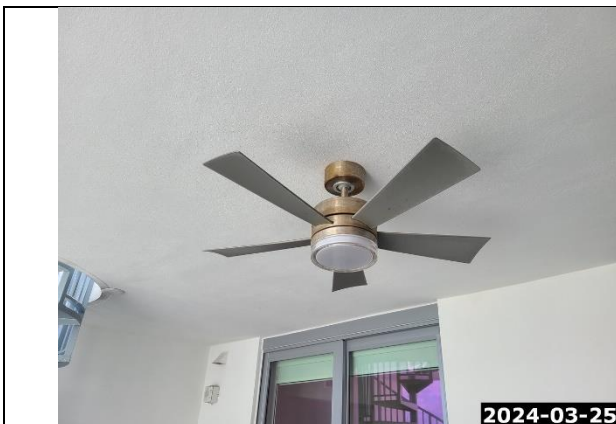
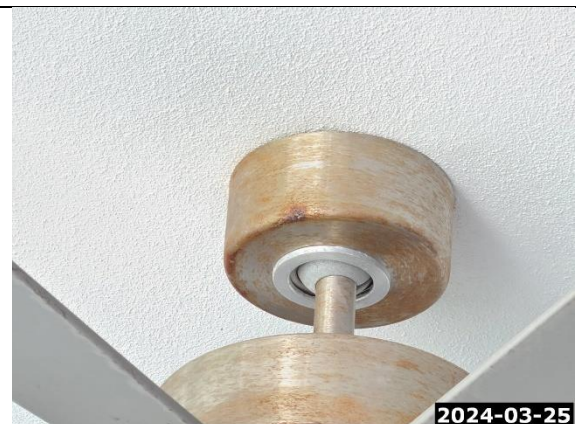
**Rust Visible at Device**

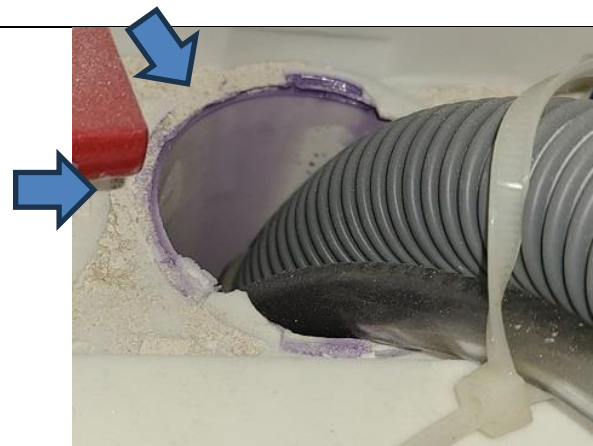
**Damage at PVC at  
Laundry Supply Box**
