# Inspection Report

Prepared Exclusively For:  
Sample Report

Property Located At:  
Cape Coral, FL 33991

Inspection Date: 09/12/2025  
Inspected By: Nick Bangor  
FL Home Inspector License #: HI730

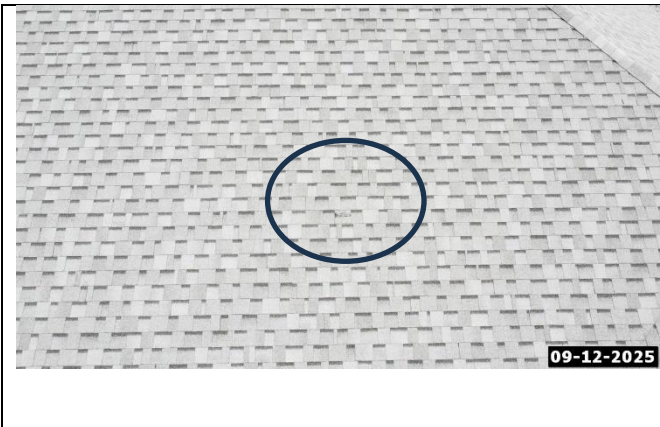
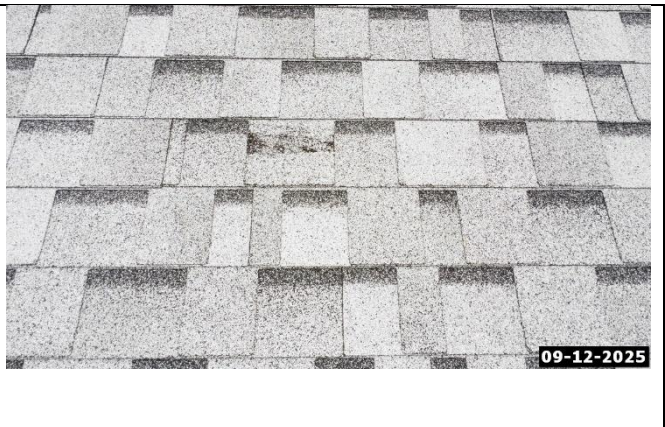
- **Shingle roof covering has a number of shingles that have visible damage; these shingles have areas that are black either from tar or wear to the shingles granule coating.**
- **There are at least four (4) small sections of shingles at the roof that have visible damage and that require replacement.**

Damaged Shingle Visible

**Replace Damaged Roof Shingle**

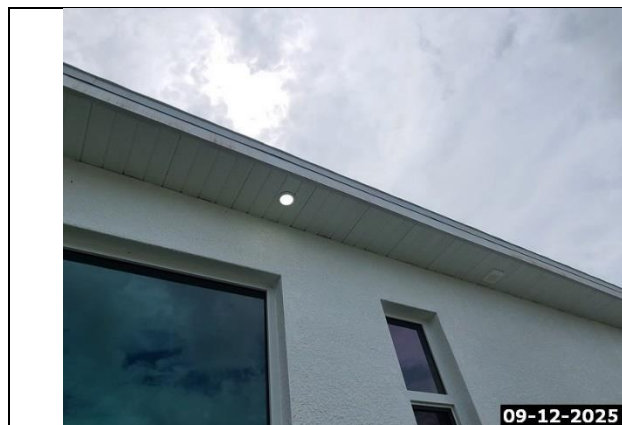
- **There is staining present at the roof fascias. Roof fascias are aluminum over wood.**
- **The roof drip edge flashing is installed without furring strips being installed between the flashing and the fascias to create a gap, this is allowing capillary action to move the draining water to the fascias instead of water dripping off the flashing directly to the ground.**
- **The drip edge flashing should have been spaced from the fascia at time of installation; Consult with a qualified contractor to determine a proper repair method that will not damage the existing drip edge flashing.**

**Staining at Fascias**

**Clean the Fascias of Staining**

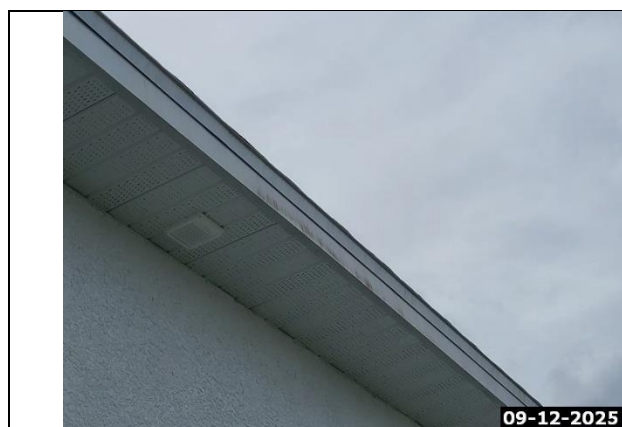
**No Gapping at Areas of Drip Edge**

**Uneven Gapping at Drip Edge**

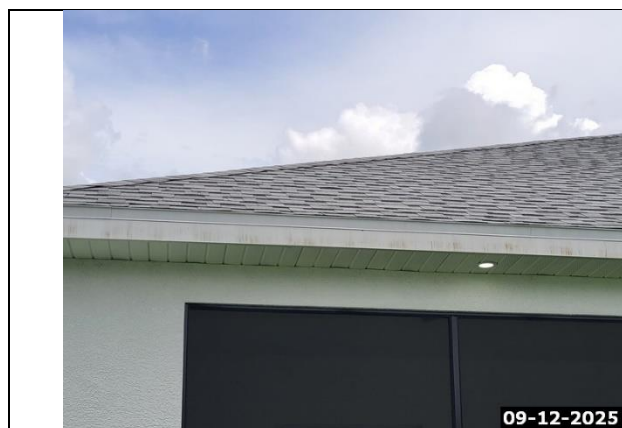
**Staining at Fascias**

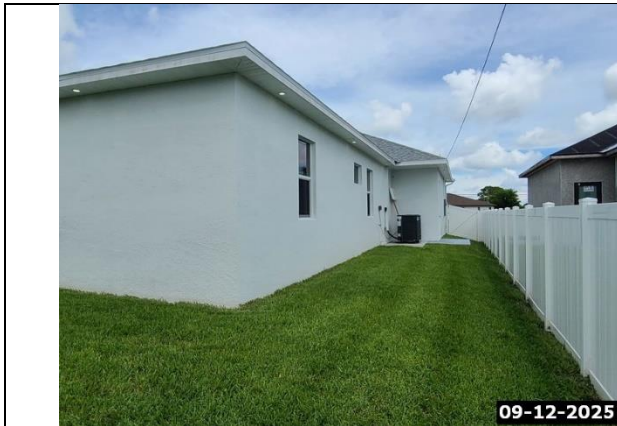
**No Gutters**

**Noticeable Erosion of Ground**

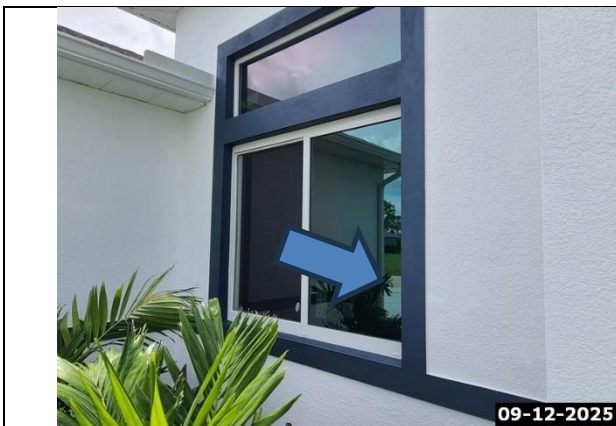
**Damaged Paint / Sealant Around Window**

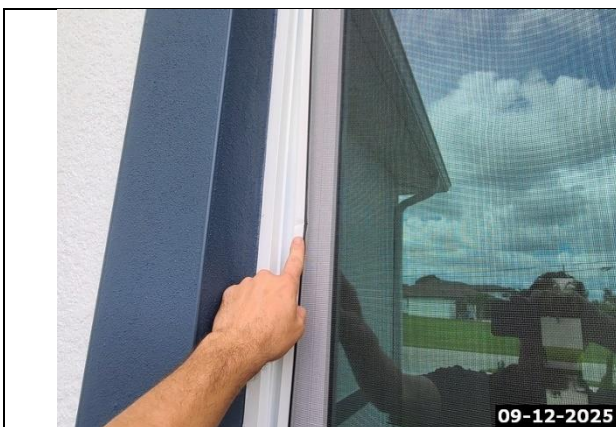
- **Front window (left of entry door) has a damaged window screen. Replace the damaged window screen.**
- Replace Screen**
- **Fixed window installed at the rear elevation has trim installed over the weather seals at the bottom of the window; water appears to be getting behind this trim. Staining present at window frame under the seam between the mentioned trim and the window, this is evidence of moisture draining from the seam from behind the trim.**
  - **Reinstall trim and install seal and if required.**
- Seal Trim at Rear Window**

**Damaged Window Screen**

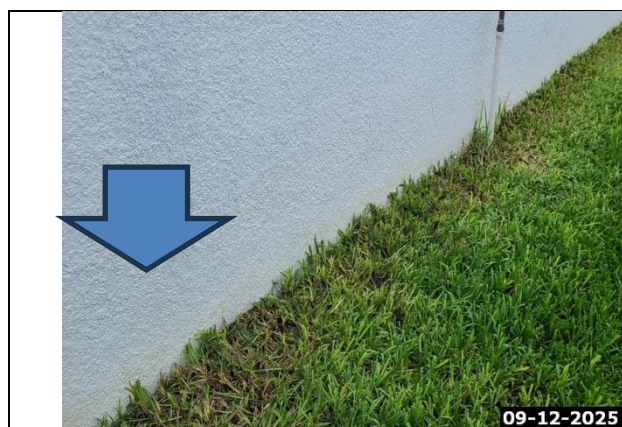
**Staining at Bottom of Wall**

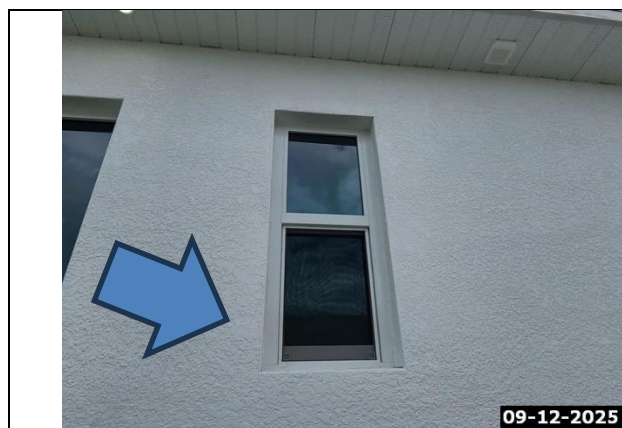
- **Sealant / caulking installed at windows, doors, and exterior water faucet piping is cracking; install additional sealant / caulk to seal cracking.**

**Cracking at Window Sealant**

**Install Additional Sealant / Caulk****Driveway Condition: Fair**

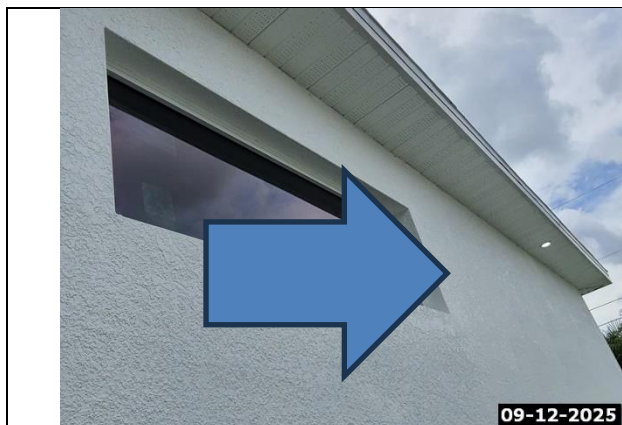
**Wall Appears Gray  
(Not Enough Paint)**

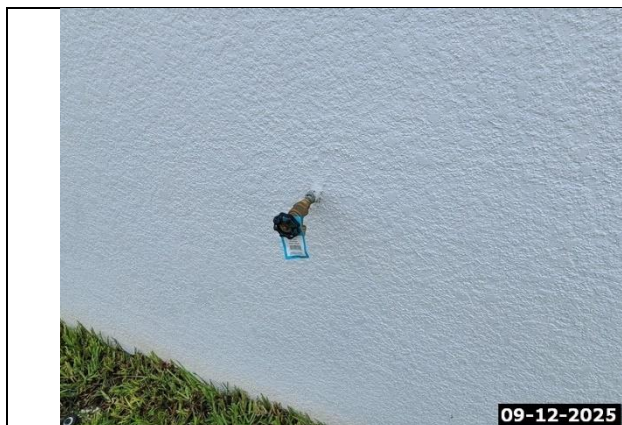
**Cracking at Sealant**

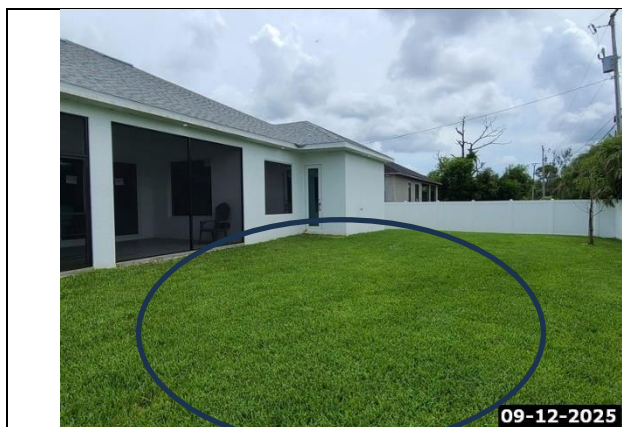
- **Rear yard is uneven at areas, this is likely due to erosion of ground fill (see other comments). Have ground fill leveled after causes of erosion are mitigated.**

**Uneven Ground**

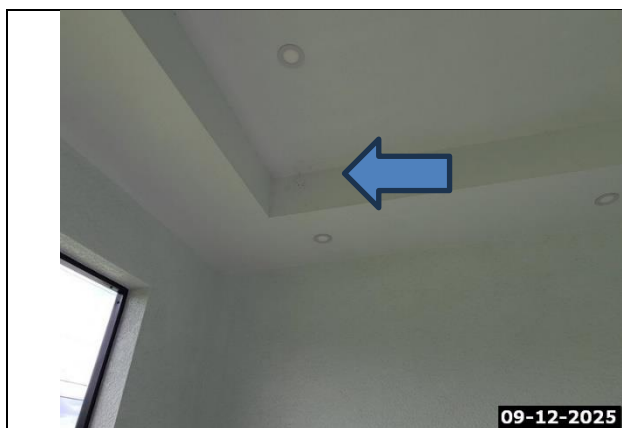
- **Spider webs (cobwebs) present at the rear patio ceiling; webs and debris appear to have stained the ceiling. Clean away insect debris from ceiling and paint if discoloration remains after cleaning.**
- Remove Insect Debris and Clean / Paint**

**Ceiling – Stains from Insects**

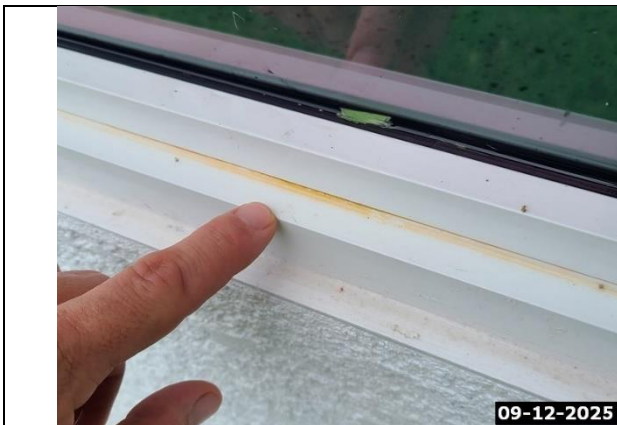
**Staining at Seam Under Window Trim**

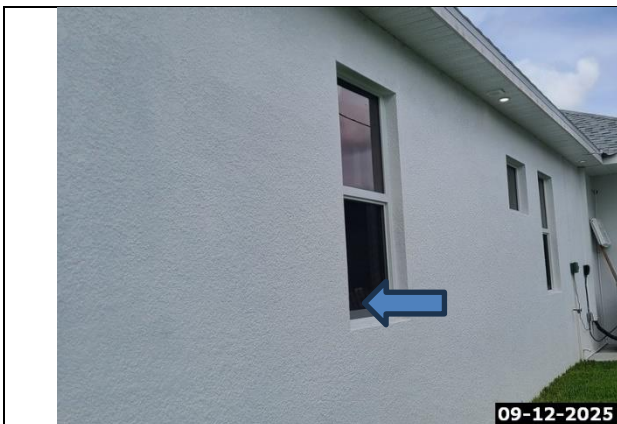
**Cracking at Caulking**

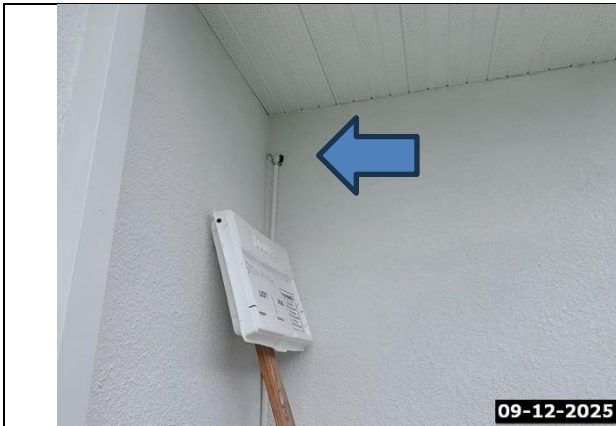
- AC system condensation drain runs through a hole in garage wall to the exterior. The opening around the condensation drain line is sealed with a temporary solution (loose insulation / fabric). Install a permanent sealant at gaps around the AC system condensation drain pipe.

**Gaps Present around AC System  
Condensation Drain Line**

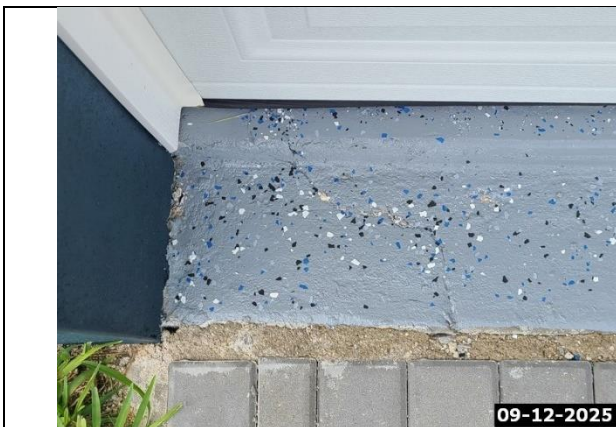
Crack Under Coating

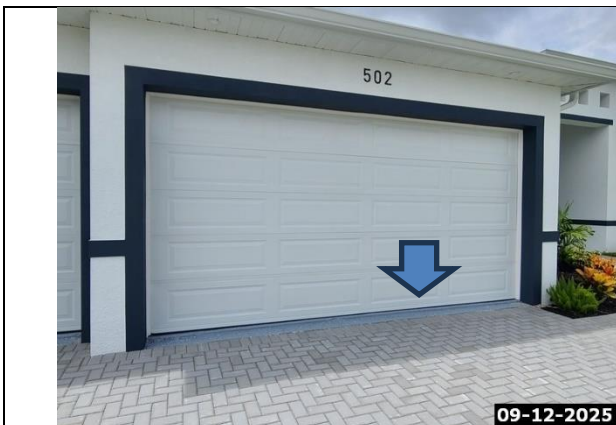
**Damaged Slab (Chip)**

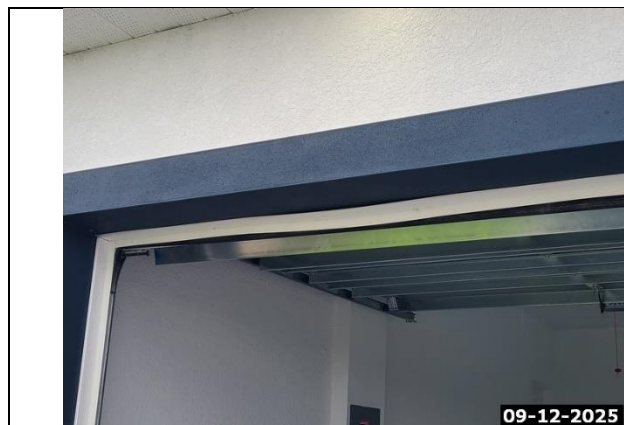
**Trim Around Garage Door Opening**

**Nails Improperly Installed at Trim Around Garage Door Opening**

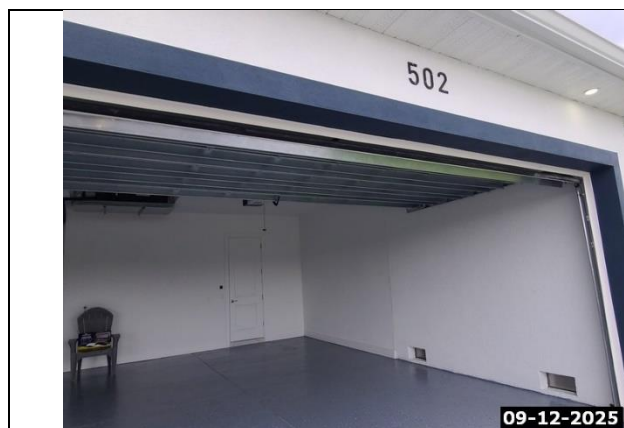
**Trim Around Garage Door Opening**

**Nails Improperly Installed at Trim Around Garage Door Opening**

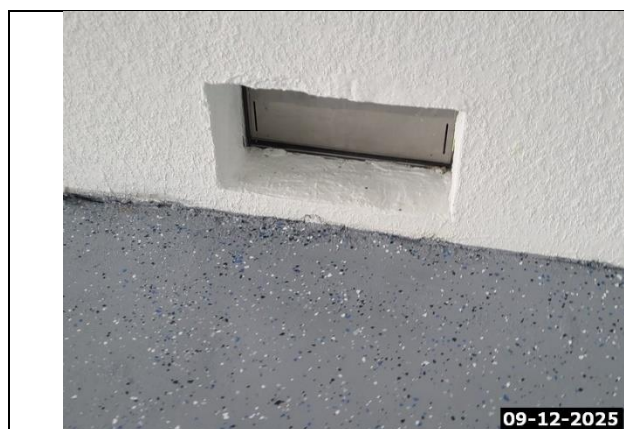
**Openings for Garage Wall Vents are Not Perfectly Square and Have Poorly Installed Paint**

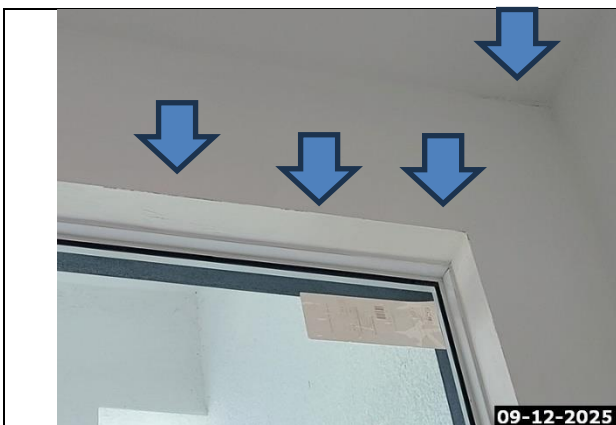
**Exposed Corner Bead at Window + Lack of Paint at Wall Corner**

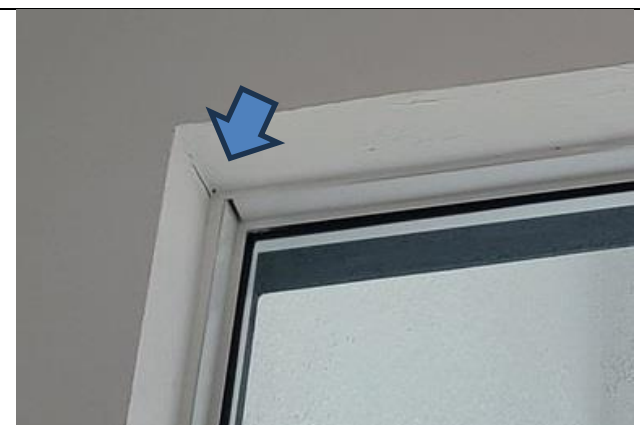
**Cracking at Wall Around Window**

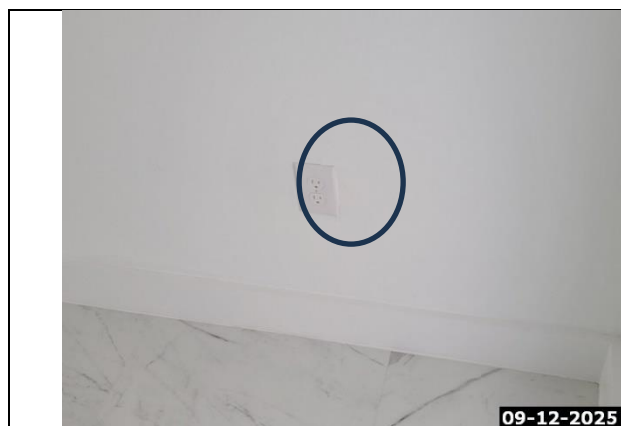
**Wall Repair Visible Around  
Outlet Next to Front Entry**

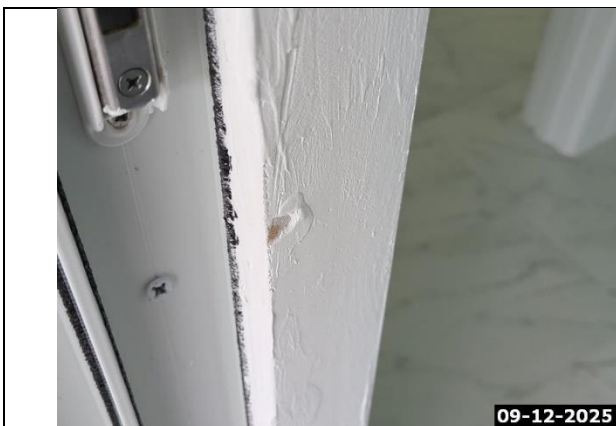
**Wall Around Sliding Patio Door  
Excessive Joint Compound  
Damage Present**

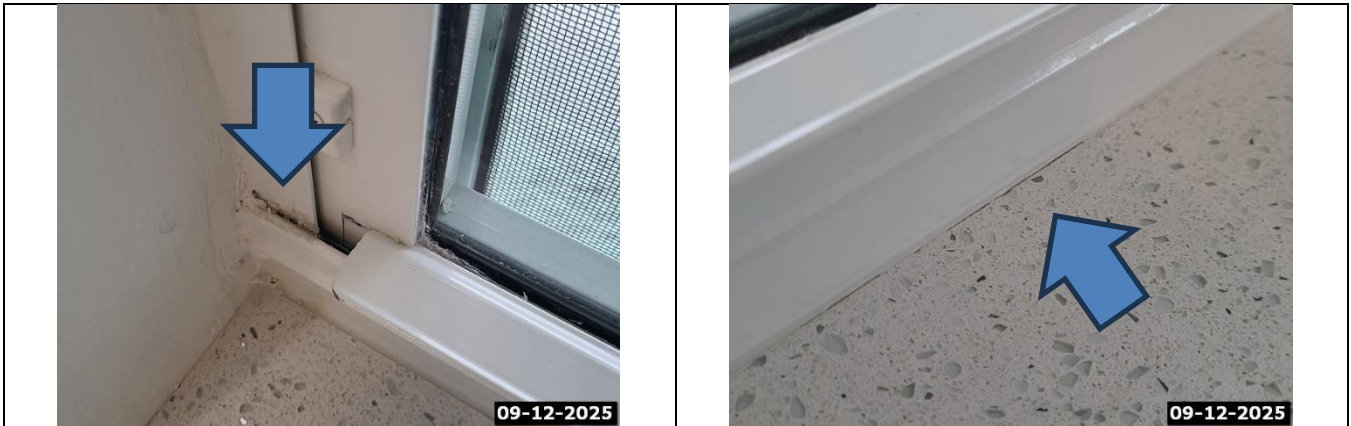
Caulking separated at Window Frame

Cracking at Caulk Seam Between Window and Window Sill

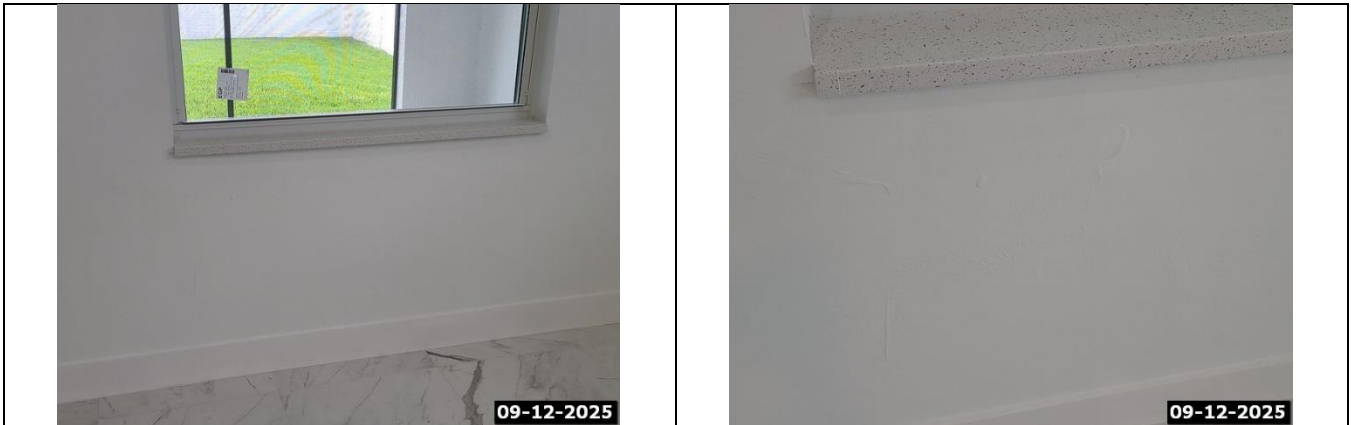
Poor Wall Texturing

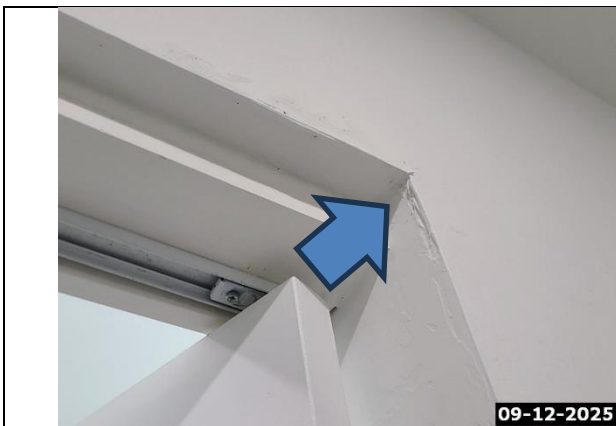
**Poor Wall Texture**

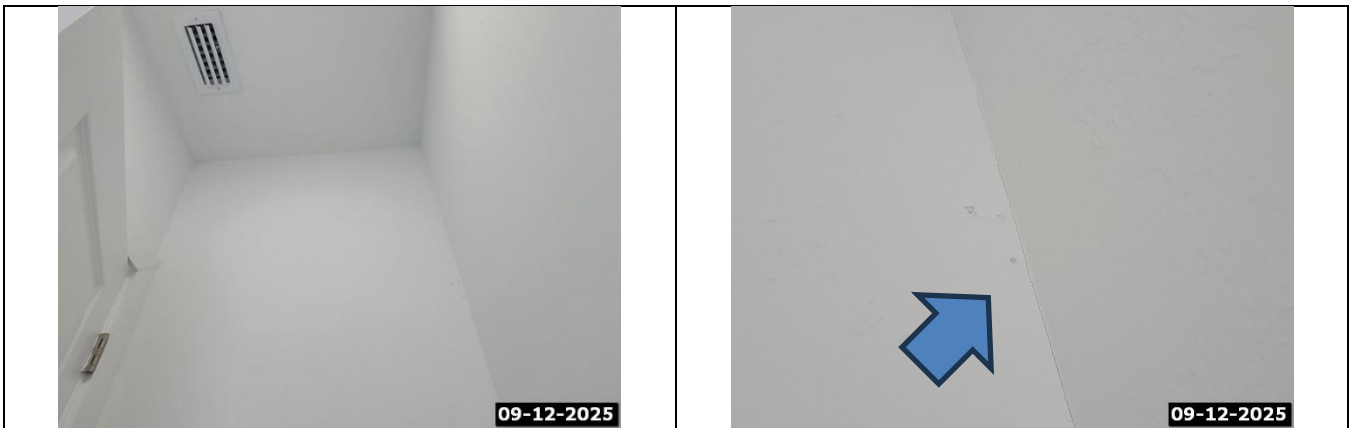
**Poorly Installed Wall Texture  
Master Bathroom Corner Cracking**

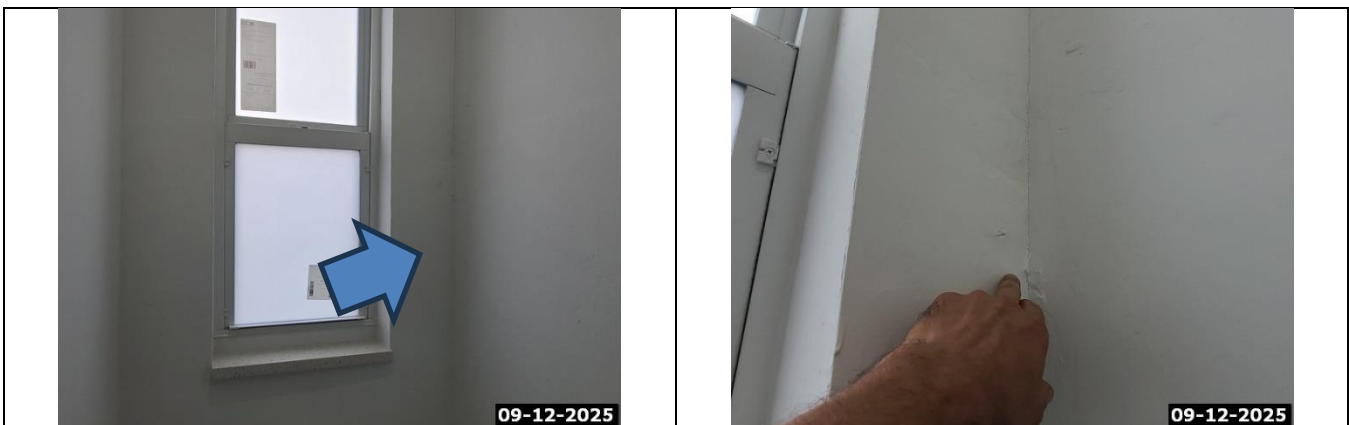
**Thick, Poorly Installed Wall Texture**

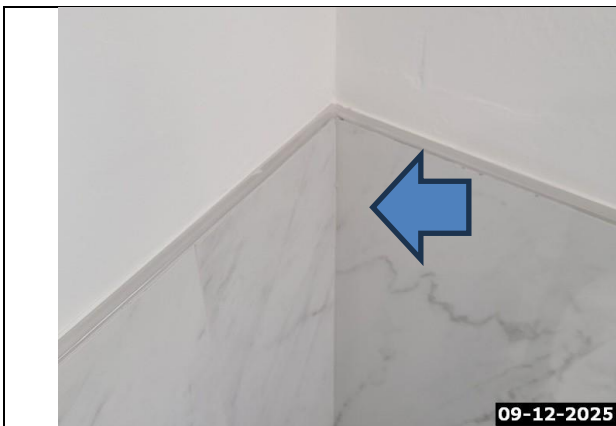
**Cracking at Grout / Caulk at Corner  
Seam of Wall Tile**

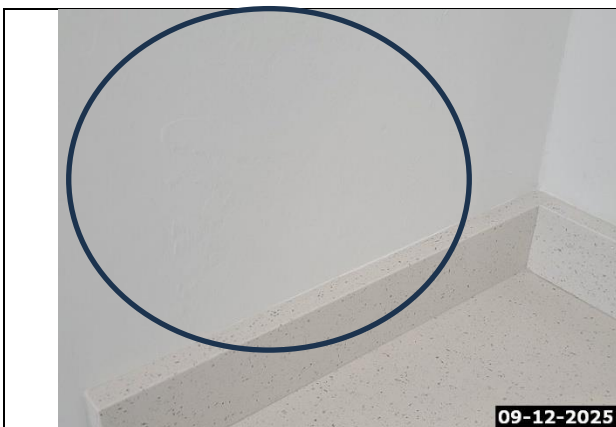
**Poorly Installed Wall Texture  
Left of Master Bathroom Sink**

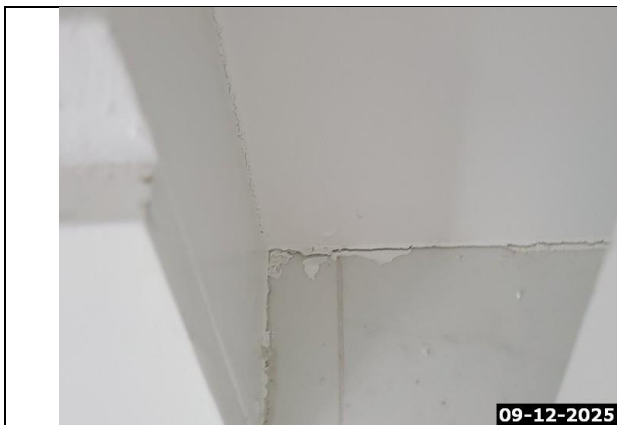
**Paint on Tile**

**Trim Around Door is Not Aligned**

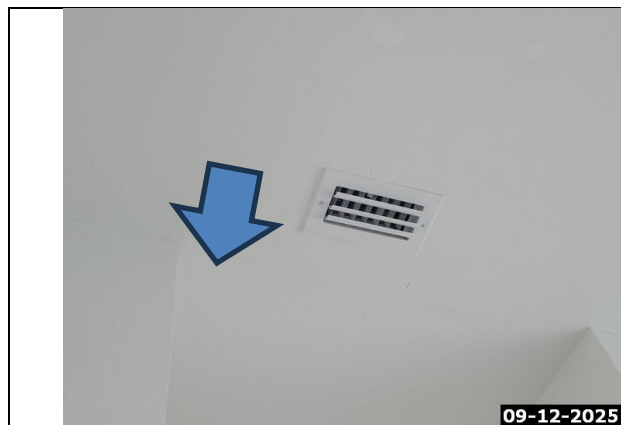
**Cracking at Ceiling  
Master Bathroom**

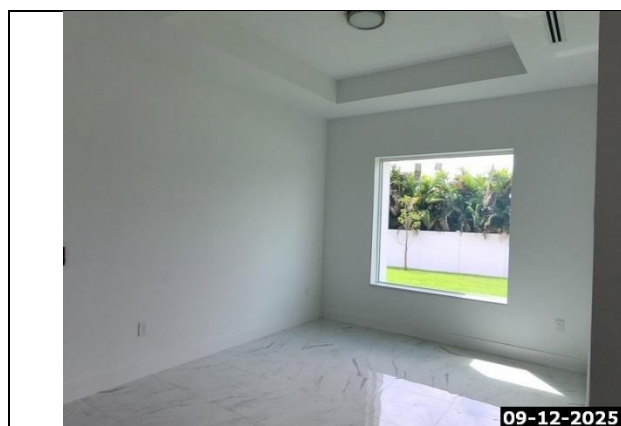
**Dining Room**

**Unpainted Wall Repair**

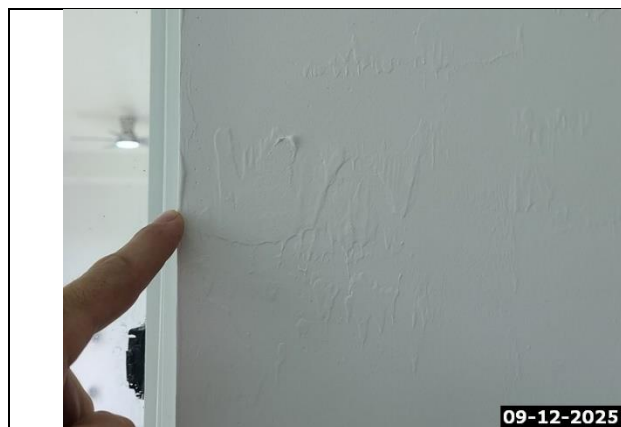
**Poorly Installed Wall Texture**

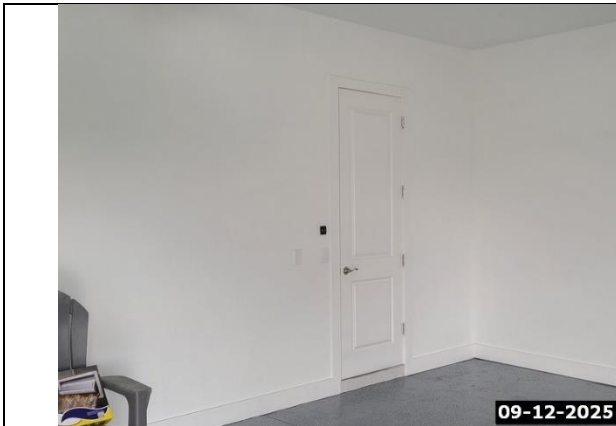
**Garage-to-Home Door**

**Paint at Hinges**

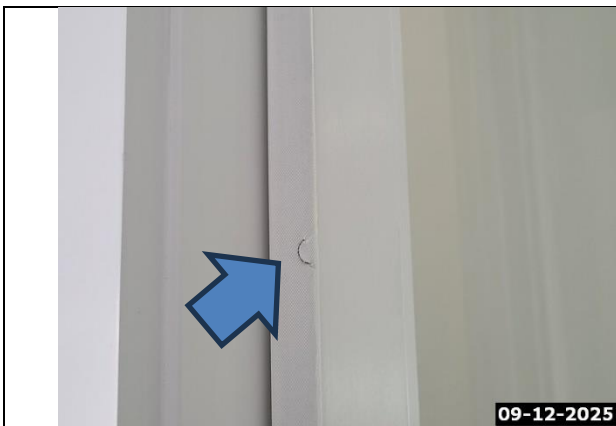
**Damaged Weather Seal at Door**

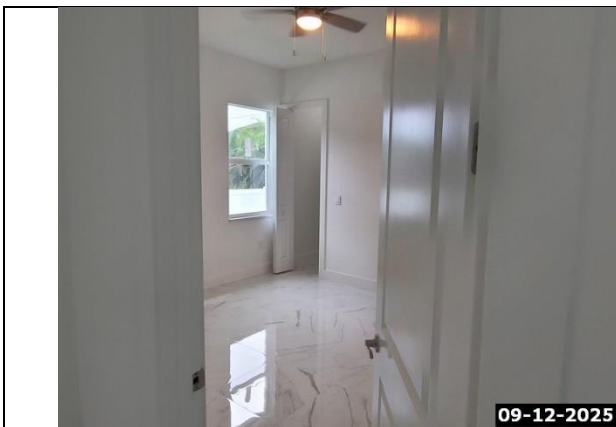
**Southwest (left-Rear) Bedroom**

**Poorly Installed Wall Texture**

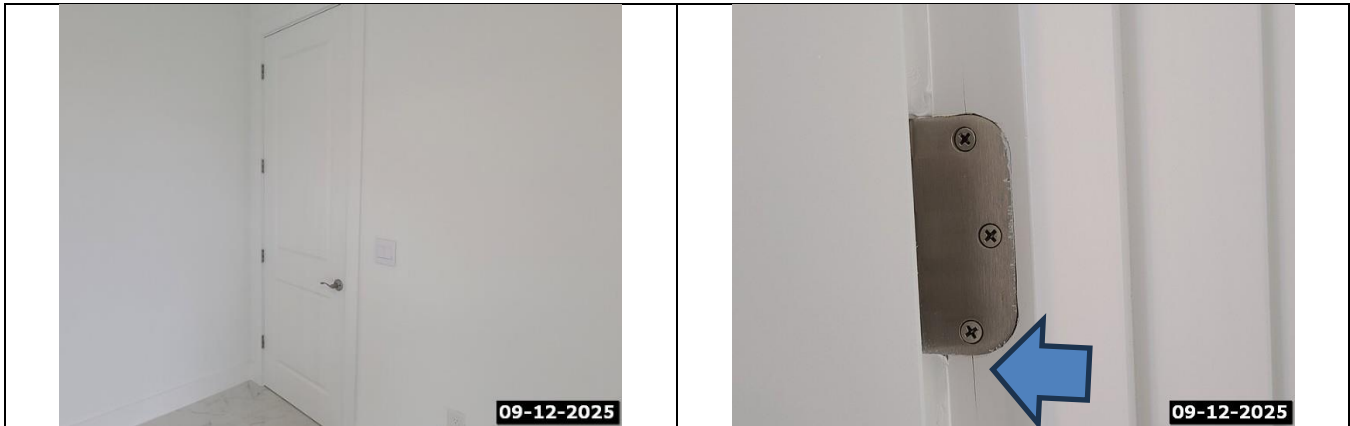
**Southwest (left-Rear) Bedroom  
Door**

**Damage at Door Frame Around  
Hinge Bore**

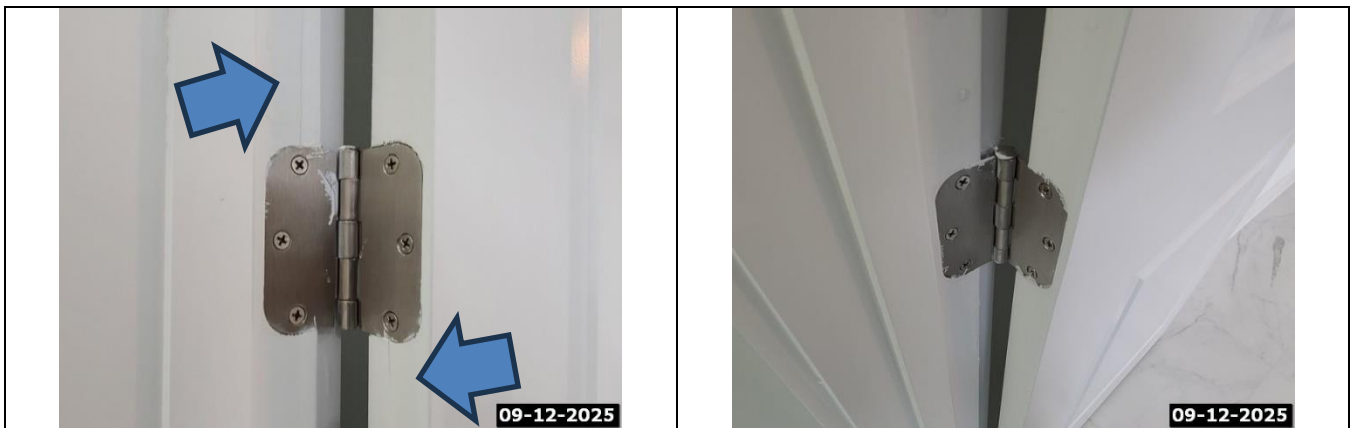
**Southwest (left-Rear) Bathroom  
Cracking at Door Frame and Door**

**Poorly Installed Wall Texture**

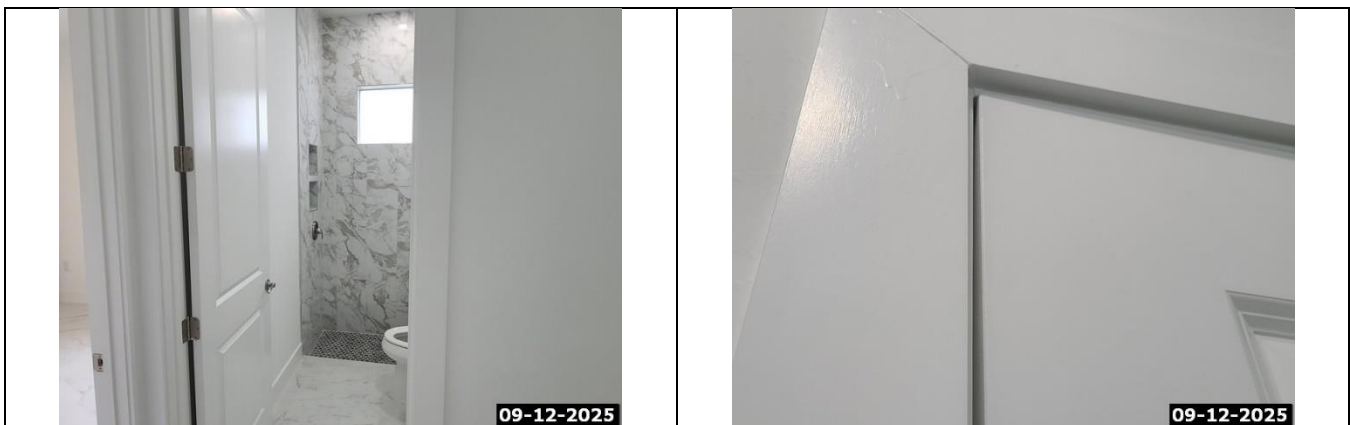
**Hall Bathroom**

**Hall Bathroom Door Appears  
Warped – Top of Door Bowing Out**

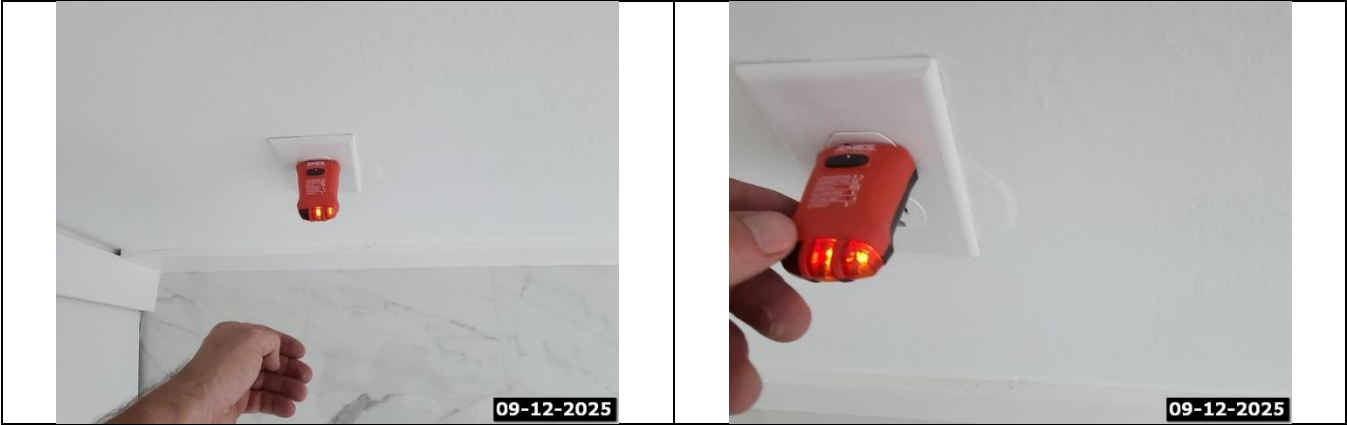
Wall Damage Near Outlet

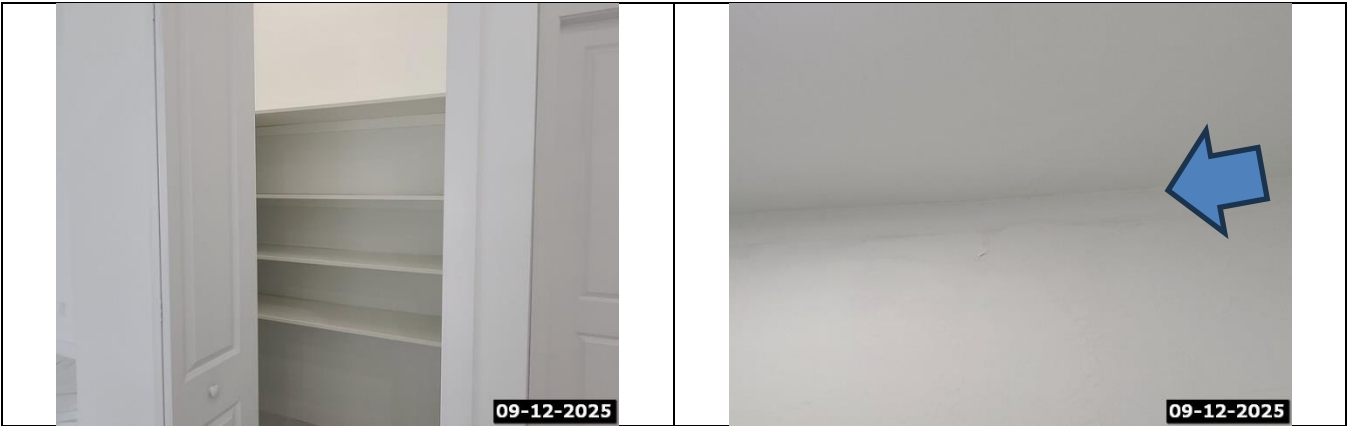
Kitchen Pantry

Insufficient Wall Paint

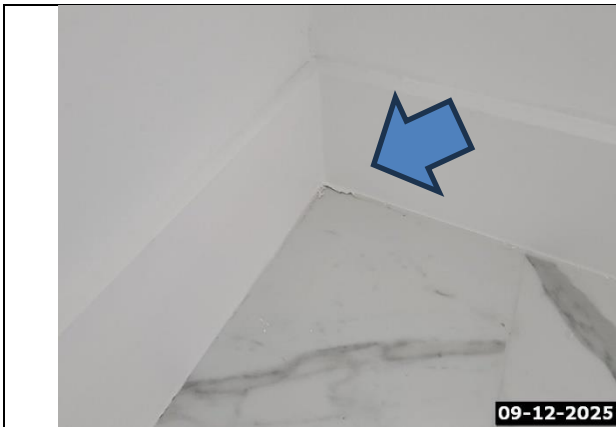
**Caulking Cracking Between Wall Moulding and Floor Tile**

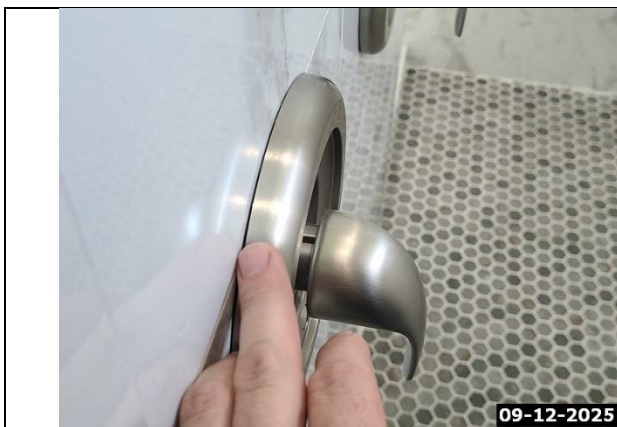
**Shower Faucet Hardware – Install  
Caulk to Prevent Standing Moisture  
and Mildew Growth****Shower Faucet**

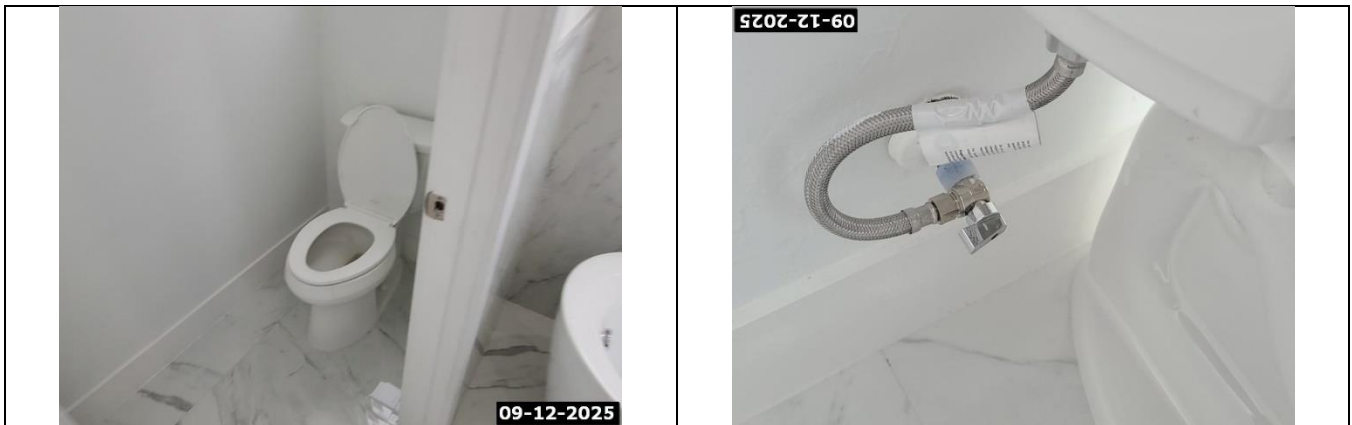
**Toilet****Toilet Shutoff Valve  
Escutcheon Covering Opening at  
Wall is Loose**

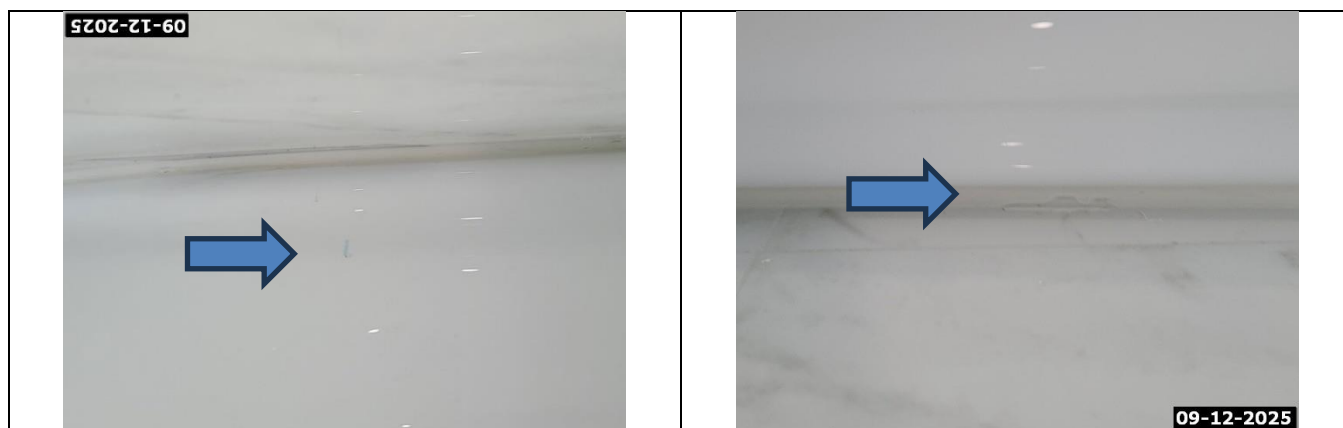
**Bathtub – Paint on Tub**

**Bathtub – Caulking Under Tub  
Damaged**

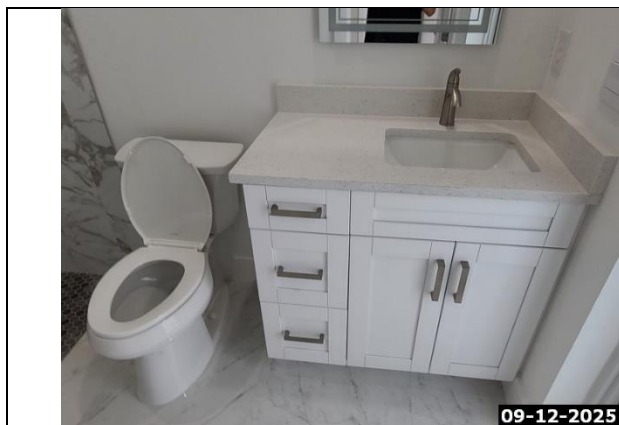
**Bathroom #2 Images****Bathroom #2 Sink Drain  
Gap In Wall Around Drain**

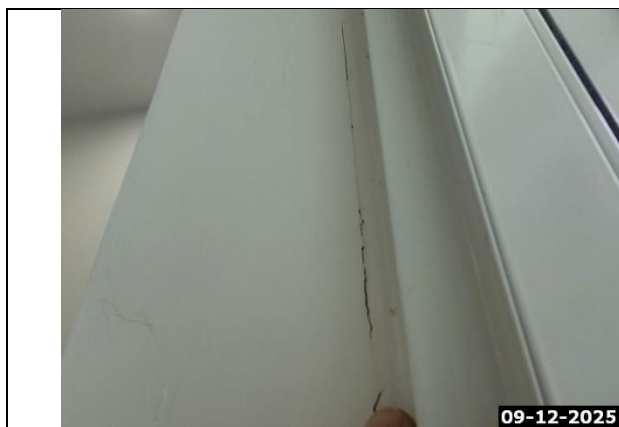
**Cracking at Wall Around Door  
Frame at Exterior Door****Sticker Remaining at Door**
