# Inspection Report

Prepared Exclusively For:  
Sample Report

Property Located At:  
Delray Beach, FL 33444

Inspection Date: 03/25/2024  
Inspected By: Nick Bangor  
FL Home Inspector License #: HI730

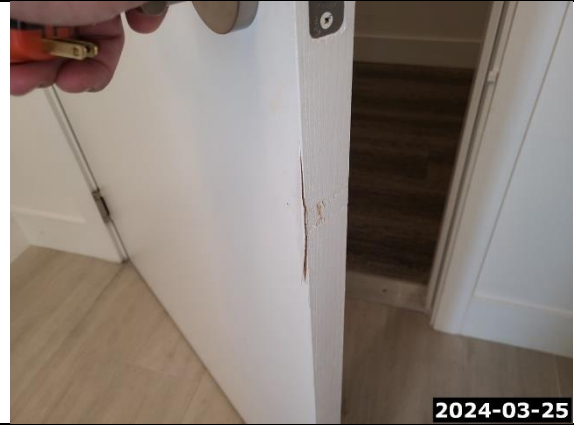
**Damage at Front Door**

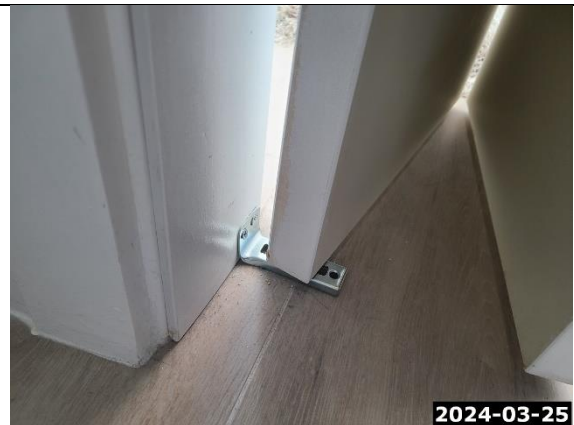
**Anchor Attachment Appears to be  
in Incorrect Location**

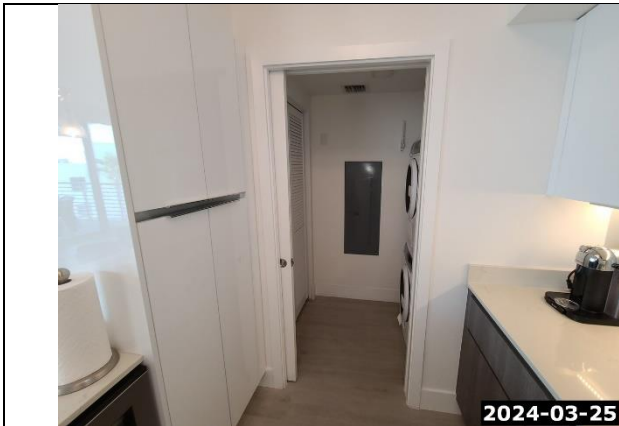
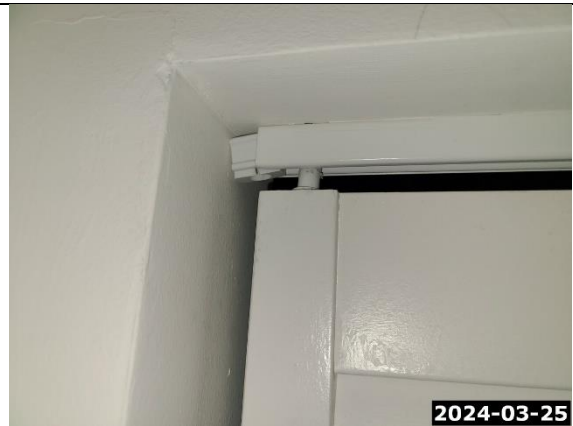
**AC Closet Door Track Service  
(Inside Utility Room)**

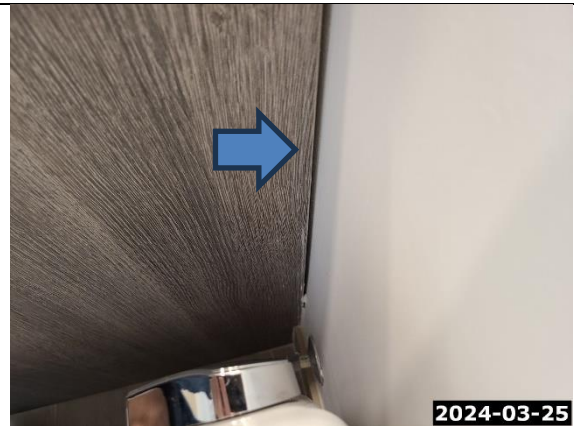
**Caulking Incomplete at Cabinet**

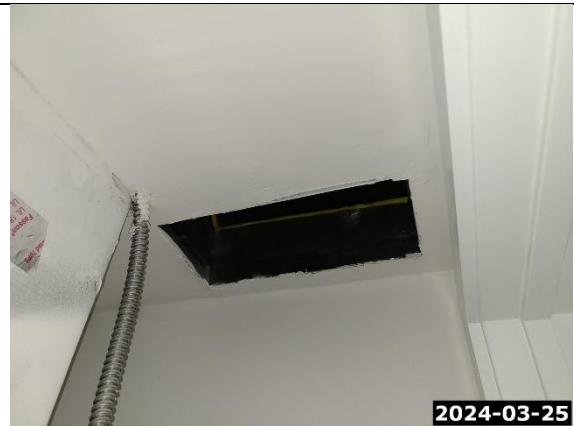
- **Missing ceiling vent register cover at AC system closet (closet shared with water heater). Currently there is only an opening in the ceiling to the duct with no metal cover.**  
**Duct Register Est \$100+**

**Opening in Ceiling in Utility Closet –  
Vent Register Required**

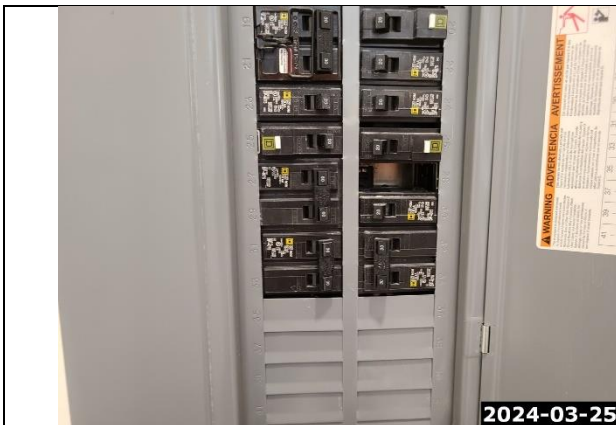
- **Circuit breaker panel is a Square D brand panel.**
- **One circuit breaker was removed from the panel and replaced with a panel blank that is undersized. The blank is large enough to prevent access and is sufficient for safety. Replace the plastic blank with a larger blank to fill the entire opening as is desired.**

**Cover Sitting On Breakers Instead  
of Around Breakers**
