# Inspection Report

Prepared Exclusively For:  
Sample Report

Property Located At:  
Cape Coral, FL 33991

Inspection Date: 09/12/2025  
Inspected By: Nick Bangor  
FL Home Inspector License #: HI730

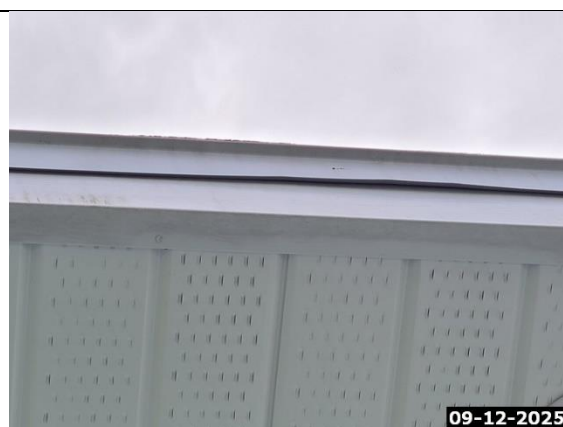
**Uneven Gapping at Drip Edge**

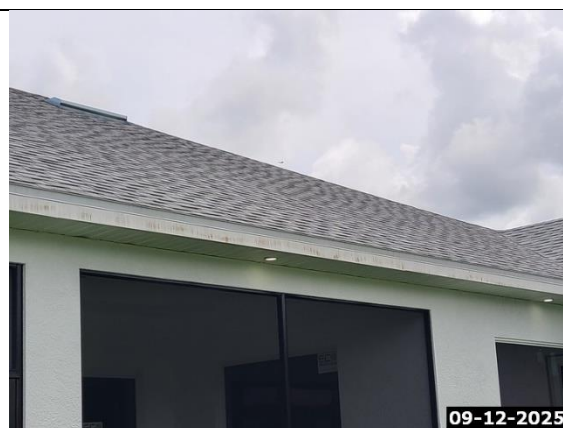
**Staining at Fascias**

**Clean the Fascias of Staining**

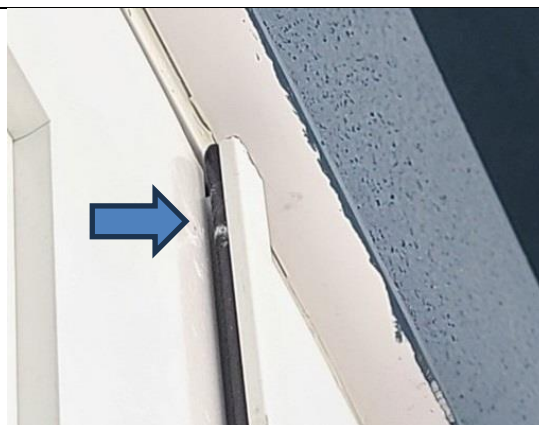
**Gap at Door Astragal**

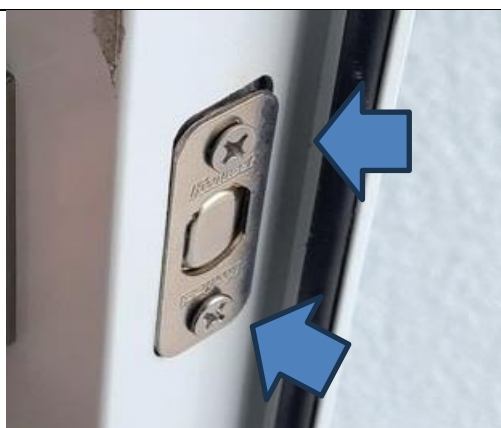
**Strikeplate and Hardware Not Flush**

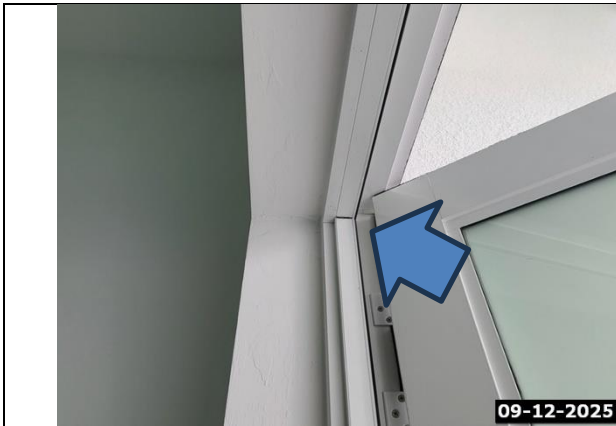
**Gap at Door Frame**

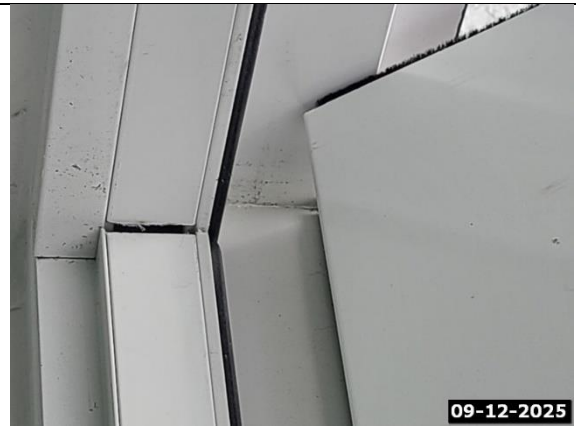
**Gap at Door Frame**

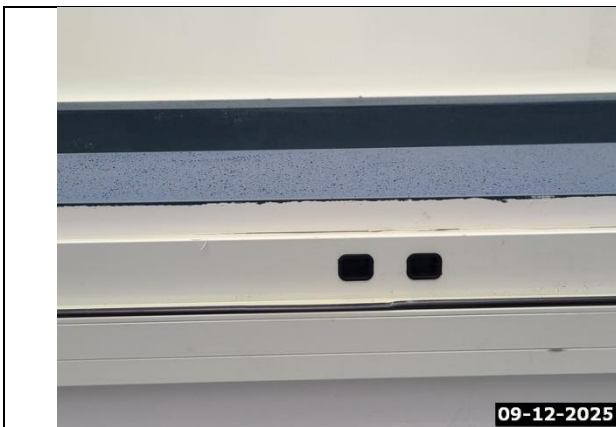
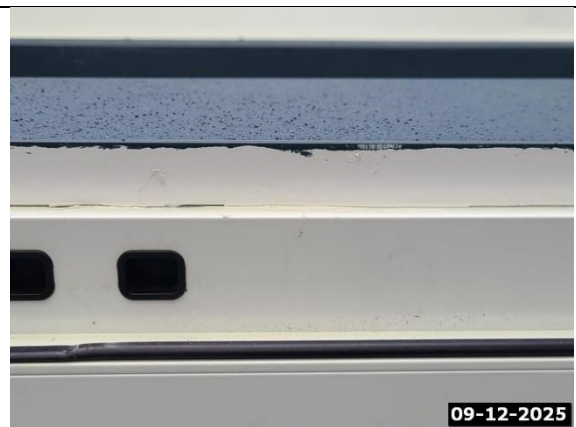
**Paint Poorly Installed –  
Around Door**

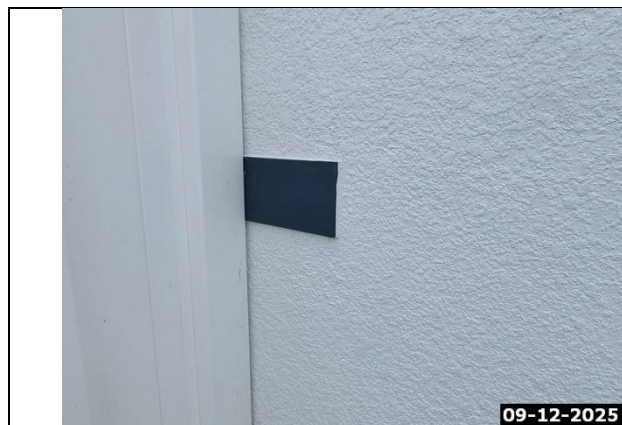
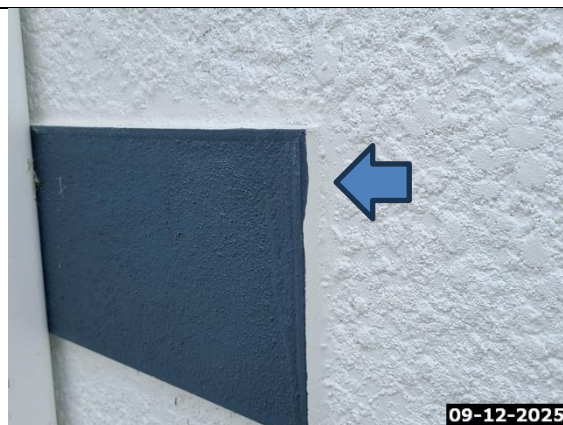
**Poor Paint Lines at Transitions**

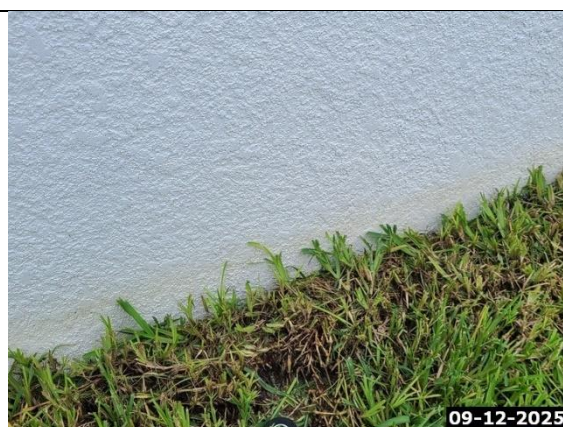
**Staining at Bottom of Wall**

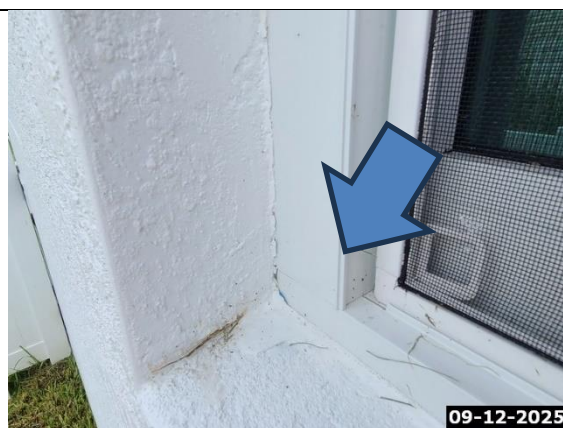
- **Sealant / caulking installed at windows, doors, and exterior water faucet piping is cracking; install additional sealant / caulk to seal cracking.**

**Cracking at Window Sealant**

**Install Additional Sealant / Caulk****Driveway Condition: Fair**

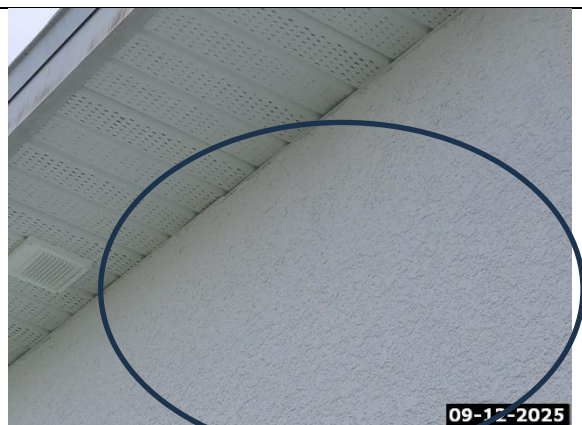
**Wall Appears Gray  
(Not Enough Paint)**

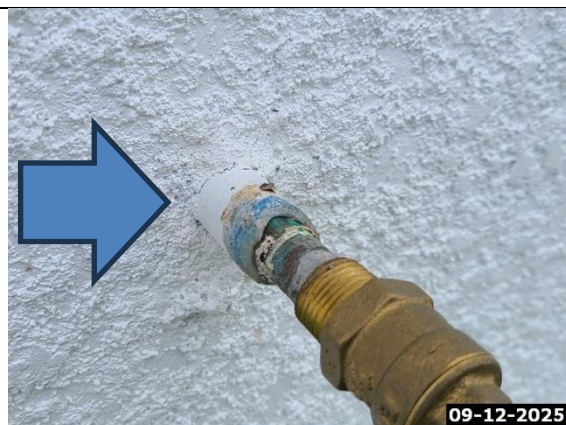
**Cracking at Sealant**

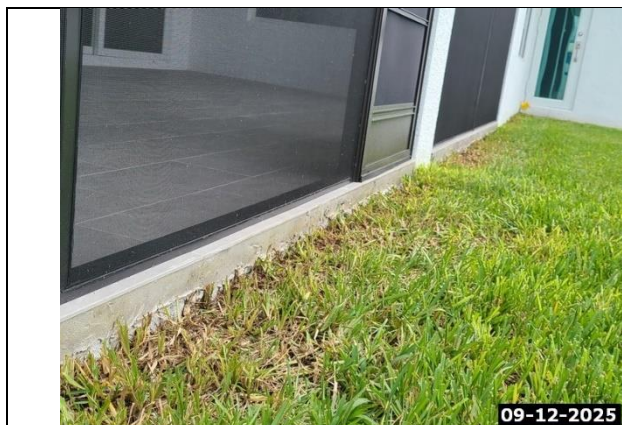
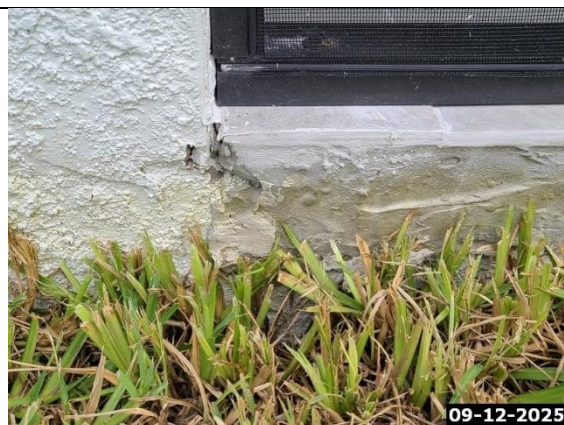
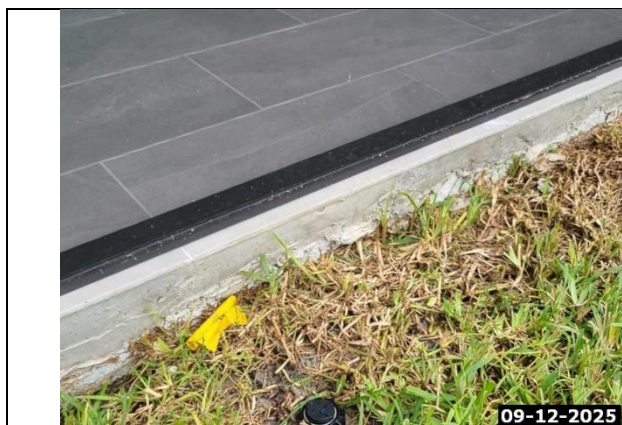
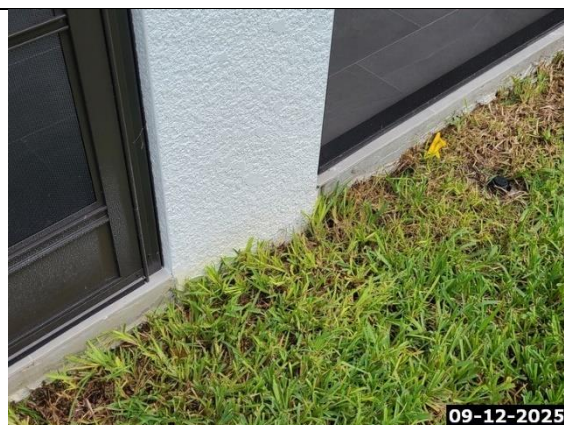
**No Stucco at Wall Under Patio**

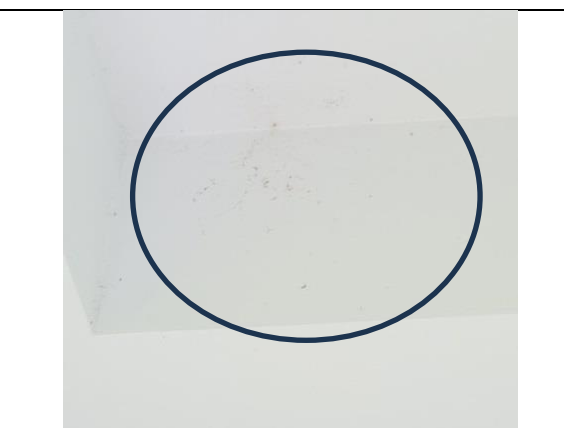
**Ceiling – Stains from Insects**

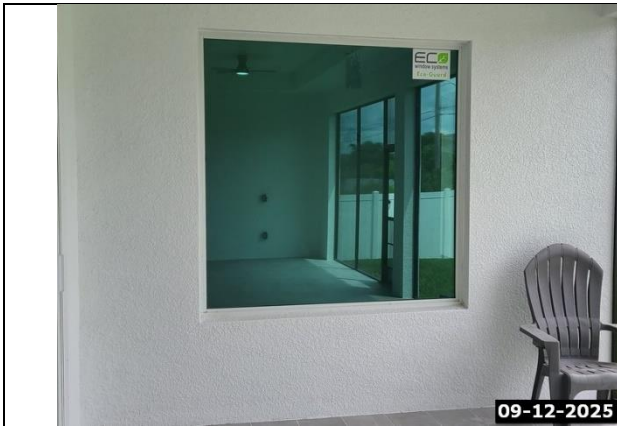
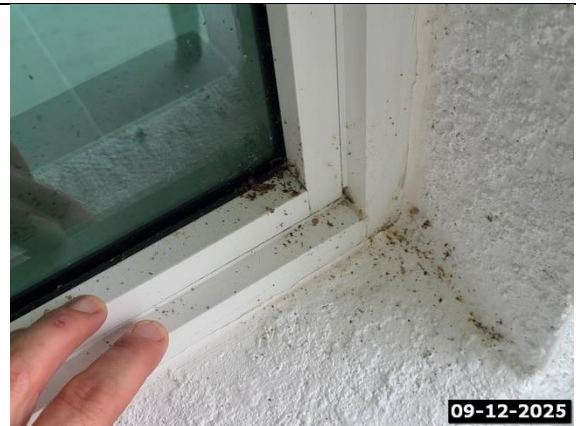
**Caulking / Sealant at Window**

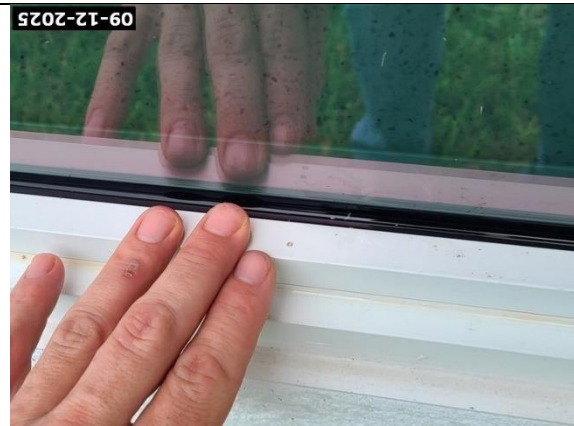
**Rear Fixed Window – Standing Water at Bottom Seal**

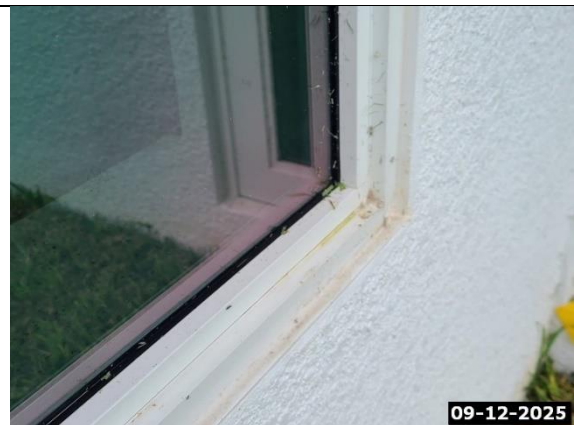
**Staining at Seam Under Window Trim**

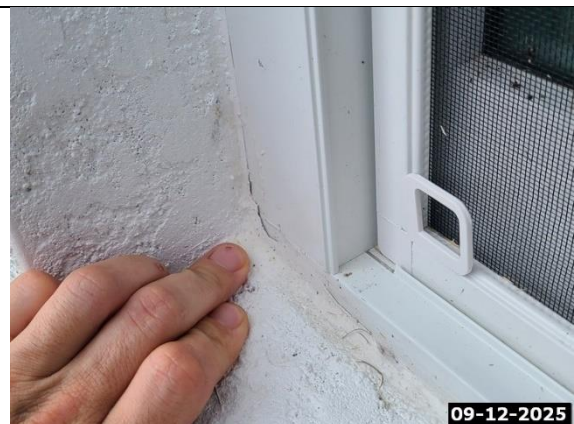
**Cracking at Caulking**

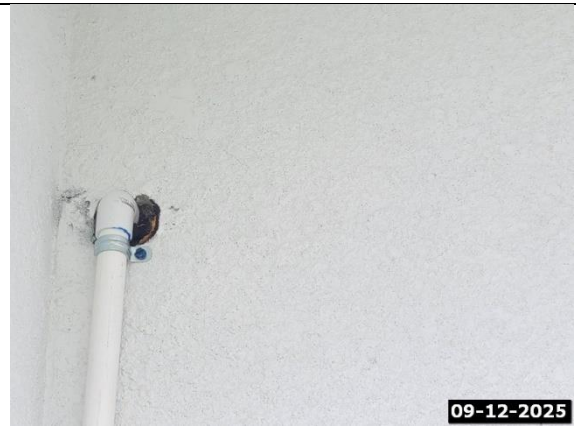
**Gaps Present around AC System  
Condensation Drain Line**

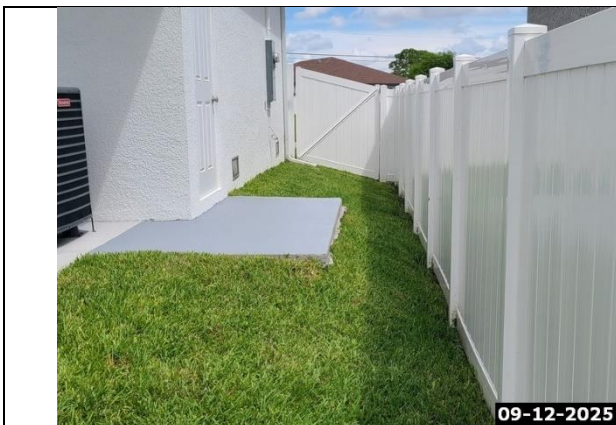
- **There is noticeable erosion of the ground fill around the home.**
- **The side yards at the home are on steep angles down from the home towards swales between the home and neighbors (this itself is creating a sloped ground that is difficult to walk on).**
- **The steep angles of the ground combined with lack of rain gutters is allowing erosion to occur (see images of slab installed outside of garage).**
- **See "Privacy Fence" comments.**
- **Recommend installing a retaining wall at the edge of the property so that ground fill can be added to the property.**
- **Underground drainage may be required; ensure property is draining water effectively.**

**Slope at Sides of Home**

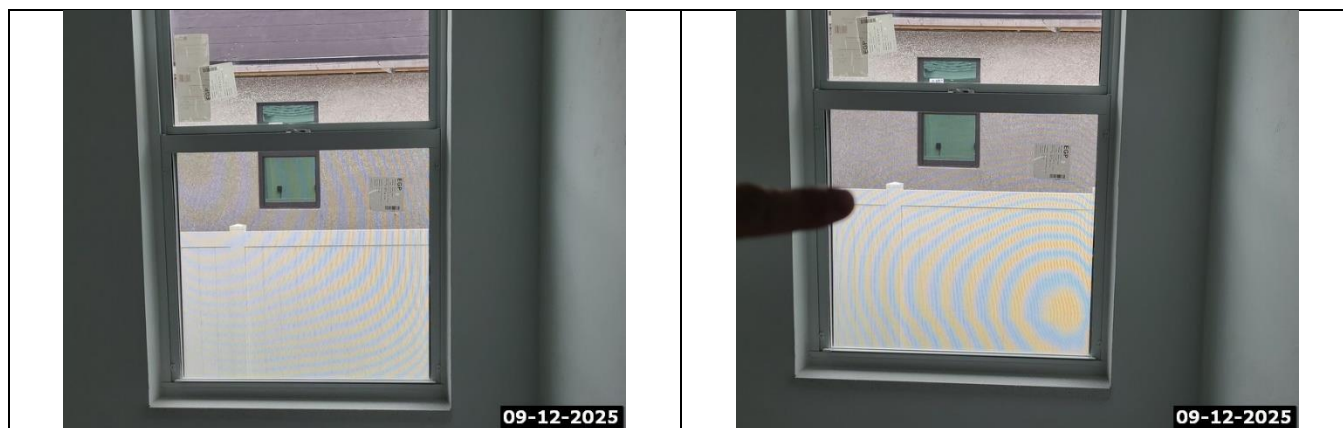
**View From South Facing Bedroom Window**

- **PVC privacy fence installed at perimeter of the home has foundations that are multiple feet lower than the foundation of the home. The lower fence foundations translate to a lower effective height of privacy behind the fence.**
- **The top of the fence appears to be at or below the height of bedroom window sills. There is no visible blocking of the neighbors bedroom windows when viewed from bedrooms inside the home.**
- **See Ground Slope" Comments.**
- **Recommend installing the fence at the time of retaining wall and ground fill installation; the fence can then be installed at a height beginning at the top of the retaining wall (if a proper foundation is poured).**

**Privacy Fence is Under the Windows of the Neighboring Home**

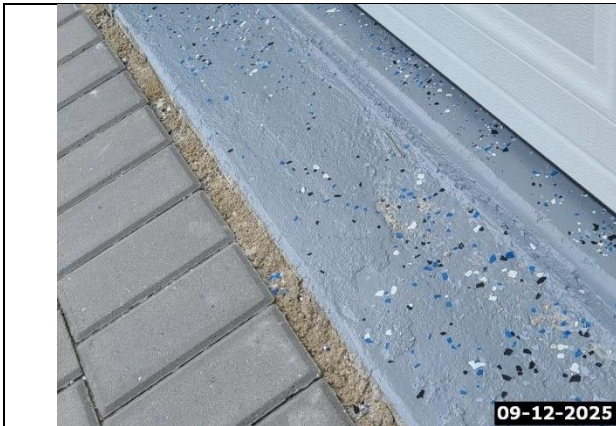
**Debris Under Coating (Uneven)**

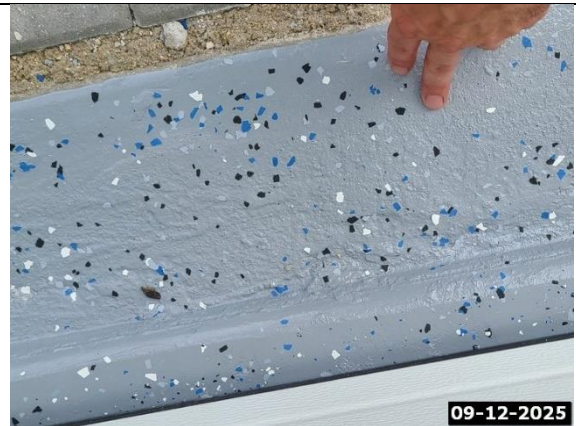
**Debris Under Coating (Uneven)**

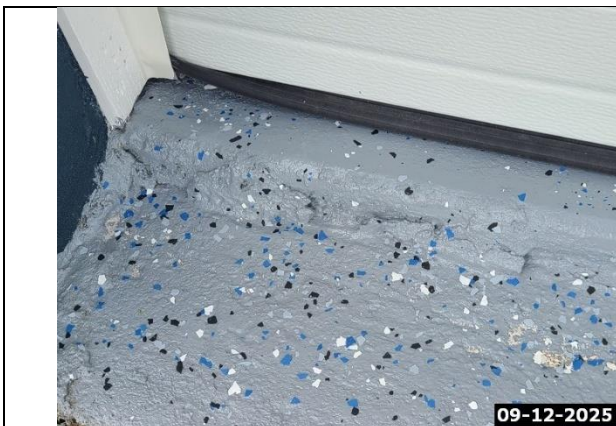
**Debris Under Coating (Uneven)**

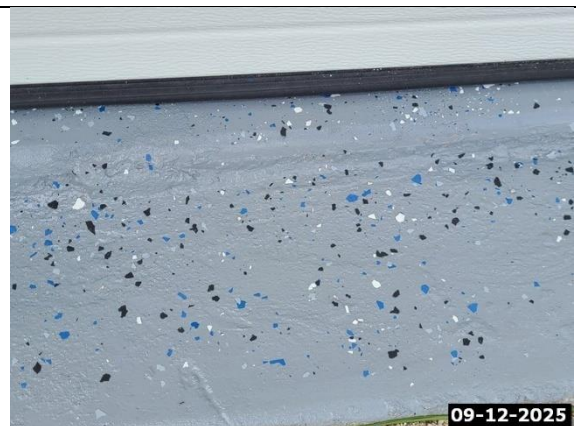
**Debris Under Coating (Uneven)**

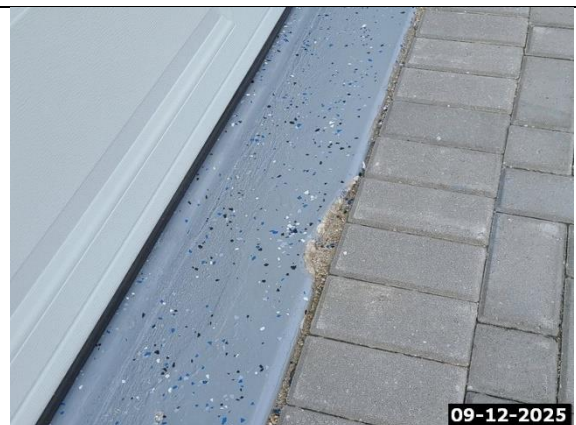
- **Damage (chipping) present at the two-car garage threshold. Ensure repairs make previous damage no longer visible.**

**Damaged Slab (Chip)**

**Repair Garage Slab Chip Damage**

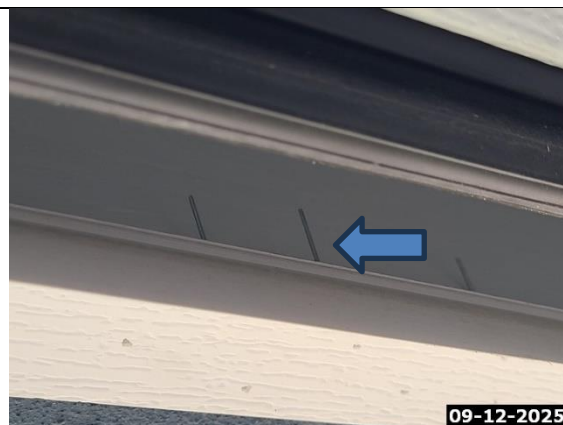
**Nails Improperly Installed at Trim Around Garage Door Opening**

**Repairs are required to reinstall the attachment hardware at the garage door opening trim..**

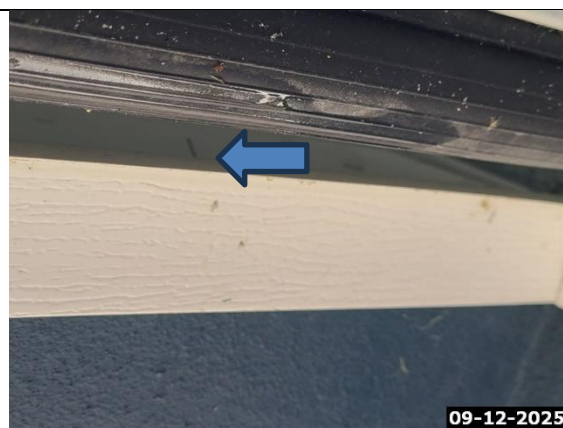
**Nails Improperly Installed at Trim Around Garage Door Opening**

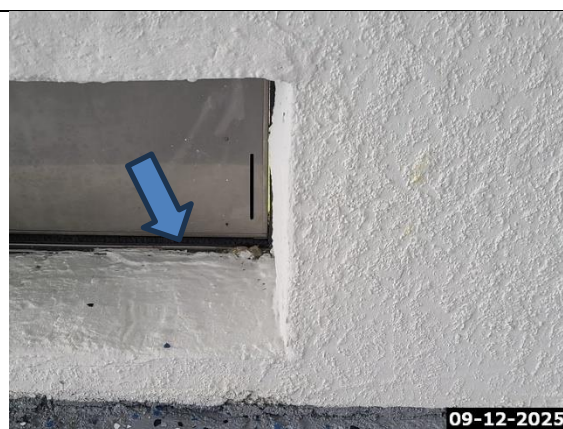
**Openings for Garage Wall Vents are Not Perfectly Square and Have Poorly Installed Paint**

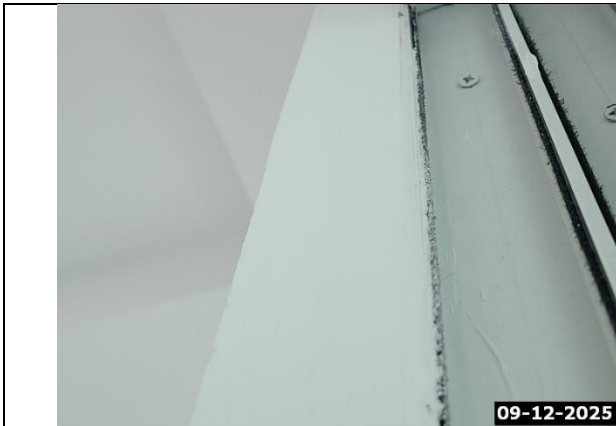
**Joint Compound + Paint at Slider Components**

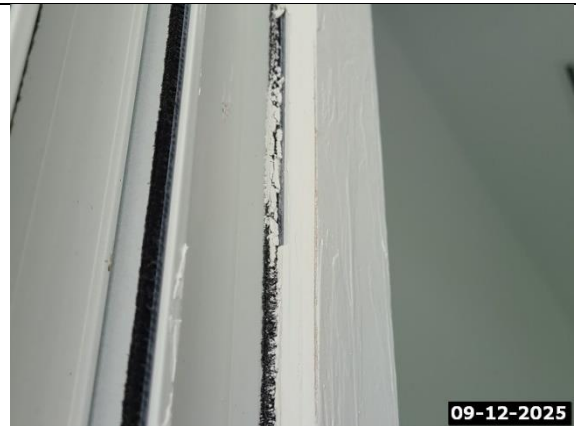
**Joint Compound + Paint at Slider Components**

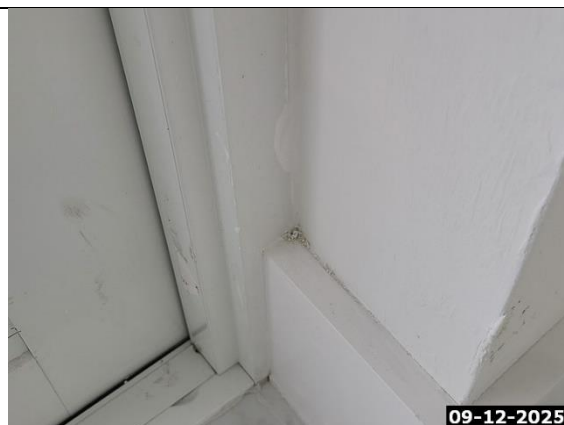
**Excess Paint on  
Different Areas Around Door**

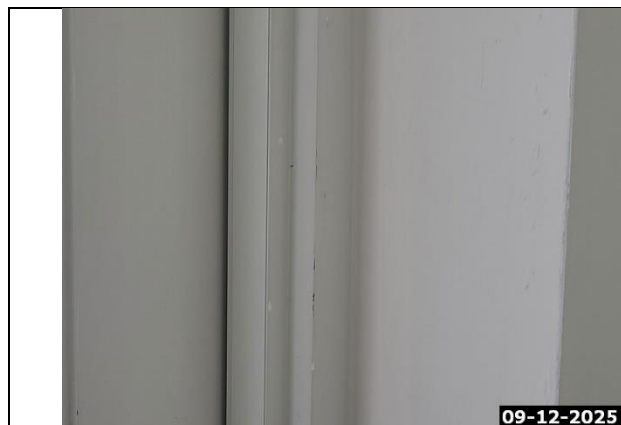
**Excess Paint on  
Different Areas Around Door**

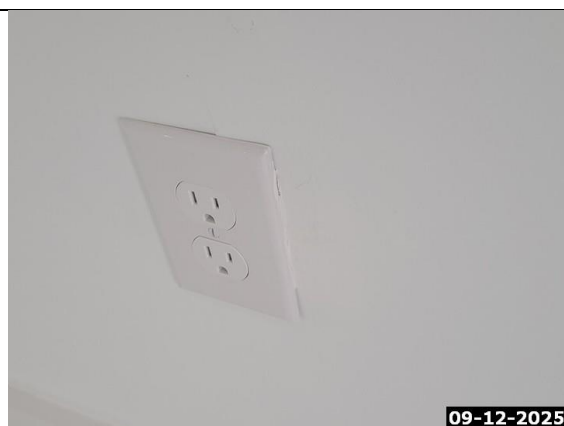
**Wall Repair Visible Around  
Outlet Next to Front Entry**

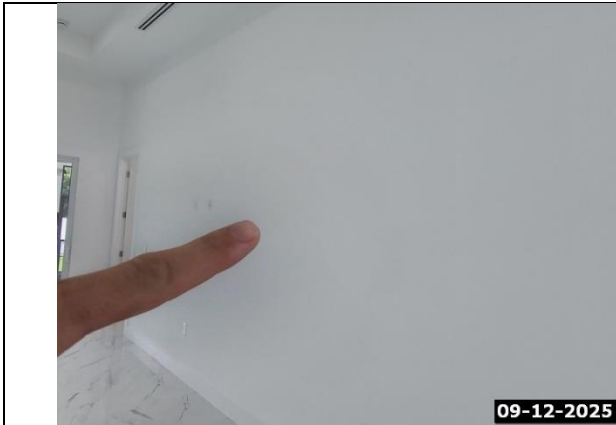
- **Interior walls are white paint over a textured coating.**
- **Areas of interior wall appear less white than others (insufficient paint); this is noted a multiple areas of wall field and at top 6-8 inches of most walls.**
- **The intentionally installed textured coating at areas of interior walls is combined with unintentional wall texture. Unintentional wall texture noted under paint includes:**
  - **Joint compound at wallboard seams that was not sanded.**
  - **Unfinished / damaged corner beads.**
  - **Buildup of joint compound at interior corners at rooms.**
  - **Unsanded joint compound at closet walls.**
  - **Large Drips (3x+ Larger than other intentional texture)**
- **Repairs to interior wall coating / paint are extensive; see images for many different representative locations of required repairs.**

**Living Room Wall (North)  
Gray Areas Visible  
(Insufficient Paint)**

**Repair Wall Coating / Paint**

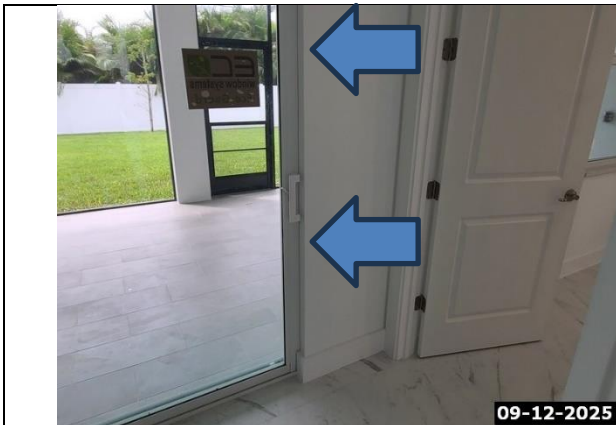
**Wall Corner Falling Apart Near  
Sliding Patio Door**

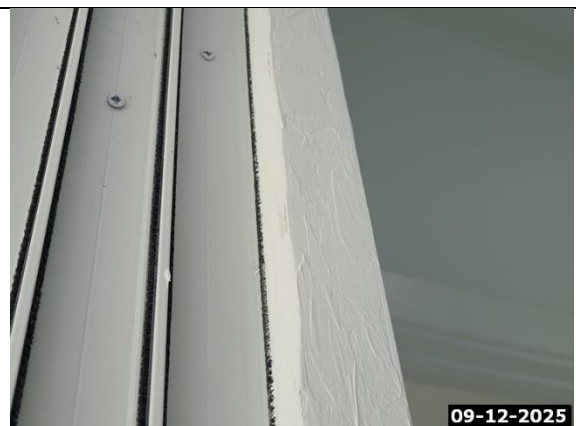
**Wall Around Sliding Patio Door  
Excessive Joint Compound  
Edges Not Straight**

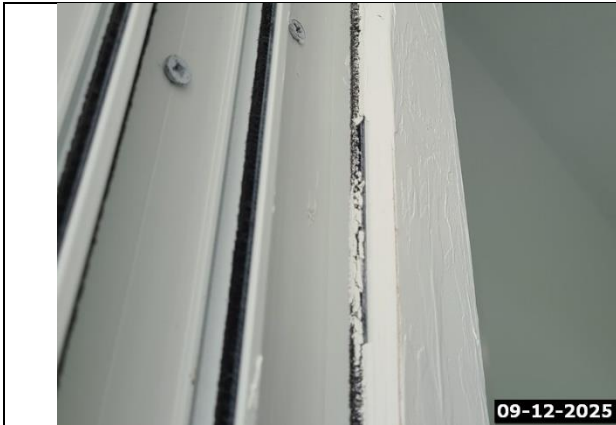
**Wall Around Sliding Patio Door  
Excessive Joint Compound  
Joint Compound Falling Away**

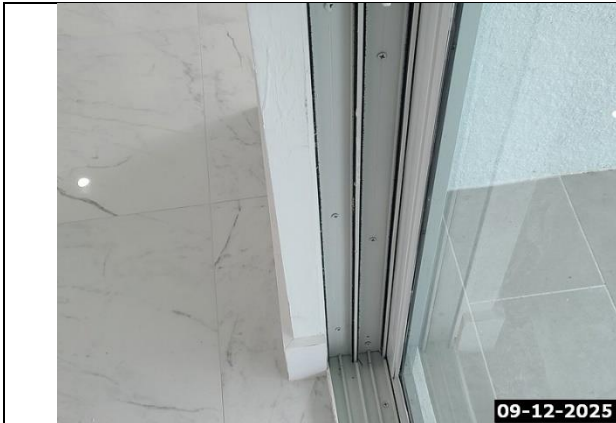
**Wall Around Sliding Patio Door  
Excessive Joint Compound  
Edges Not Straight**

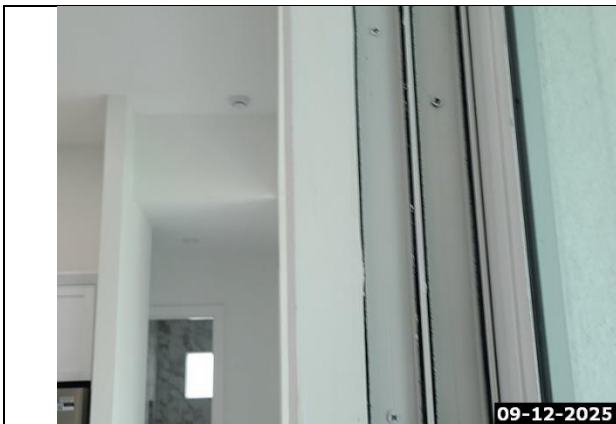
**Wall Around Sliding Patio Door  
Excessive Joint Compound  
Edges Not Straight**

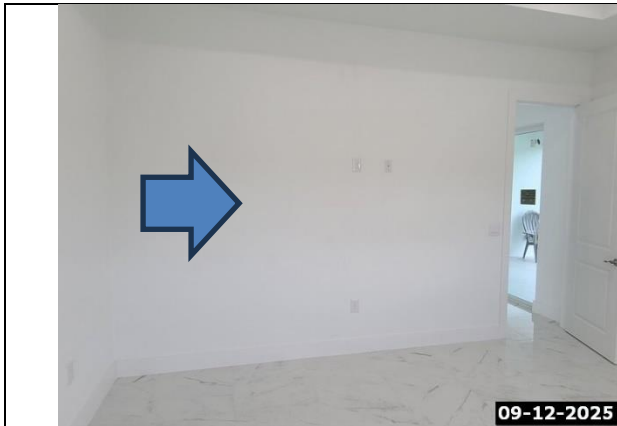
**“Gray” Area of Wall  
(Insufficient Paint)**

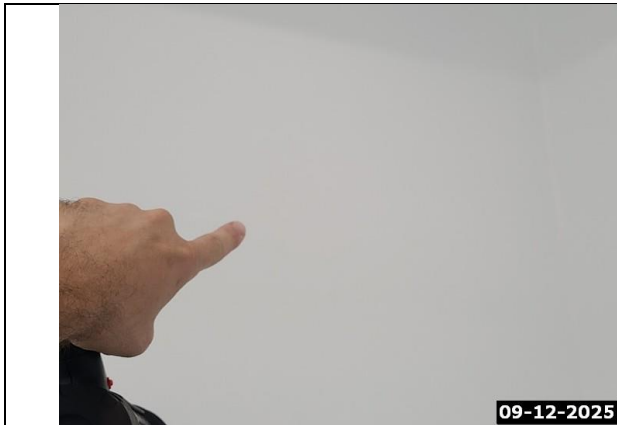
**“Gray” Area of Wall  
(Insufficient Paint)  
And Poor Wall Texture**

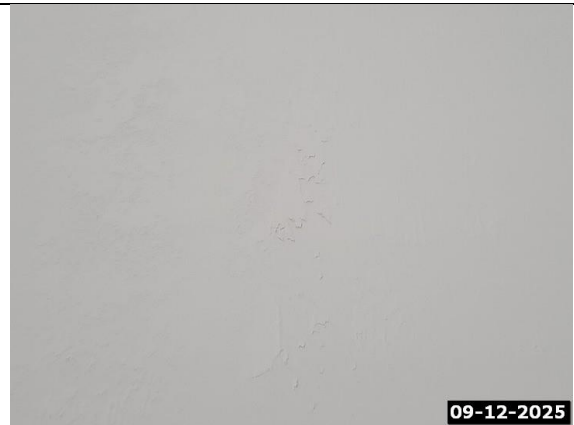
**“Gray” Area of Wall  
(Insufficient Paint)  
And Poor Wall Texture**

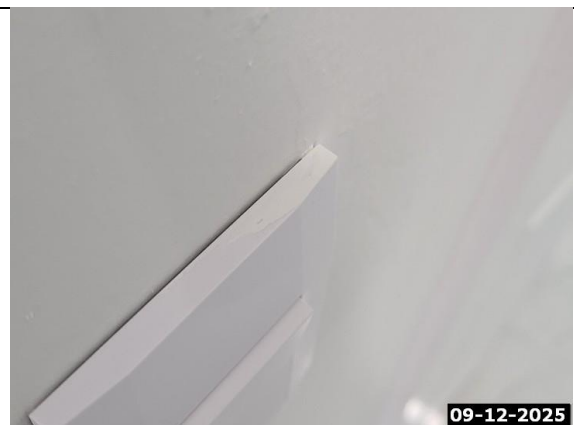
**Paint on Hallway Light Switch**

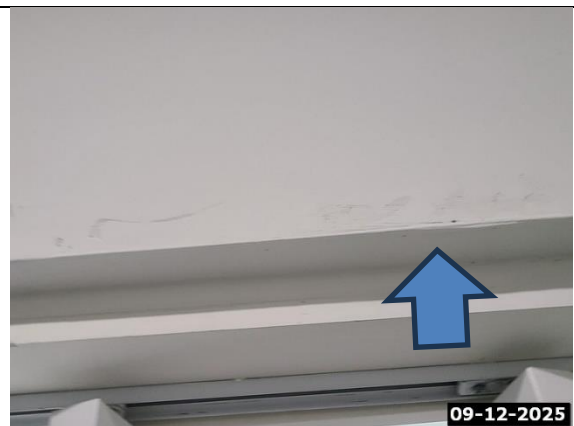
**Poor Wall Texture**

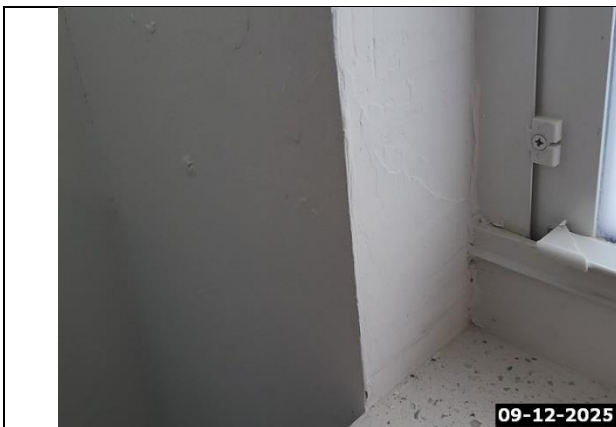
**Poor Wall Texture  
Master Bathroom Window**

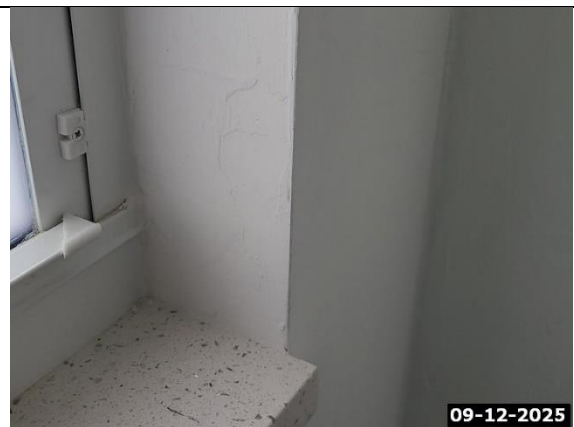
**Poor Wall Texture  
Master Bathroom Window**

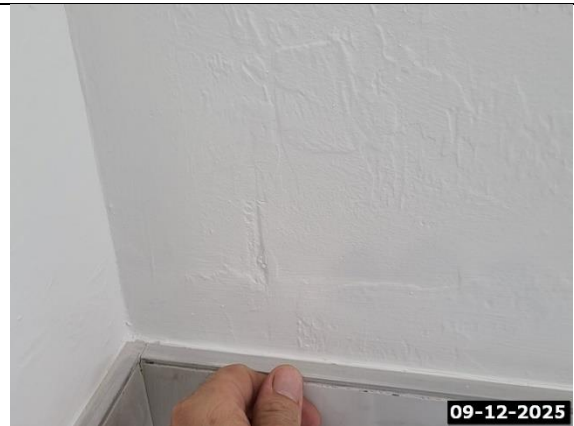
**Poorly Installed Wall Texture**

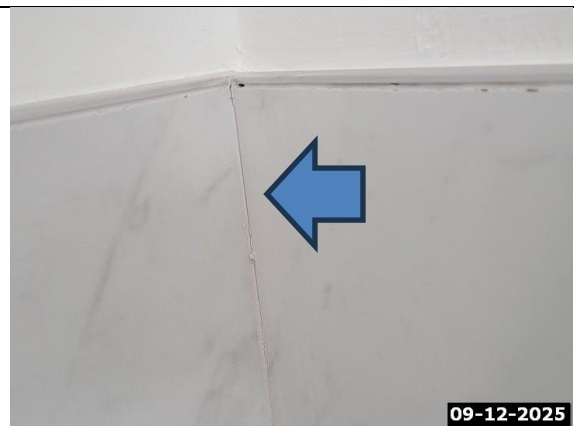
**Cracking at Grout / Caulk at Corner  
Seam of Wall Tile**

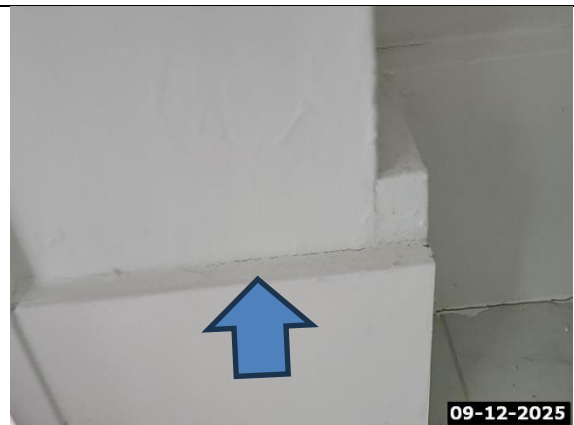
**Cracking at Paint**

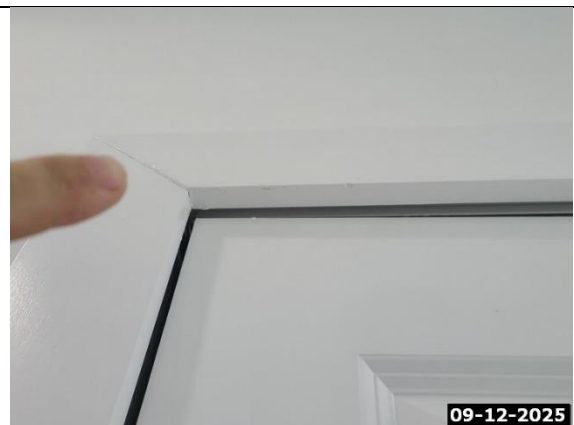
**Trim Around Door is Not Aligned**

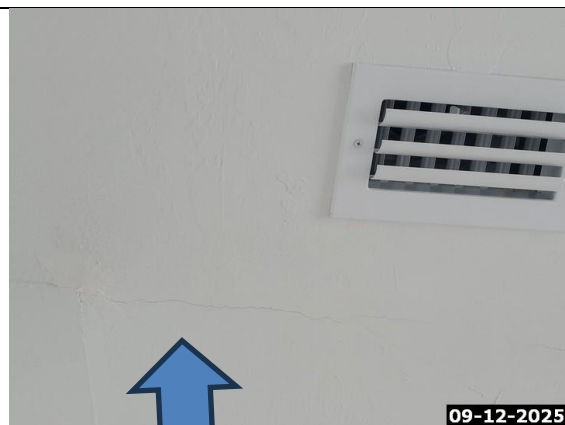
- **Ceilings have paint / texture imperfections similar to walls; see "Wall" comments. See Photos below for greater detail.**
- **Ceilings have unpainted joint compound, cracking, and insufficient paint at areas.**

**Cracking at Ceiling  
Master Bathroom**

**Repair Ceiling Paint / Coating**

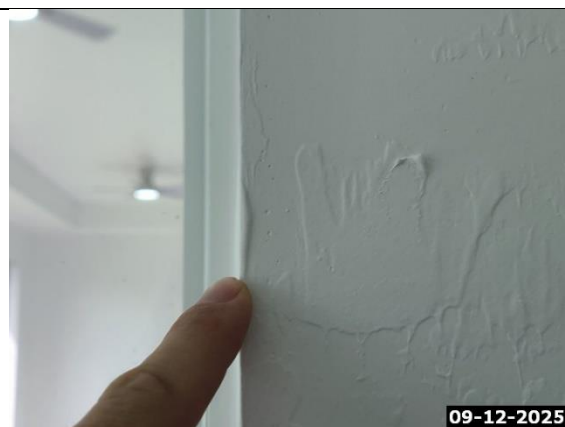
**Poorly Installed Wall Texture**

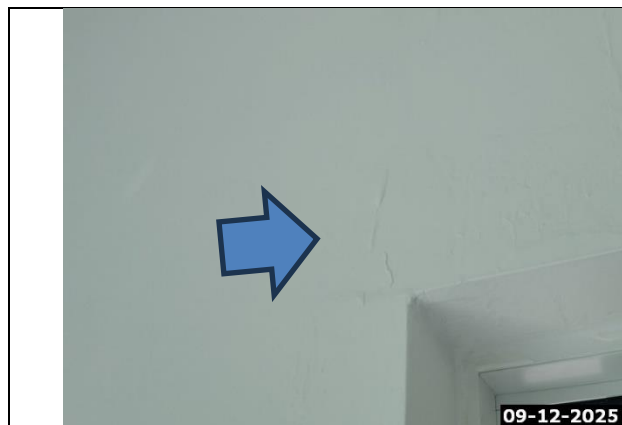
**Poorly Installed Wall Texture**

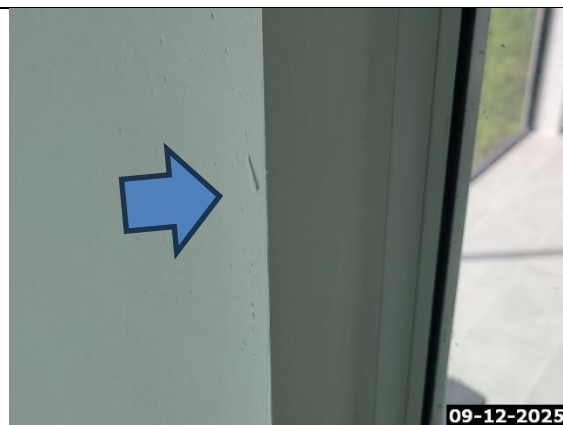
**Poorly Installed Wall Texture**

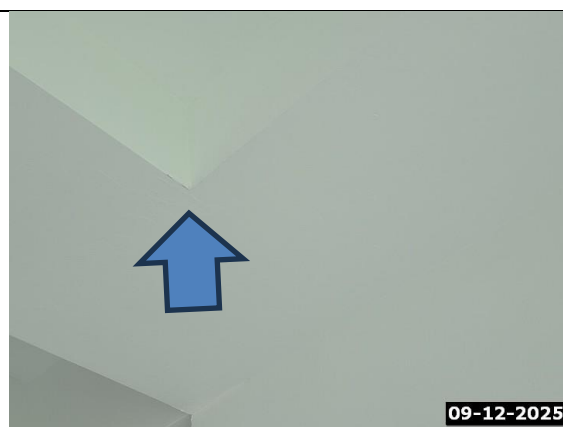
**Insufficient Paint at Wall Edges**

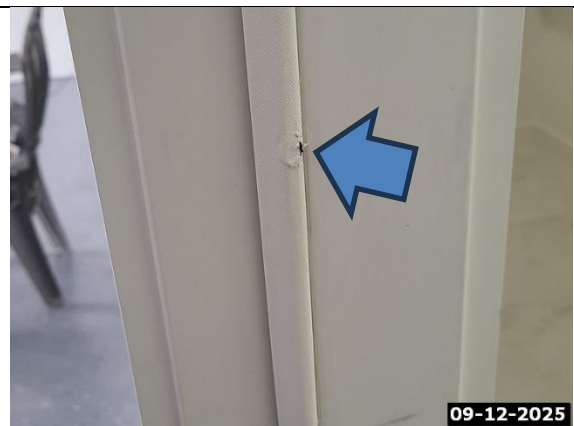
**Damaged Weather Seal at Door**

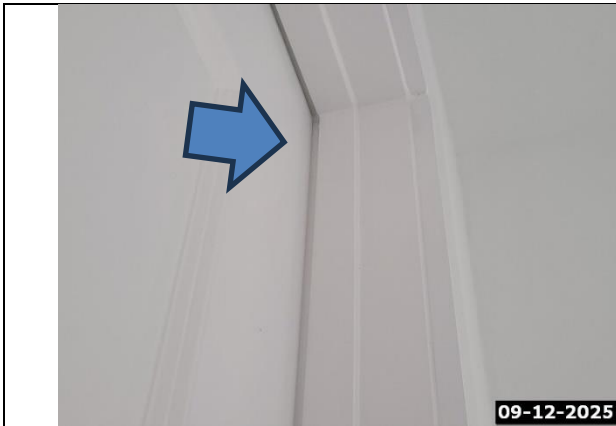
**Hall Bathroom Door Appears  
Warped – Top of Door Bowing Out**

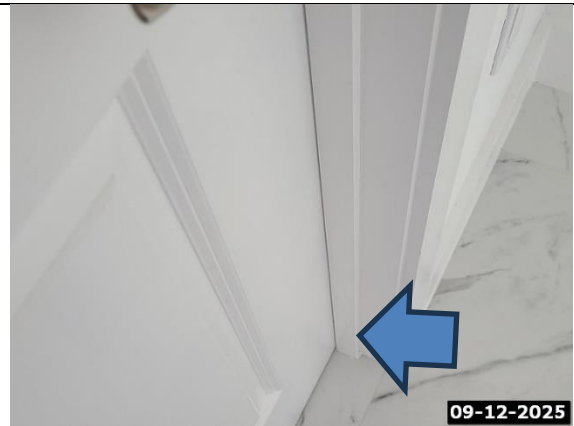
**Hall Bathroom Door Appears Warped – Top of Door Bowing Out**

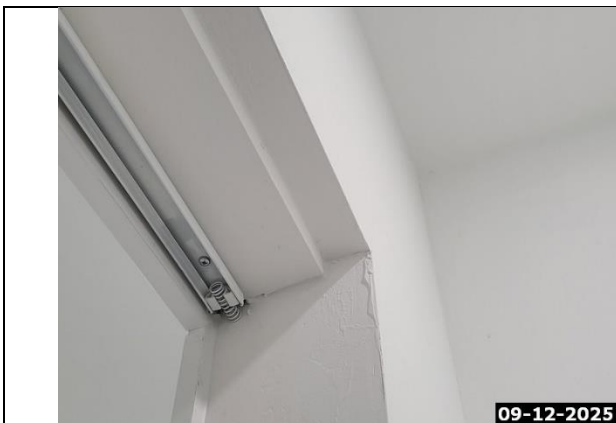
**Poorly Installed Wall Texture**

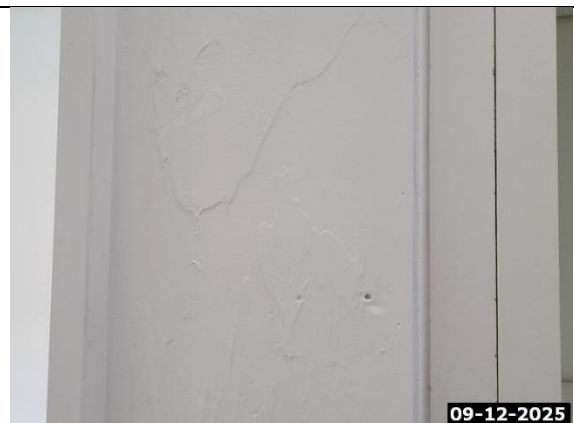
**Poorly Installed Wall Texture**

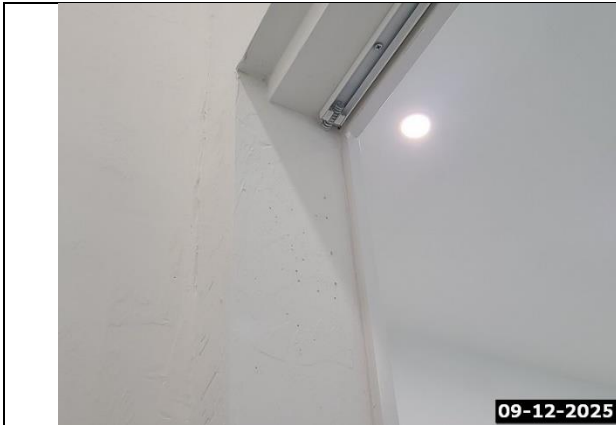
**Poorly Installed Wall Texture**

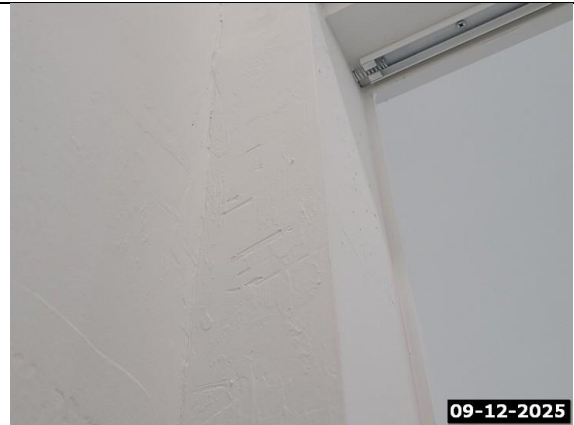
**Poorly Installed Wall Texture**

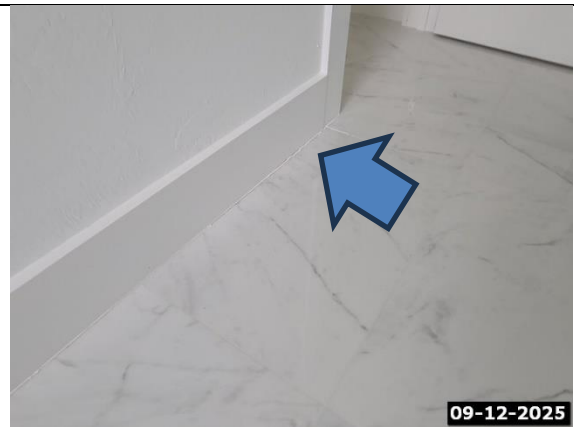
**Caulking Cracking Between Wall Moulding and Floor Tile**

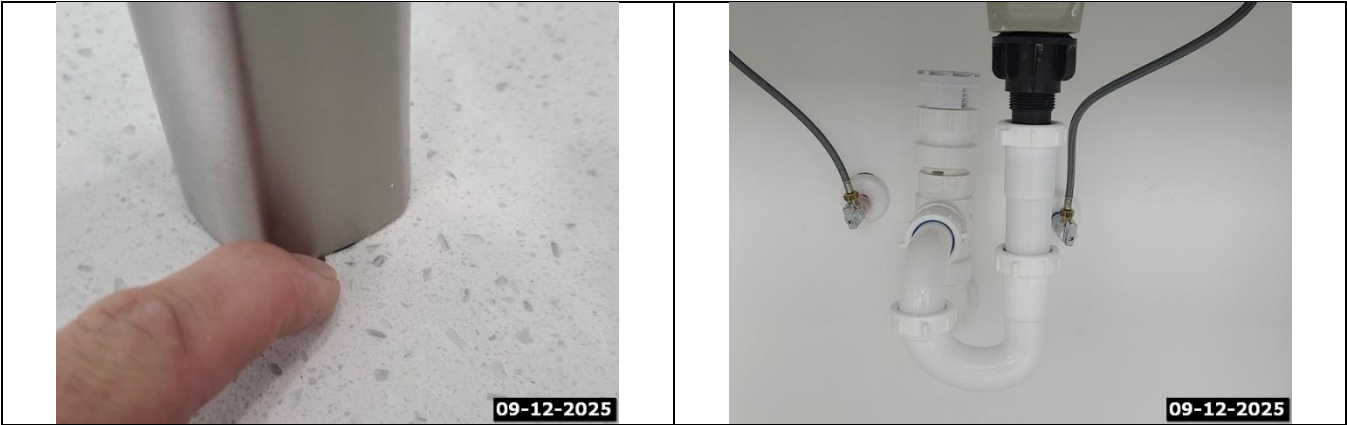
| Gap Around Faucet | Bathroom #1 Images |

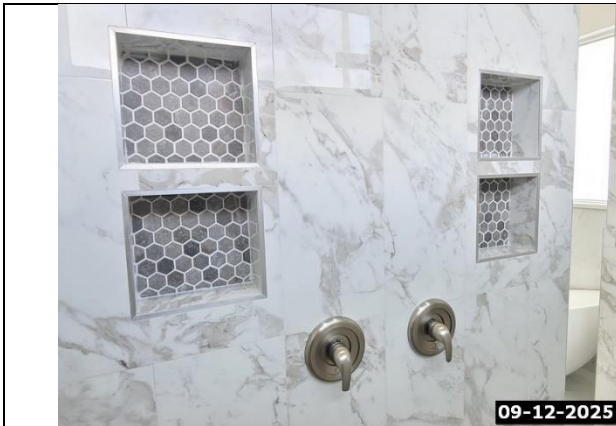
- **Alcove shelves present at shower. The wall tile that is installed around shelved was cut to fit, the cuts at the tile are rough and have caused chipping (damage) along edges of tile. Replace damaged tiles.**

**Tiles Edges Rough Where Cuts Were Made**

**Replace Damaged Tiles**

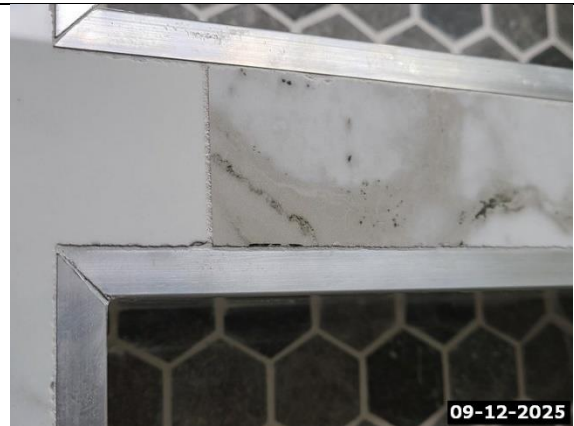
**Small Chipping Visible at Edges of Wall Tile at Shower**

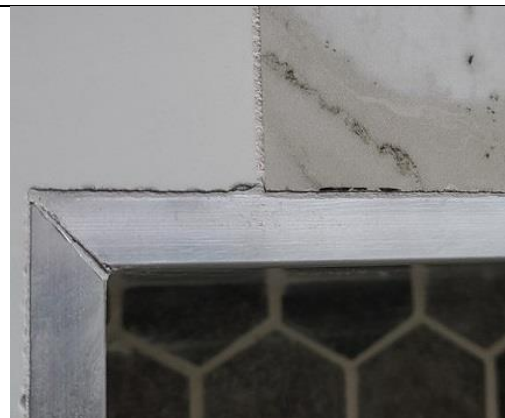
**Small Chipping Visible at Edges of Wall Tile at Shower**

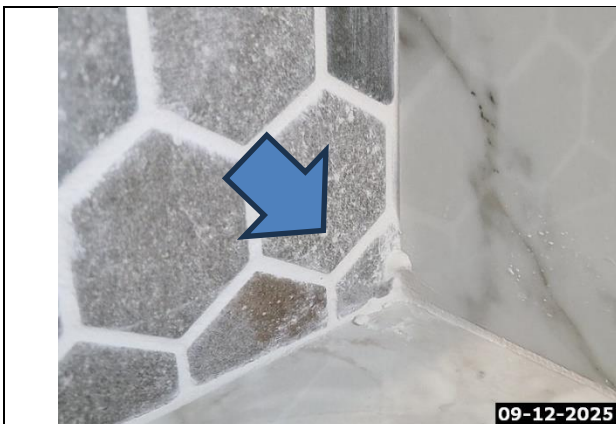
**Grout on Tile at Shower**

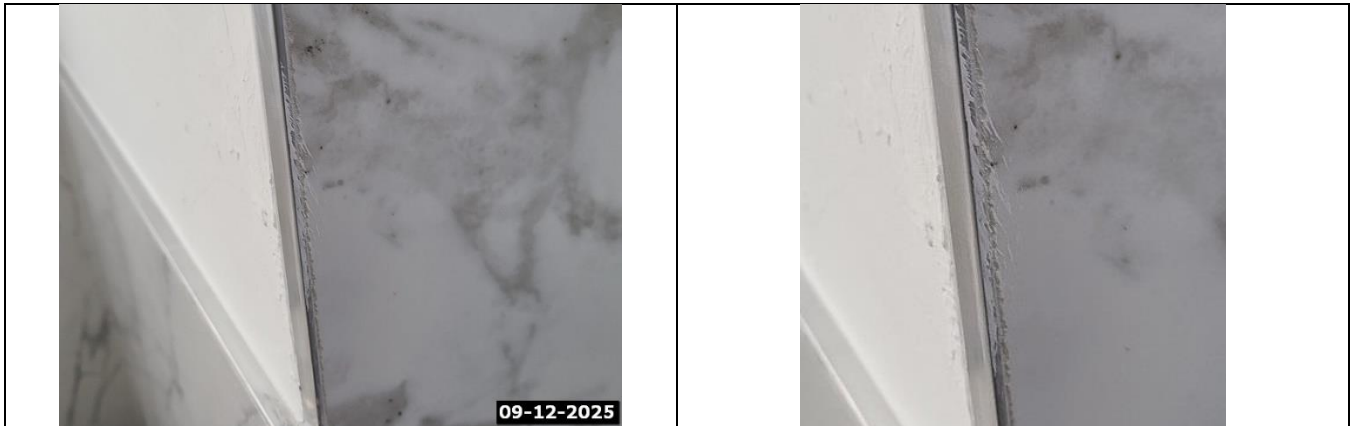
**Paint / Debris on Shower Tile****Paint / Debris on Shower Tile**

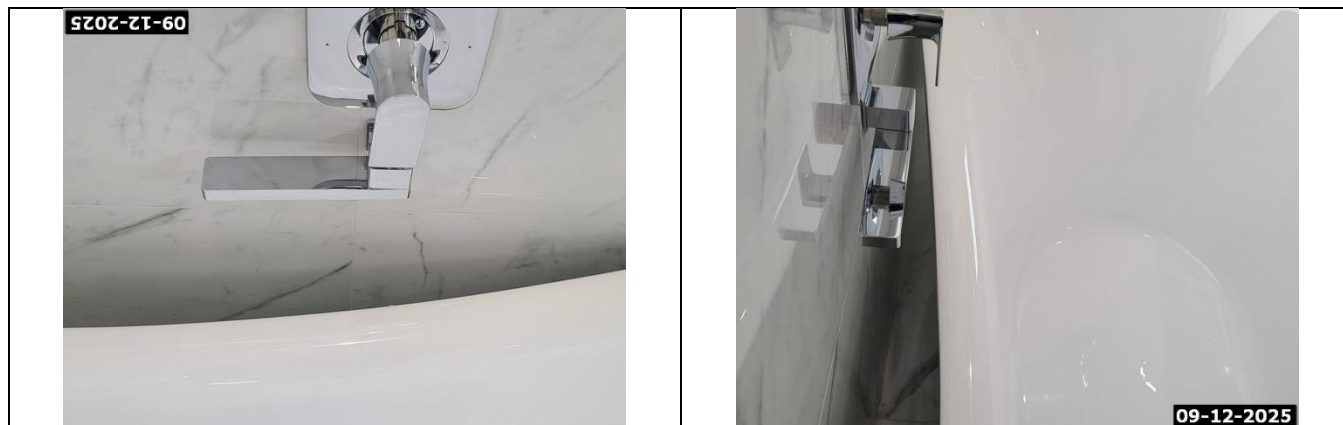
**Bathtub Faucet – Faucet Turns  
Enough to be Outside of Bathtub**

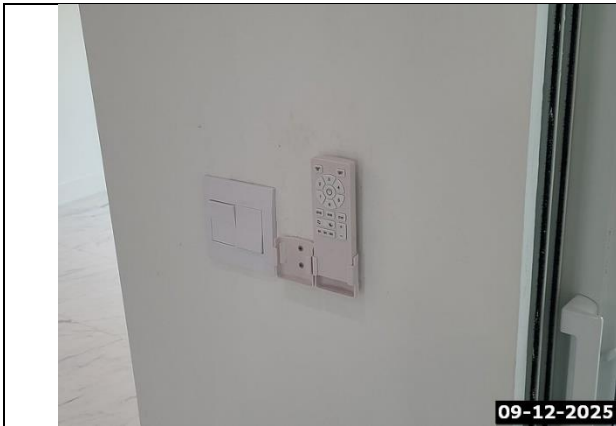
**Fan Remote Holders Not Properly Installed**

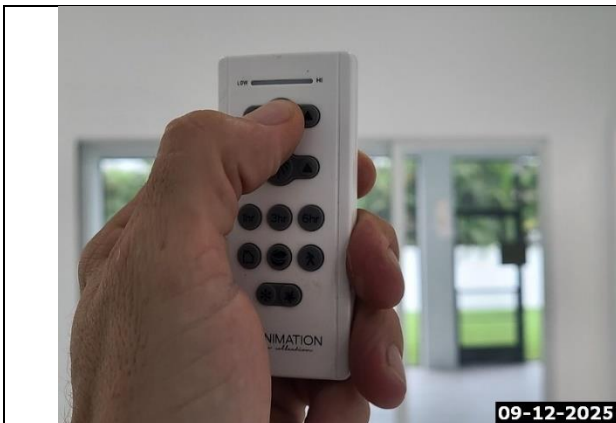
**Living Room Fan Battery Dead**

**Replace Fan Remote Battery**

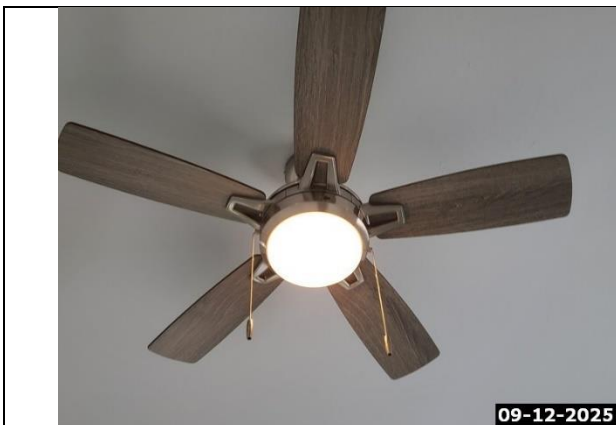
**Living Room Fan Battery Dead**
