# Inspection Report

Prepared Exclusively For:  
Sample Report

Property Located At:  
Cape Coral, FL 33991

Inspection Date: 09/12/2025  
Inspected By: Nick Bangor  
FL Home Inspector License #: HI730

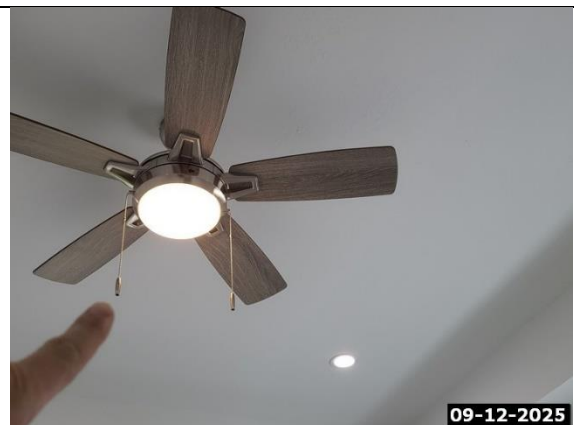
**Ceiling Fan Cords Too High**

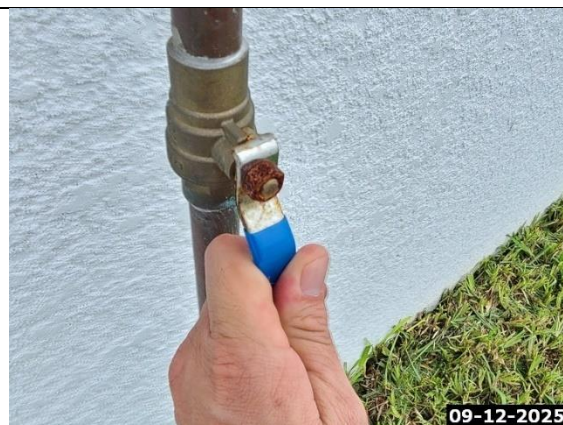
Main Water Valve Condition: **Fair**

- **Rust damage present at nut securing the main plumbing supply valve handle in place; replace damaged nut.**

**Plumbing – Main Shutoff Valve  
Rust at Nut Securing Handle**

**Replace Nut Securing Supply Valve Handle**
