**Florida Strong LLC**

# Understanding Four-Point Inspections

## Understanding the Four Point Form

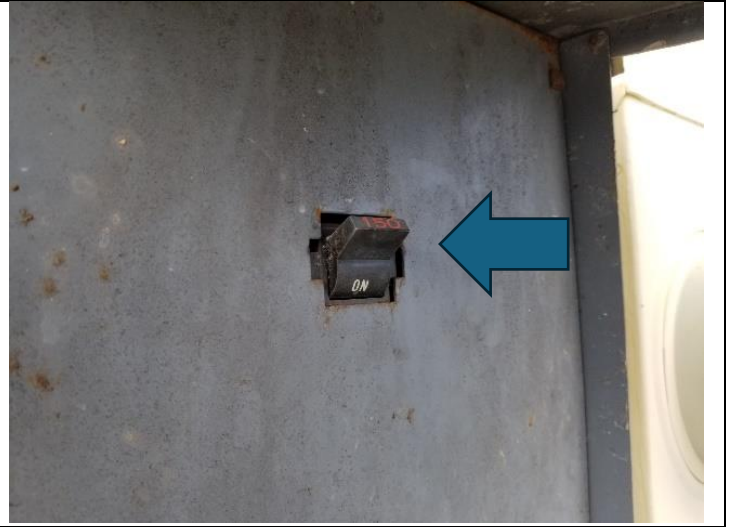
**FPE Panel – Breaker Design a Sign of Manufacturer (Red Font)**

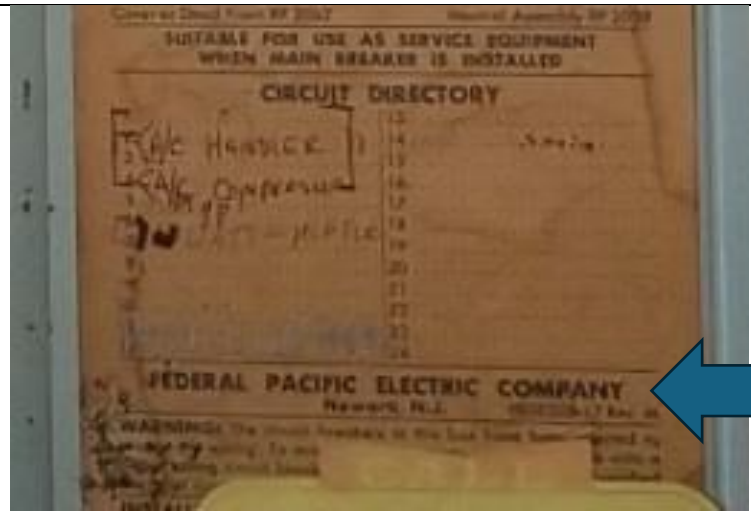
**Name Present at Label**

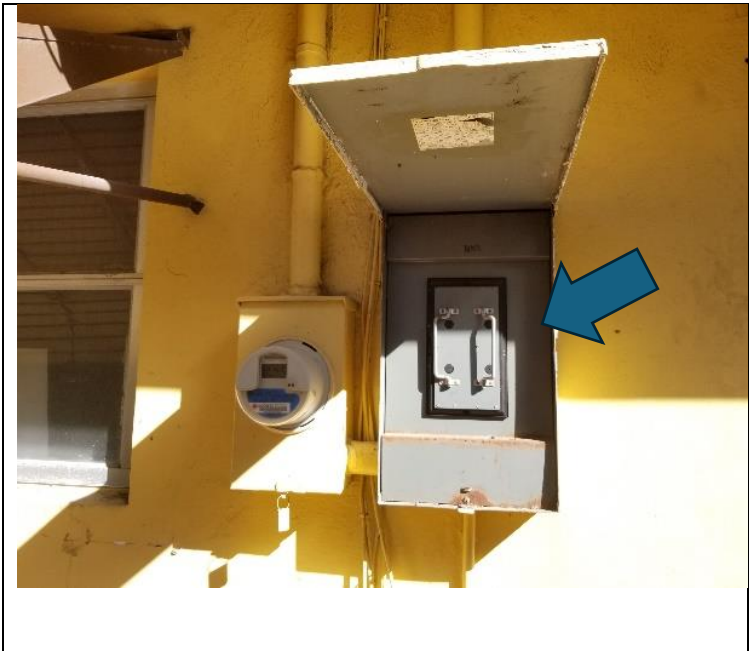
**Pull-Out Fuse  
Main Disconnect Panel**

Fuse panels are no longer installed at homes as the main shutoff panel or as distribution panels and have not been common for many years. Presence of fuse panels will typically cause failure of a four-point inspection (some insurers may still allow fuse panels in good condition).

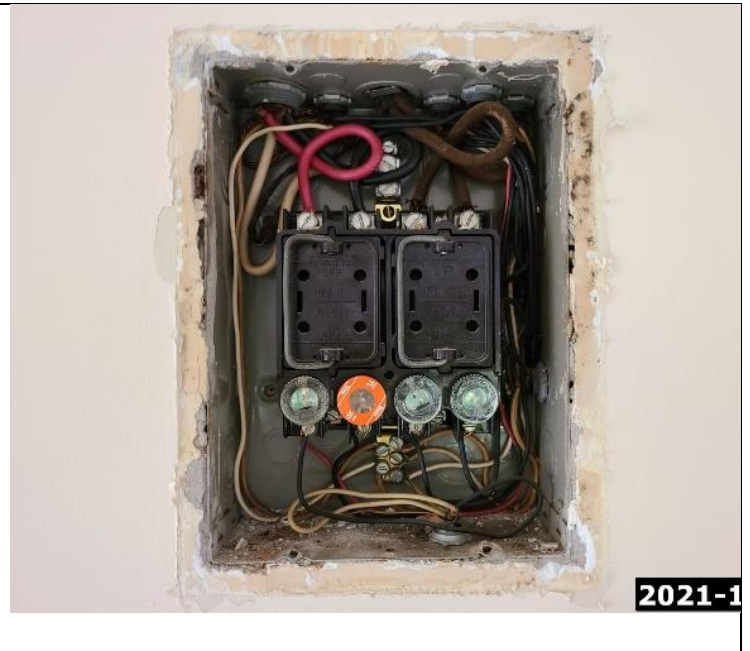
**Fuse Subpanel Being Used**

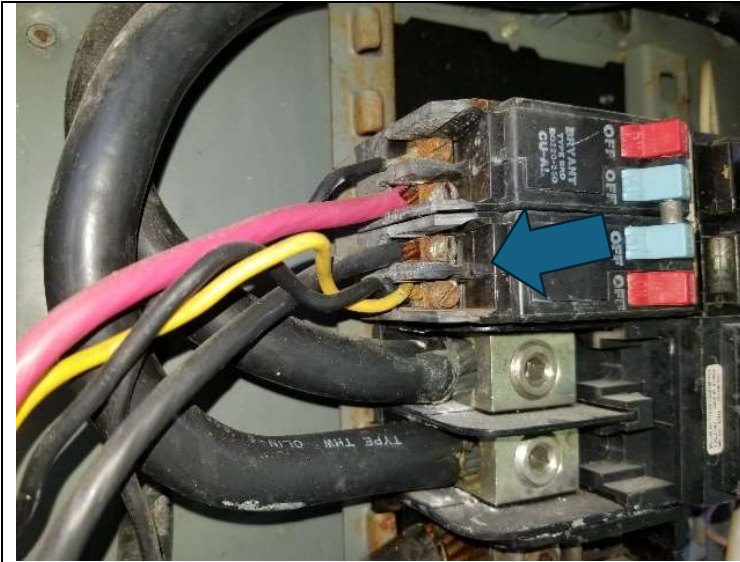
**Double Tap - Two Wires at Breaker**  
(Breaker also has less common failure or corrosion damage)

The most common electrical system issue found is referred to as a **“Double Tapped” Circuit Breaker**. A double tap occurs when two wires enter into one circuit breaker (and the breaker is not designed for that function) or when two or more wires enter into a service connection (main lugs) designed for one wire. Double taps are typically caused by inexperienced contractors and can be easily repaired by licensed electricians.

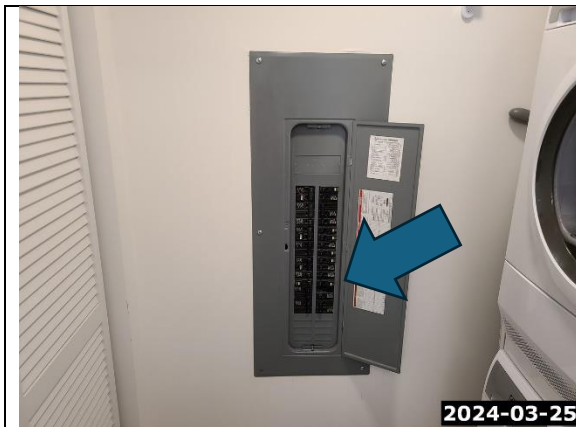
**Open Breaker Socket at Panel**  
(Repaired Easily with Clip-In Panel Blank)

When inspecting the electrical system one issue that can cost as little as \$1 to repair is often found; **Openings in the panel (typically removed breakers)**. Openings in the panel from missing breakers can be repaired with clip-in “panel blanks”, these plastic covers clip in place in the openings left after removing a circuit breaker. Electrical tape can also be used to seal openings.

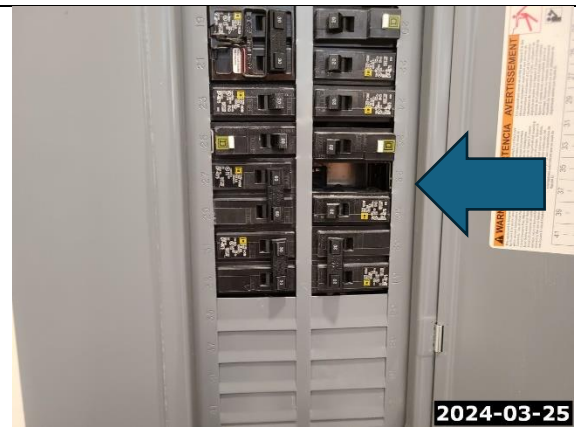
**Open Breaker Socket at Panel**  
(Repaired Easily with Clip-In Panel Blank)

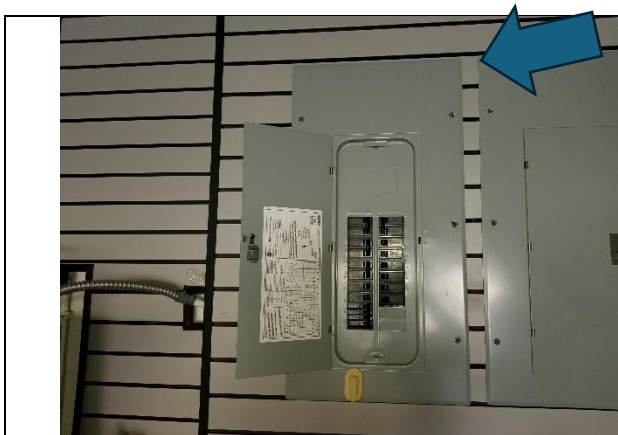
**Panel Installed Over a 1 Inch Thick Slat Board**  
(Gaps Between Panel and Breakers)

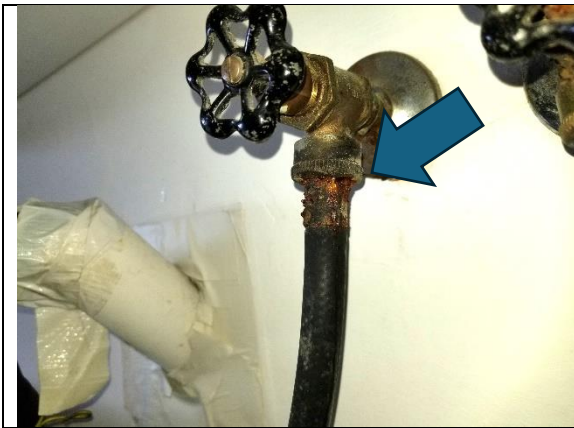
**Corrosion at a Washing Machine Supply Hose Connection**

Really bad plumbing leaks are not a common failure as they are easy to see and will typically lead to immediate repairs. **Small leaks** at plumbing connections are much more common, this can show as **corrosion at the plumbing connections**. Intermittent leaking is a common plumbing failure, this will show as either **active moisture under a sink drain**, or as **staining under the drain** with damage at drain components.

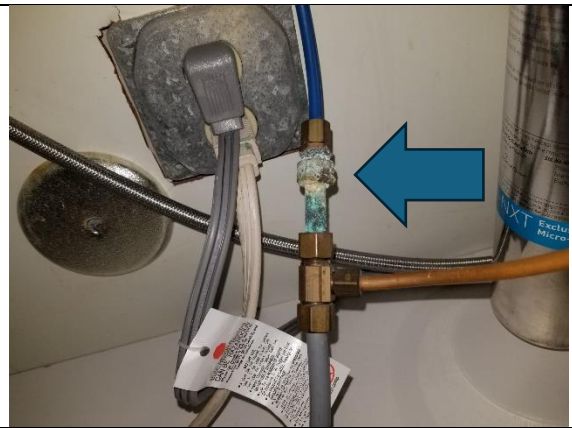
**Corrosion at a Supply Line Connection Under a Sink**

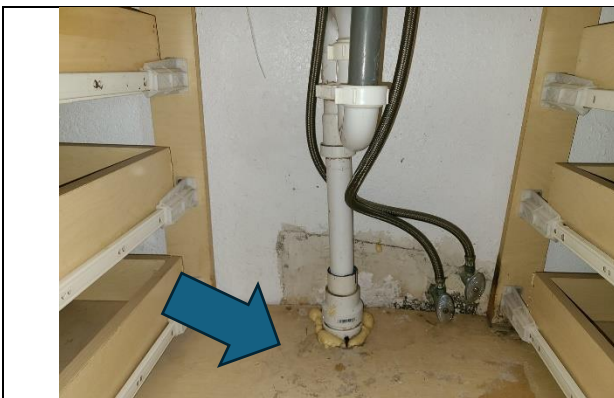
**Cabinet Damaged from Leak**

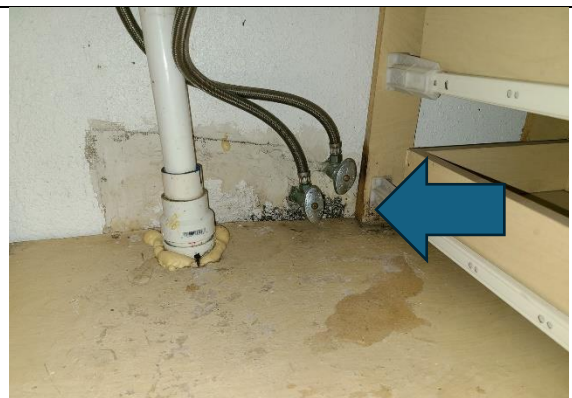
**Wall Damage from Leak Moisture**

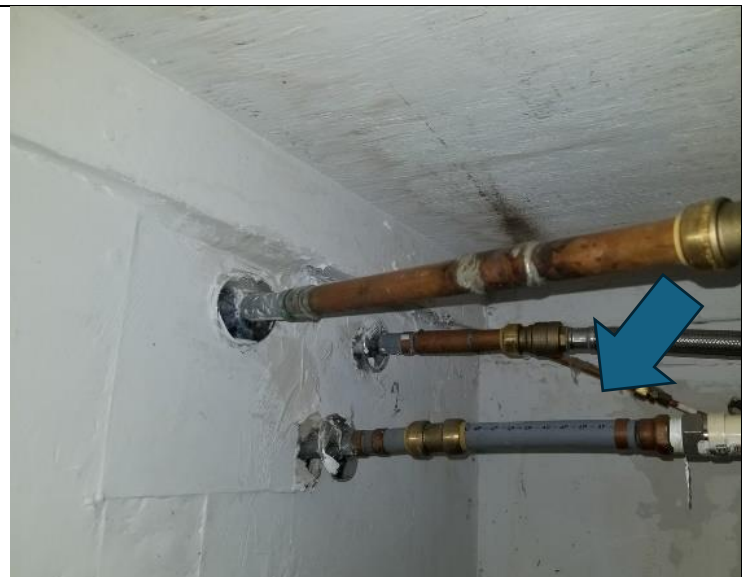
**Polybutylene Plumbing  
(Note Gray Color)**

Polybutylene supply plumbing is a gray colored supply piping and was used in the 1980s – mid 1990s. This plumbing is thought by insurers to have a high rate of failure at the copper/zinc connectors used throughout the installation process to secure line segments together. Most insurers are unwilling to write a policy for a home with polybutylene supply plumbing, Citizens has been known to require removal / replacement of any polybutylene supply plumbing.

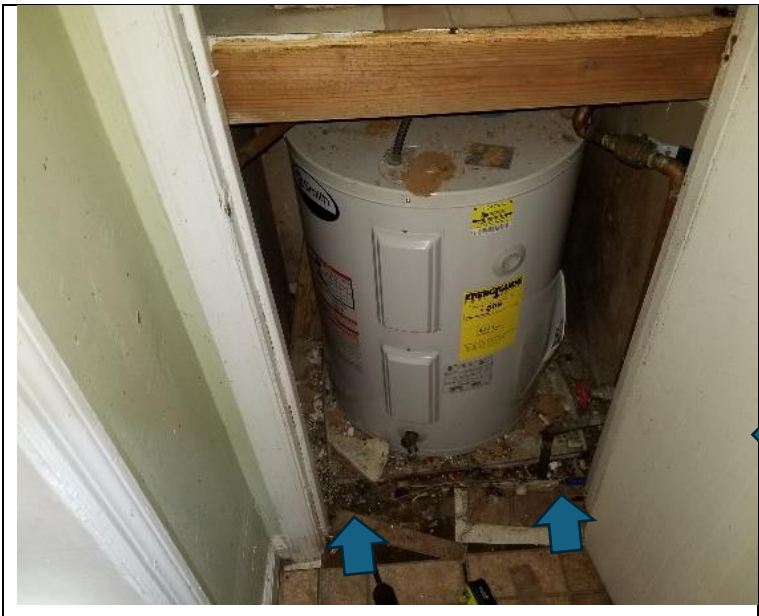
**Water Damage at Water Heater Closet Caused by Relief Valve**

Water heaters can present many issues that are common. **Age** can be a factor with water heaters, many insurers are giving lifespans of 15 years on tank water heaters. **Leaking** at piping or connections will cause a failure. **Rust Damage** visible at the tank may also cause a failure.

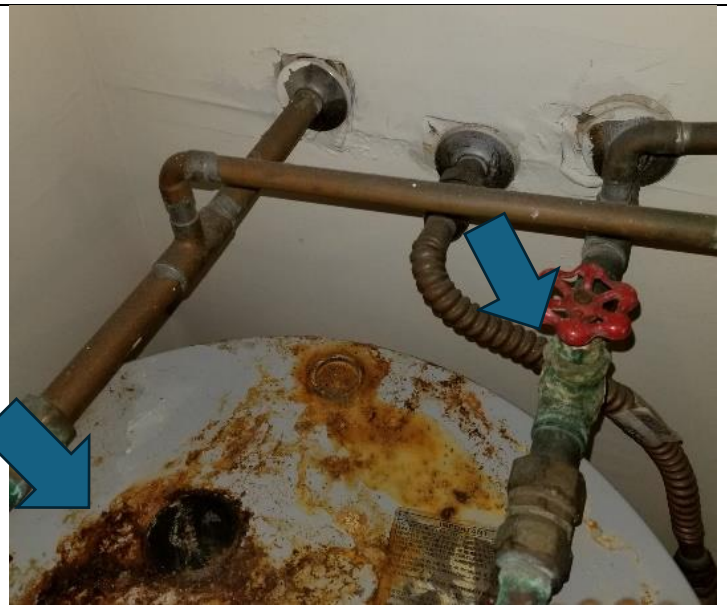
**Leaking at Plumbing Valve Causing Rust at Water Heater**

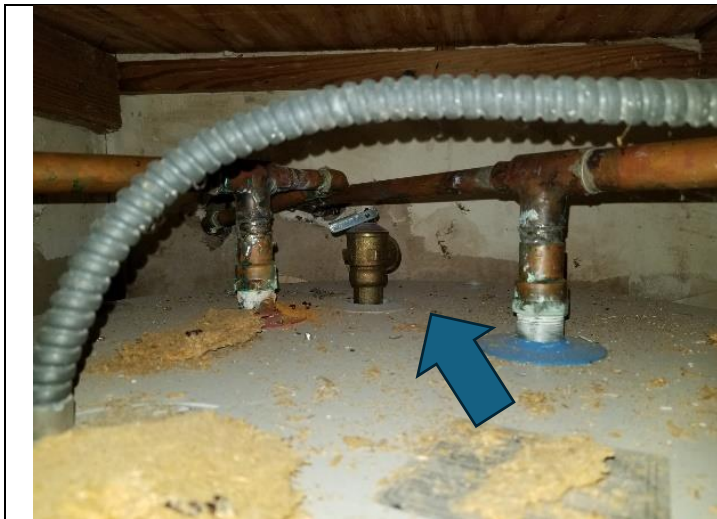
**TPRV was Never Connected  
to a Drain Line**

Water heater tanks have pressure relief valves that connect to drain lines, a common failure is a **pressure relief valve not being connected to drain piping**. (In the case of water heaters installed in garages, the water heater pressure relief valve can drain to the lower garage slab but must still have a drain pipe that brings the end of the pipe to within 6 inches of the ground.)

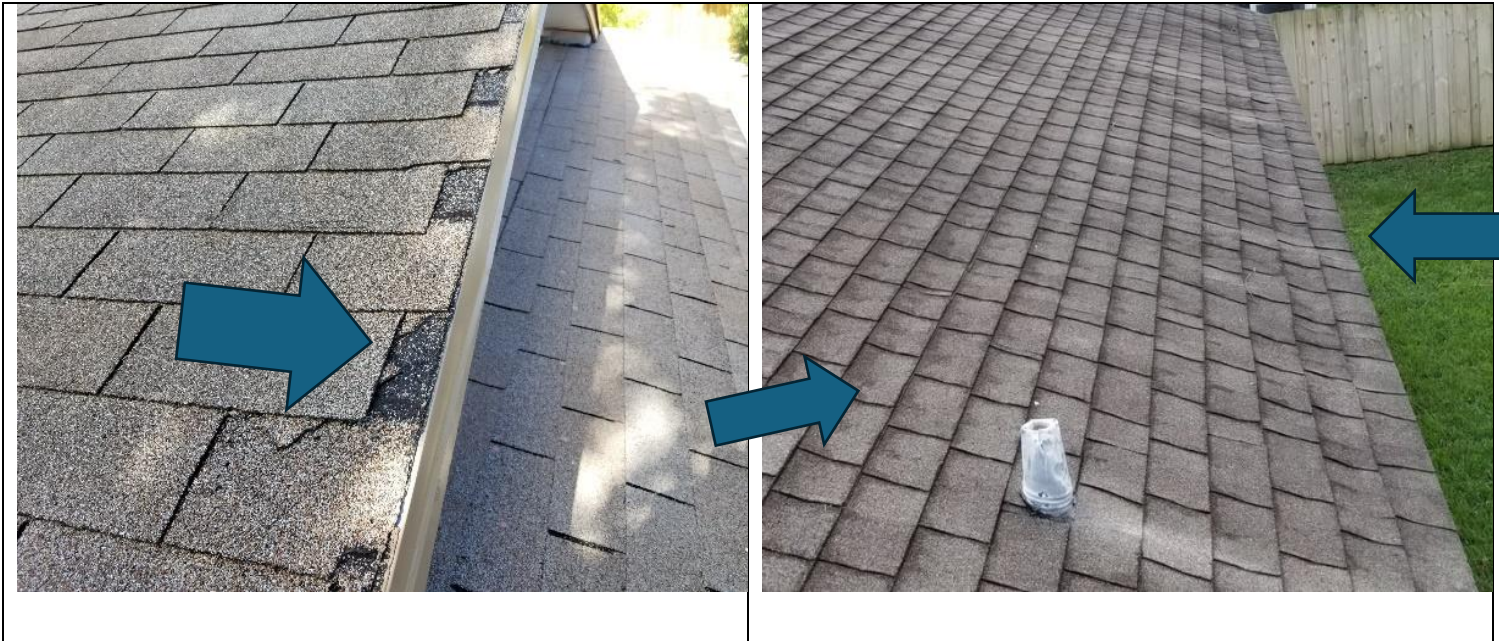
**Missing Shingle**

**Curling Visible at Shingle  
(Edge of this Roof Also has  
Multiple Areas of  
Soft/Damaged and Sunken  
Roof Decking Visible)**

Missing shingle or damaged shingles can lead to damage at the roof decking that supports the shingles.

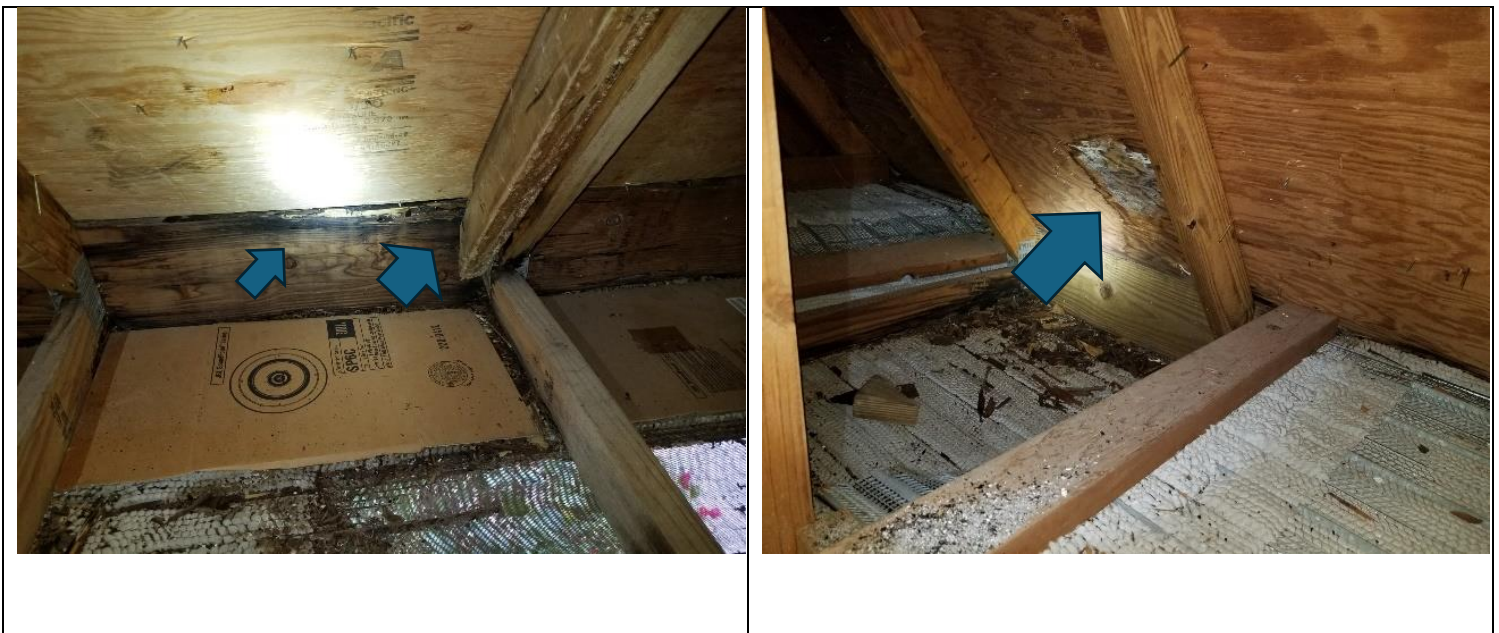
**Damaged Roof Decking  
Replaced Decking is Visible, but  
There is Still Damage at Other  
Wood Roof Components**

**Damaged / Stained Roof Decking  
(Wood Decay Fungi Present)**

As roofs age, leaks will occur, many times these leaks remain minor and hidden from the homeowner due to the visibility being isolated to the attic space. A common roof failure found by inspectors at the attic space is the presence of **moisture damaged wood (decking or framing) at the roof**. The most common cause of moisture damaged roof components is **active roof leaking**. There are also times when the roof has been repaired and the leak is not active, but damage is still present; these cases are difficult to prove as “repaired”. Wood that has been stained by moisture should **sealed with a mold inhibiting paint** (this repairs the issue and prevents images from showing damage on the report).

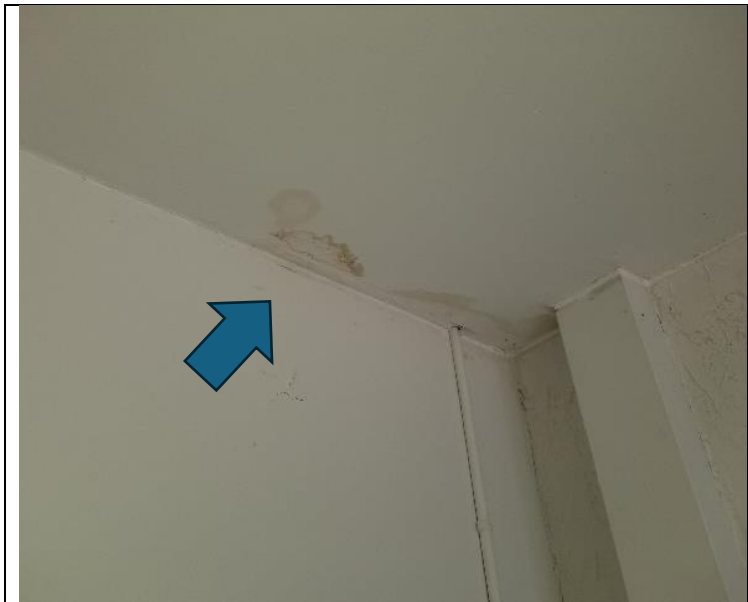
**Ceiling Stain**

Ceilings at the home are also evaluated, any **staining at ceilings will show poorly on a report**. The inspector will evaluate any stains and determine if they exist from leaks that are active or leaks that have since been repaired. When there is ceiling damage from moisture and no visible damage at the roof or attic above, the moisture levels can be read from the ceiling to determine if moisture is high at the time of the inspection, if moisture levels are not elevated the report will show that there does not appear to be an active leak.

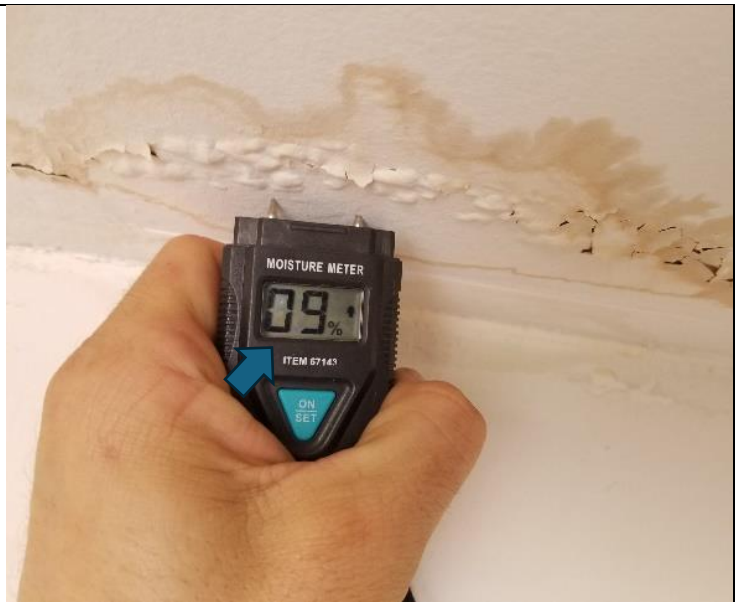
**Ceiling Moisture Reading 09%**  
**Dry: Lower than the 20% moisture threshold used to gauge gypsum board as "wet"**

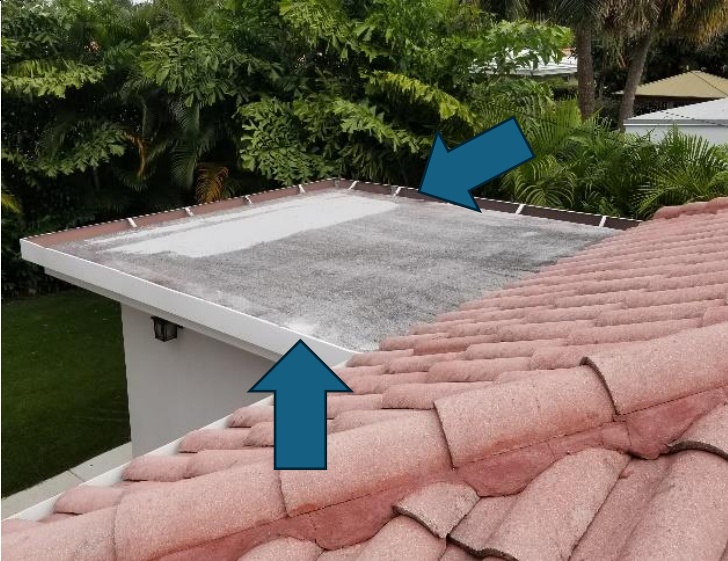
| <b>Sealant Installed at Portion of Roof</b> | <b>Poorly Installed Coating (Paint Used)</b> |

Many insurance policies for homes with flat roofs are written by Citizens, and other insurers seem to follow the standards citizens requires. This includes the 5-year requirement on lifespan, which leads to the most common failure: **Age**. Any flat roof over 10-years old will fail a four point; the only way to combat this is to install a roof coating. The common issues found with roof coating tend to be: 1) Not covering entire roof, 2) Not installed to manufacturers specifications (only one coat, etc.), 3) Improper material used (paint used instead of polymer sealant, etc.).

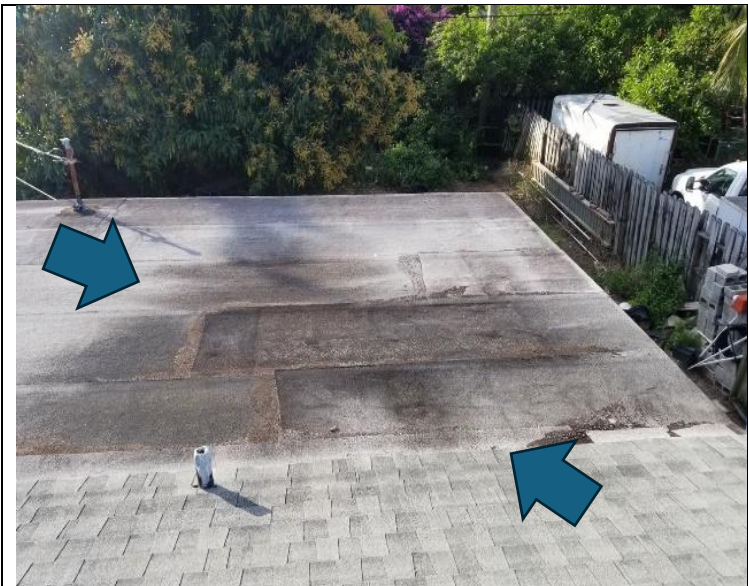
**Granule Deterioration  
and Debris Buildup  
Typical Signs a Roof has  
“Ponding” Water**

The **presence of ponding water** may also cause a failure. Ponding water is water that is present on a flat roof covering after 48 hours of no rain. Ponding water will accelerate weathering at the roof covering and lower the lifespan of the roof.

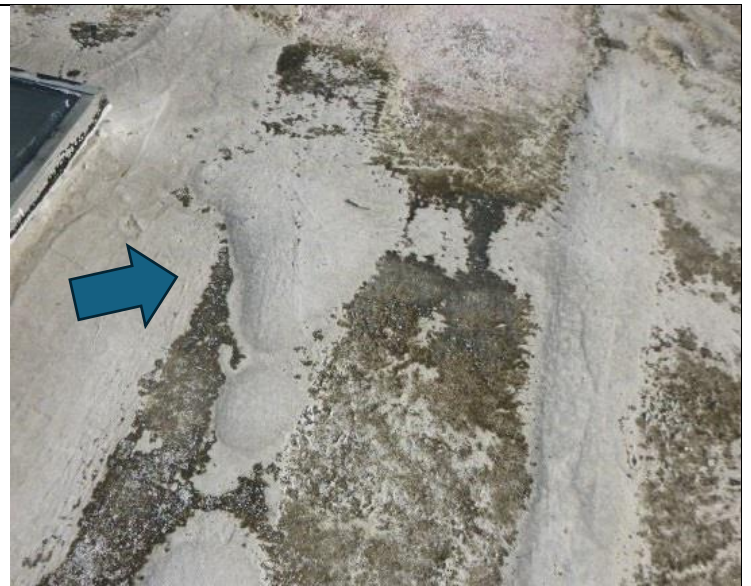
**Air Bubbles Under Material  
This Roof has an Aging Sealant that  
Failed**

Another common failure is **“Air Bubbles Under Paper”**. This failure occurs when air is able to get between layers of the bitumen roof paper and cause air bubbles to form. This defect is the most common failure for newer roofs as air bubbles can form due to defects from construction.

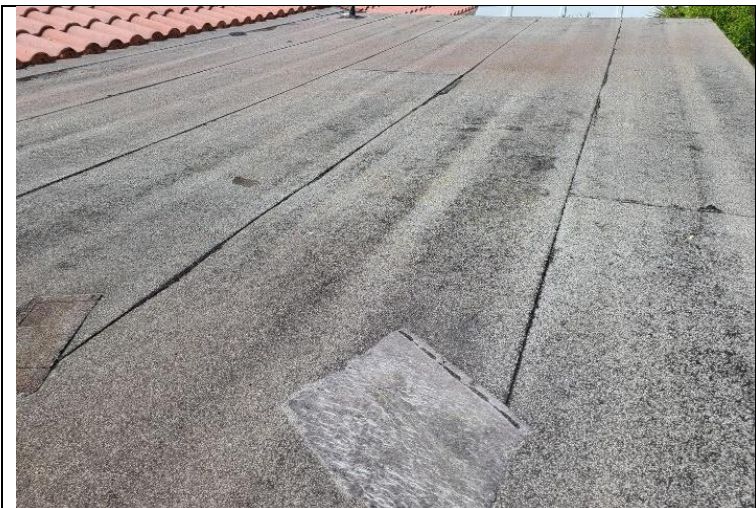
**Missing Granules / Old Roof  
(see next photo)**

Failures typically related to age can also occur due to weathering. The common failure **“granule loss / exposed asphalt”** occurs when the granules covering modified bitumen roofing are weathered away over time. The top layer of bitumen paper roofing has a granule coating present that helps to protect the material from weathering. Similar to the treads on a tire, the loss of granules at areas of bitumen paper roofs is a sign of accelerated weathering and a lower remaining lifespan.
