# Inspection Report

Prepared Exclusively For:  
Sample Report

Property Located At:  
Delray Beach, FL 33444

Inspection Date: 03/25/2024  
Inspected By: Nick Bangor  
FL Home Inspector License #: HI730

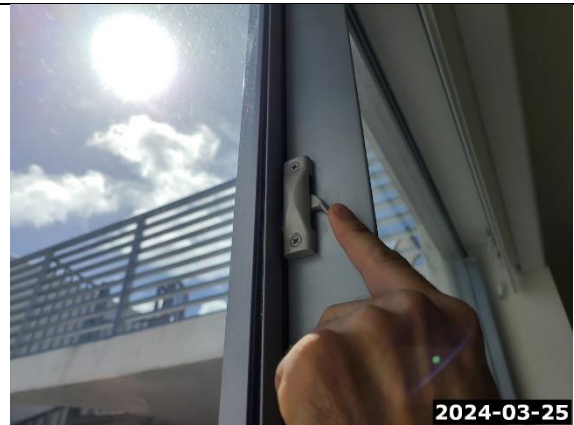
**Lock Not Latching at Window**

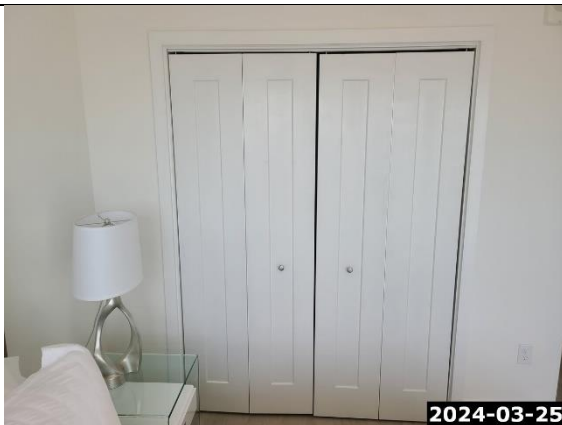
**Bedroom Closet Doors not Square**

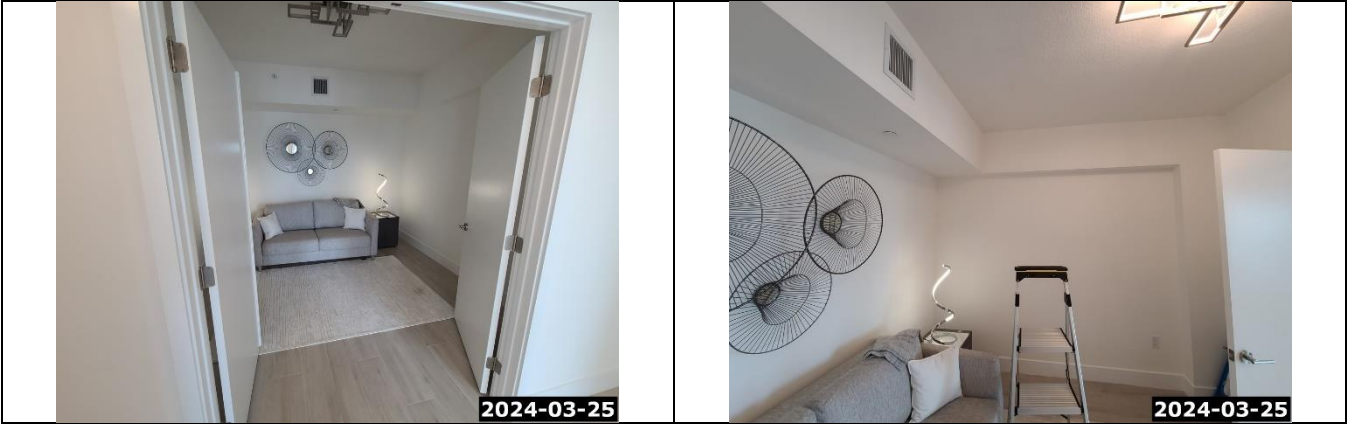
| Office / Nursery | Area Where Leak Evidence is Noted |

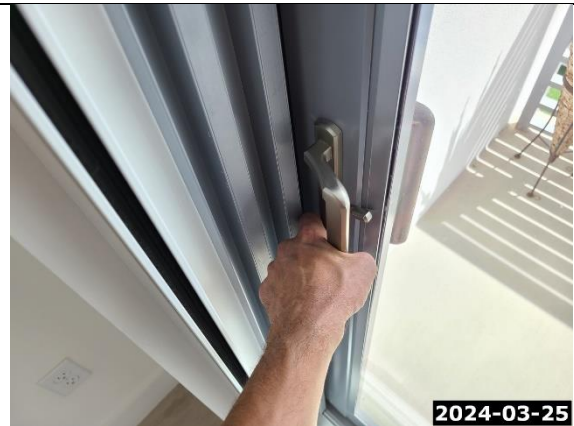
**Balcony / Balcony Doors Images****Movement at Door When Latched**

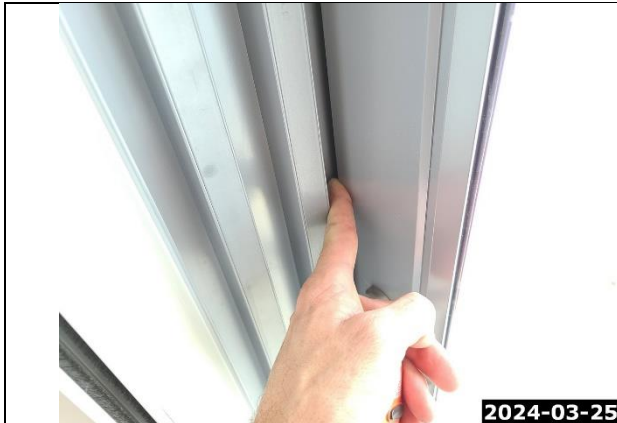
**Movement at Door When Latched –  
Door Opens About ¼ inch When Locked****Movement at Door Latch**

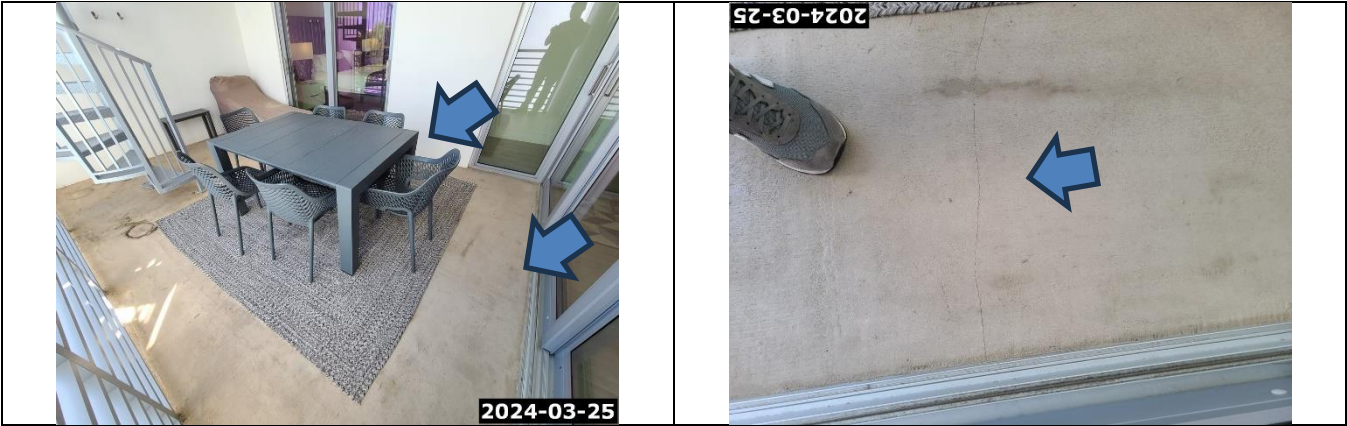
Balcony / Balcony Doors Images – Movement at Door When Latched

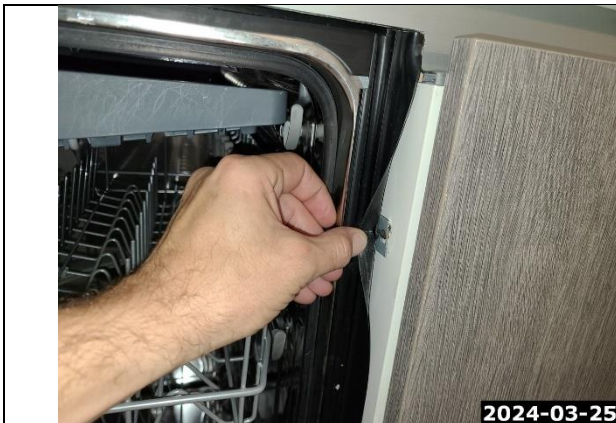
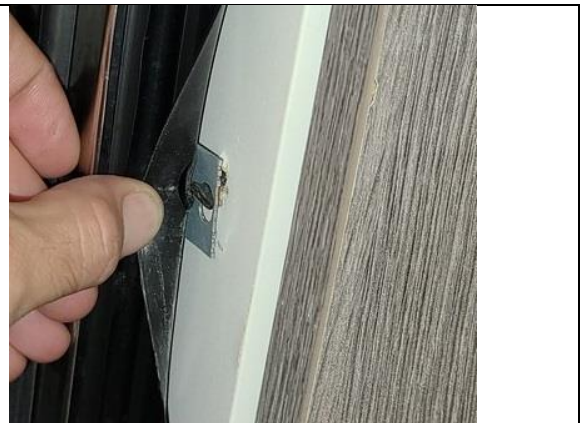
**Dishwasher  
Attachment Screw Crooked**

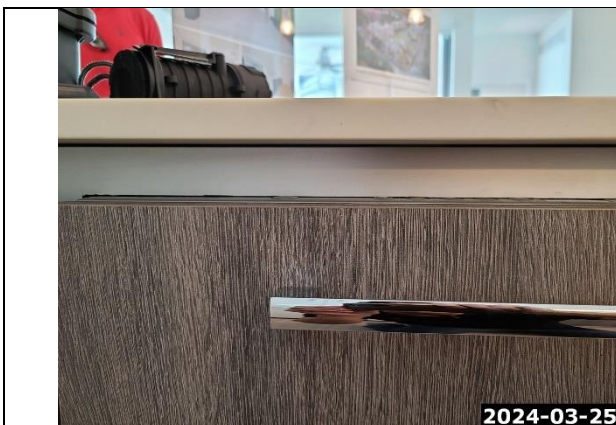
**Dishwasher –  
Buttons in Contact with Cabinet**

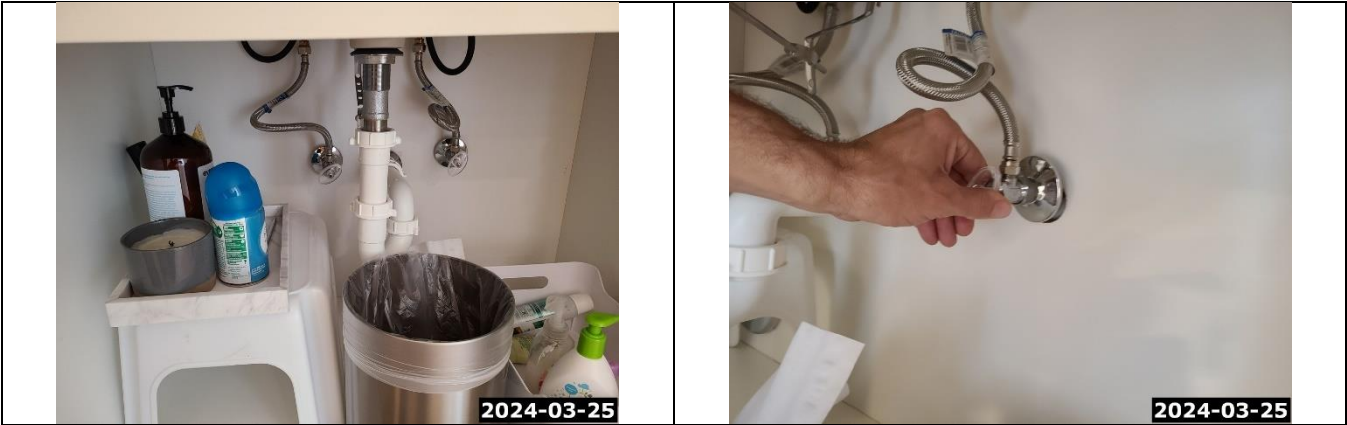
Bathroom #1  
Movement at Supply Line

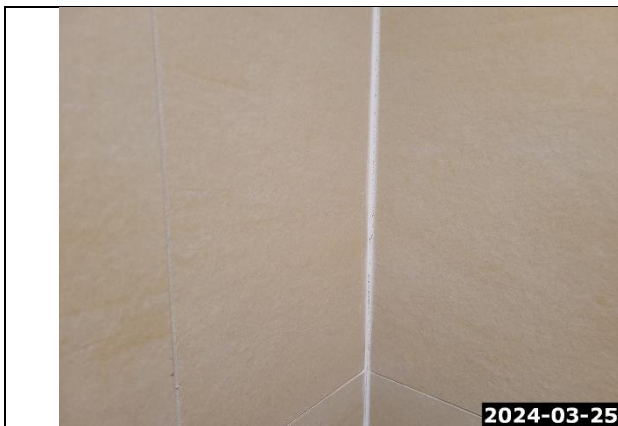
**Bathroom #1  
Cracking at Caulk****Bathroom #1  
Cracking at Caulk**

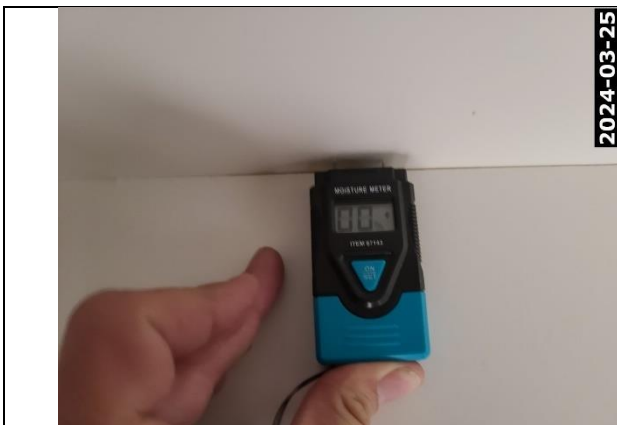
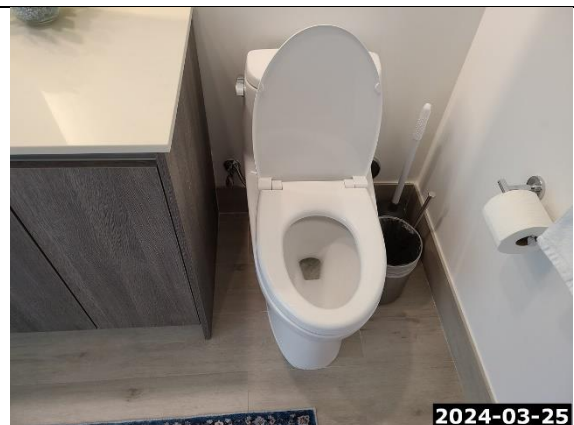
**Bathroom #2 Images****Bathroom #2  
Movement at Supply Line**

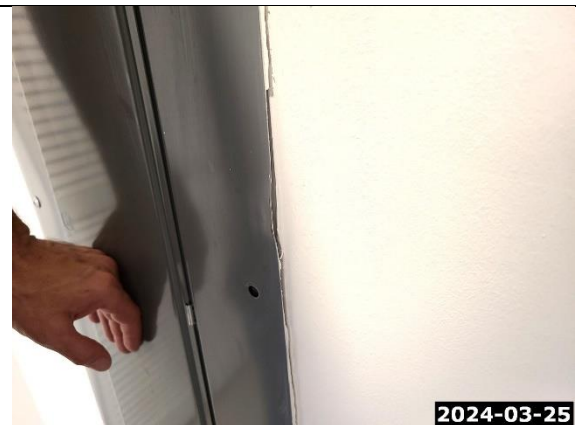
- **Condition of panel prior to inspection was that the panel was missing two of the four screws securing cover to panel box, and the panel was being bent away from the wall due to the issue with the breakers, the panel cover is also bent at right side (permanent, stays when cover is removed from wall).**

**Panel Bent**
