# Inspection Report

Prepared Exclusively For:  
Sample Report

Property Located At:  
Cape Coral, FL 33991

Inspection Date: 09/12/2025  
Inspected By: Nick Bangor  
FL Home Inspector License #: HI730

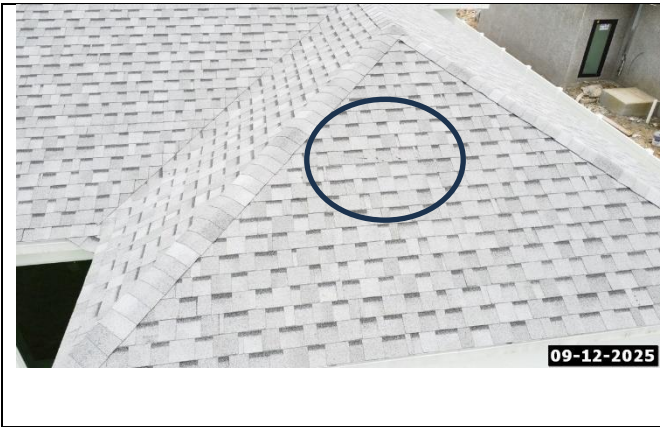
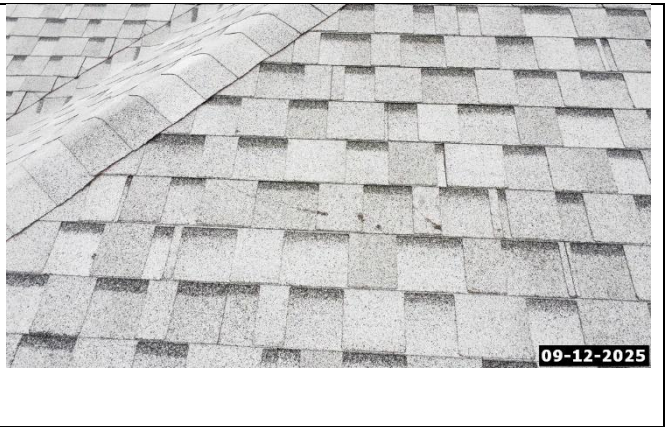
Damaged Shingle Visible

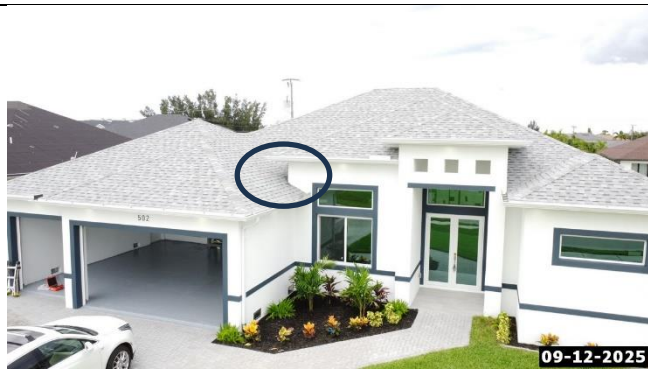
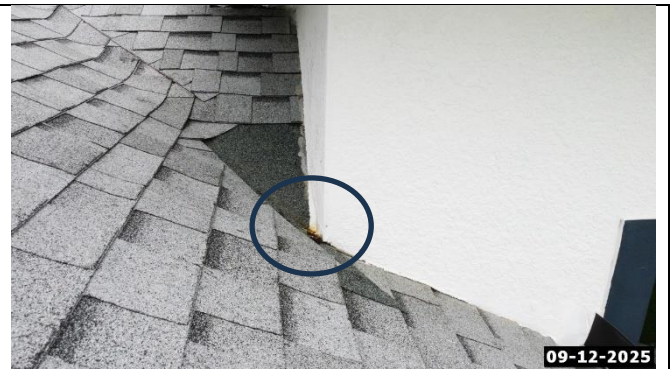
**Discoloration at Wall**

**Discoloration - Standing Water  
Causing Stains; Install Paint /  
Sealant to prevent Damage at Wall  
and Smooth Wall to Ensure Proper  
Draining**

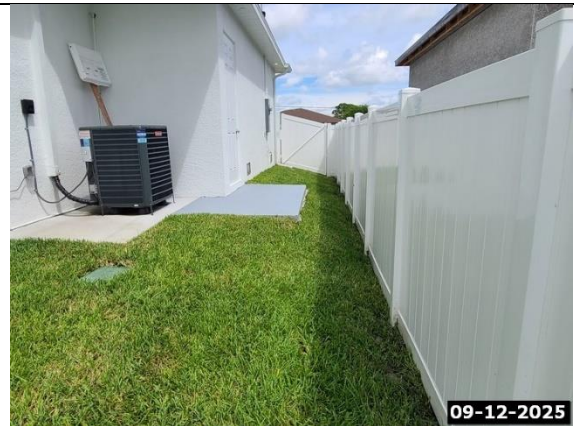
**No Gutters**

**Noticeable Erosion of Ground**

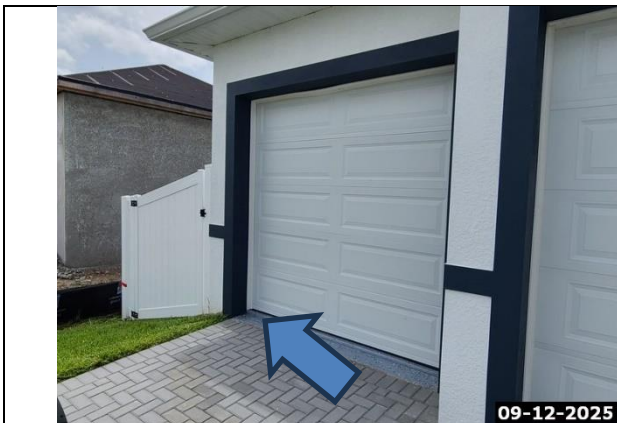
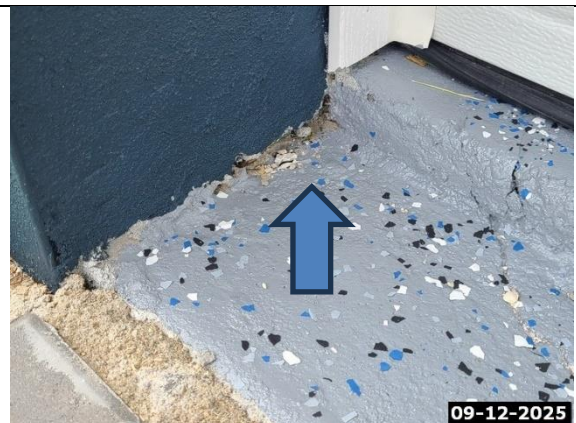
**Stucco Missing**

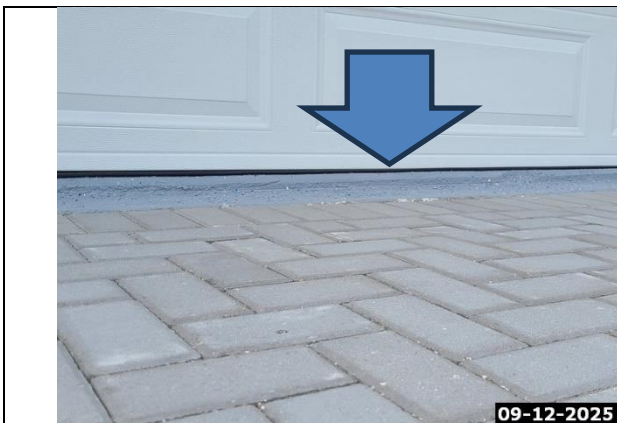
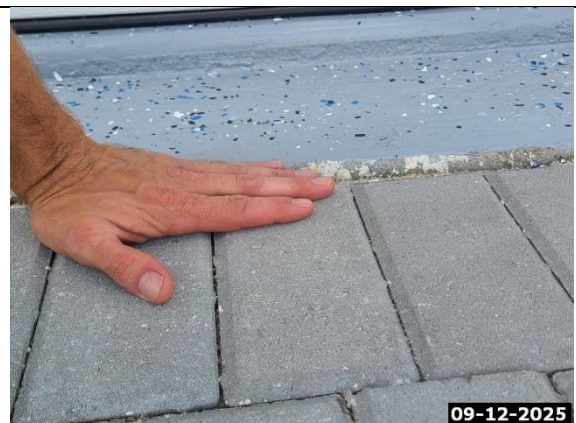
**Pavers Not Level**

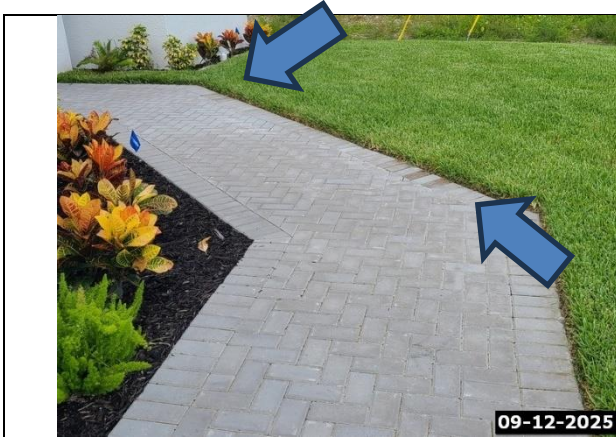
**Pavers Discolored at Walkway**

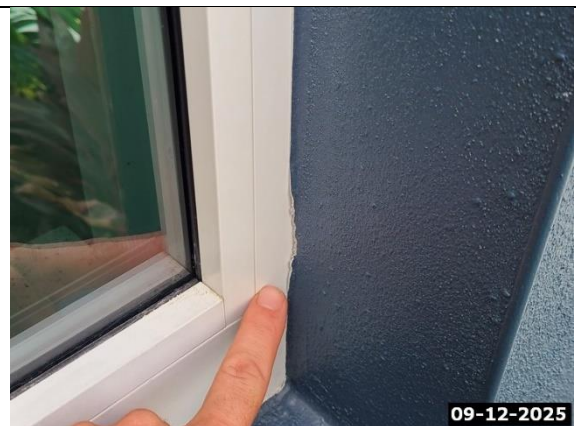
**Damaged Paint / Sealant Around Window**

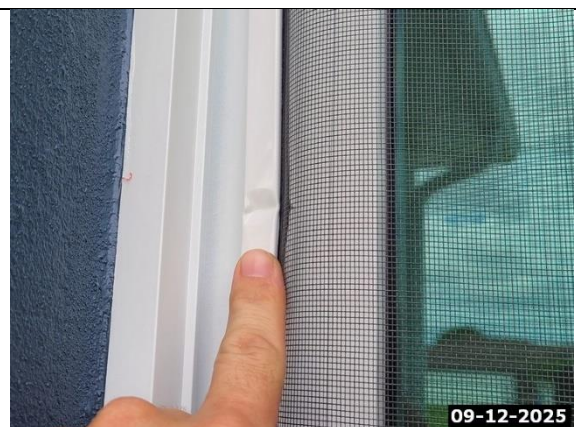
**Damaged Window Screen**

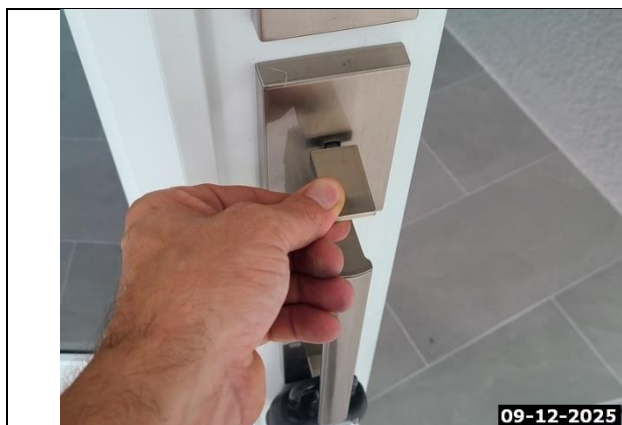
**Movement at Door Latch Lever**

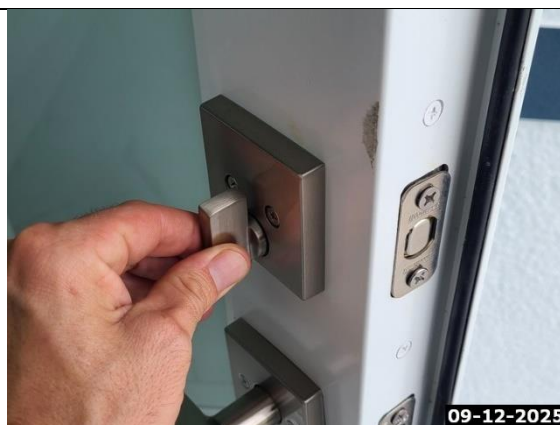
**Movement at Deadbolt Turn Lever**

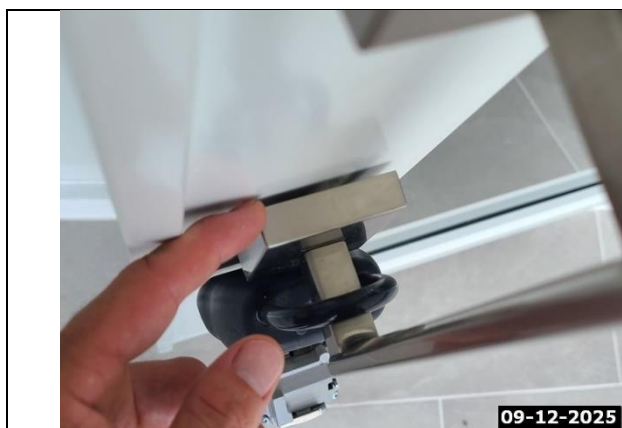
**Bottom of Door Handle Not Secure**

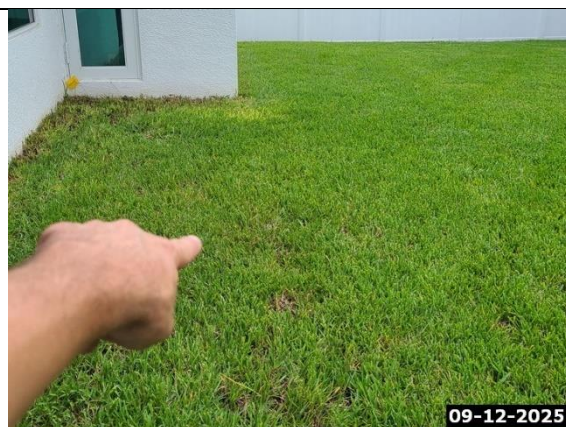
- **Rear yard is uneven at areas, this is likely due to erosion of ground fill (see other comments). Have ground fill leveled after causes of erosion are mitigated.**

**Uneven Ground**

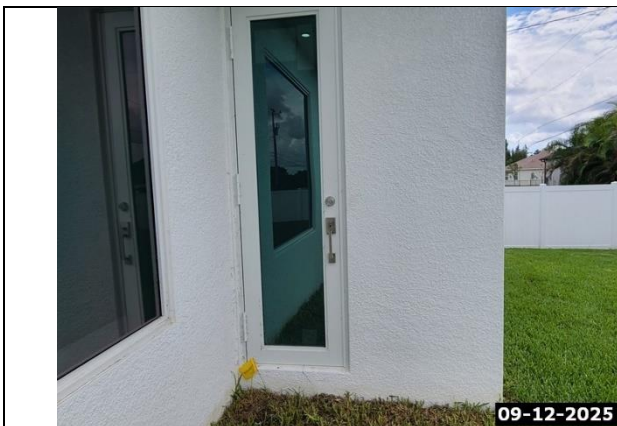
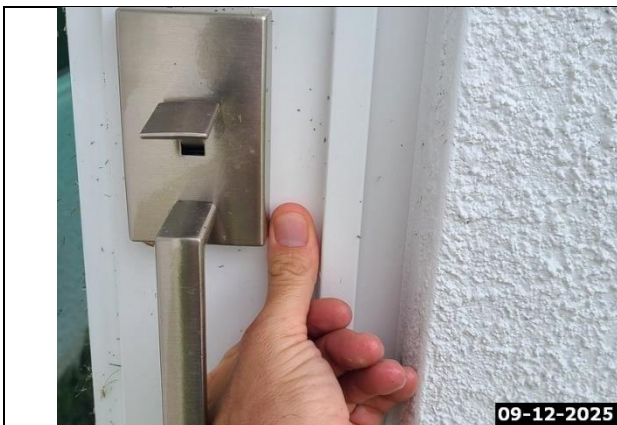
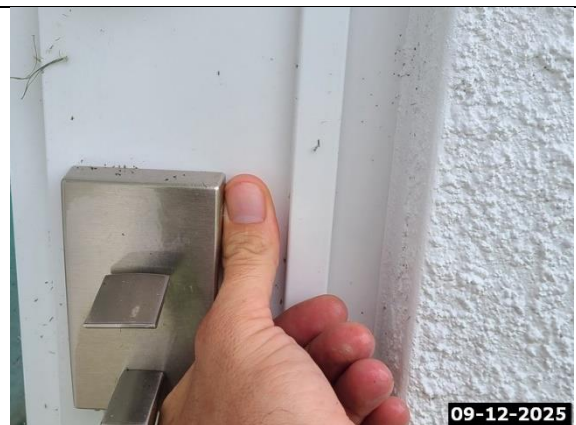
**Rear Door –  
Handle Not Square with Door**

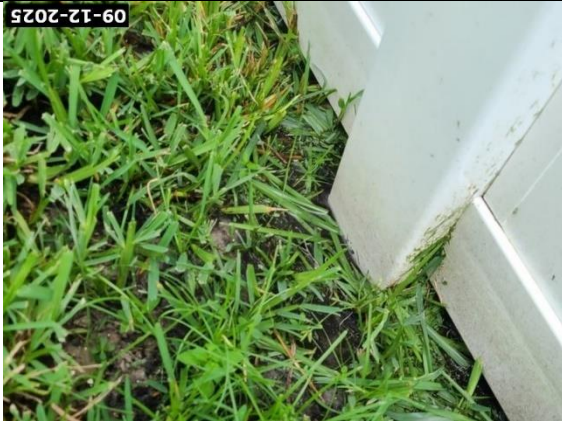
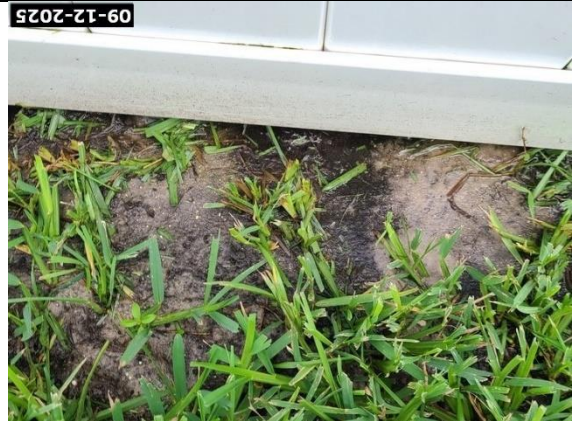
**Standing Water at Bottom of Swale**

**Standing Water at Bottom of Swale****Standing Water at Bottom of Swale**

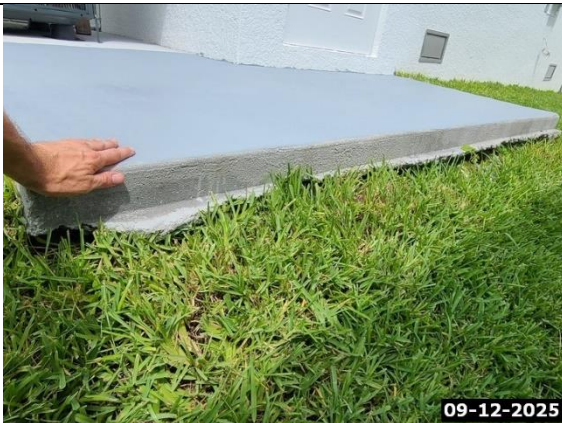
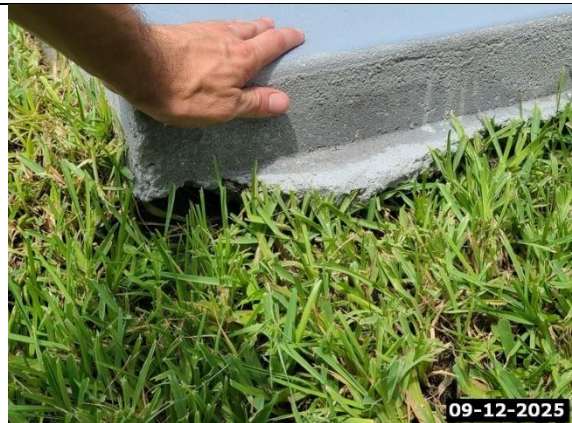
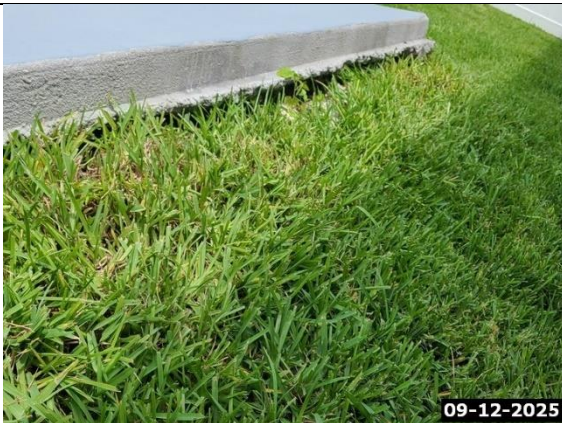
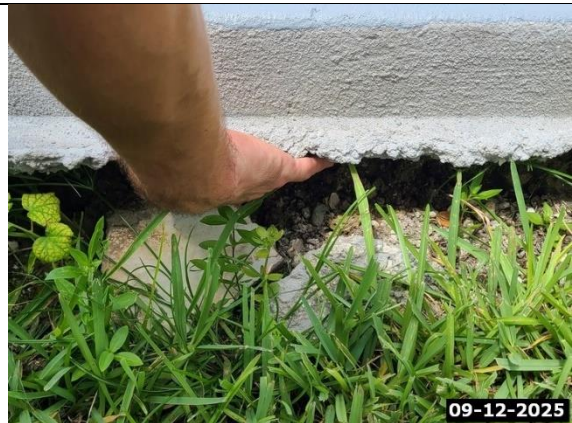
- **Concrete slab installed at left elevation of home (outside garage pedestrian door) is above ground that is exhibiting severe erosion.**
- **The slab does not appear damaged. There is significant ground fill missing under the slab.**
- **Ground slope repairs required.**
- **Install compacted fill and/or grout under garage pedestrian door's exterior slab.**
- **See "Ground Slope" comments.**

**Slab Outside of Garage****Gaps Under Slab –  
Ground Erosion**

**Gaps Under Slab –  
Ground Erosion****Gaps Under Slab –  
Ground Erosion**

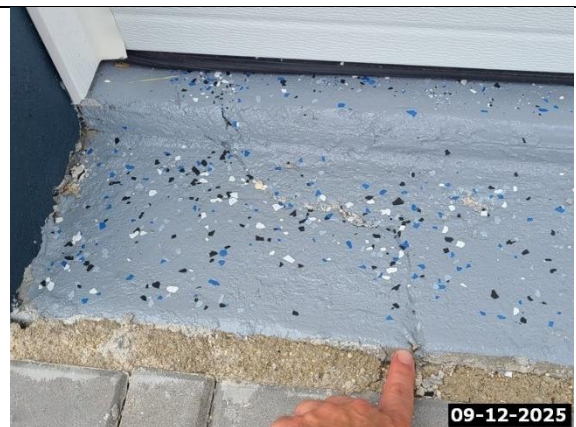
- **Cracking present at garage slab (Front-Left of home), cracking was sealed at time of slab coating installation.**
- **Underlying condition not visible, see ground slope comments and images of ground erosion at left elevation of home.**

Crack Under Coating

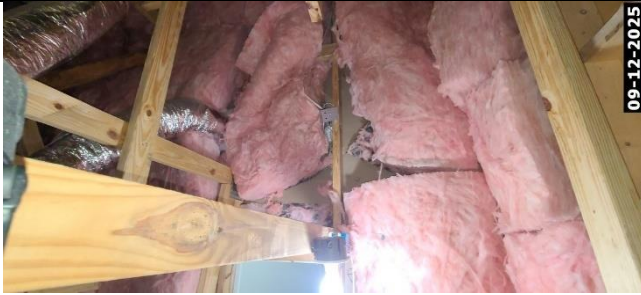
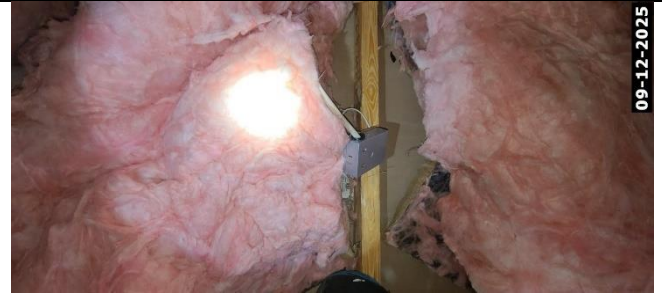
**Insulation Moved at Attic**

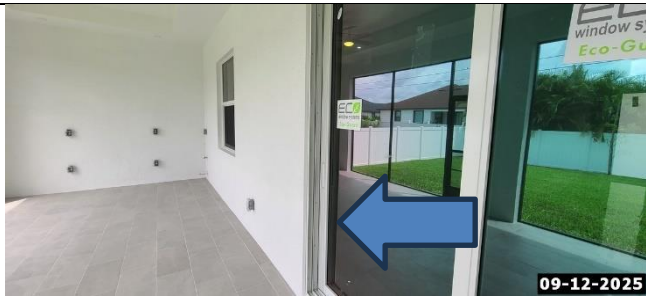
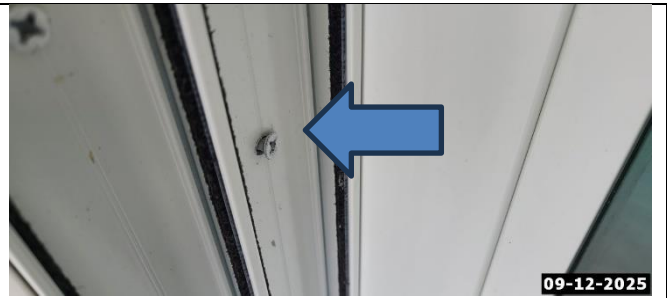
**Sliding Door Anchor Not Straight**

**Sliding Door Adjustment Required**

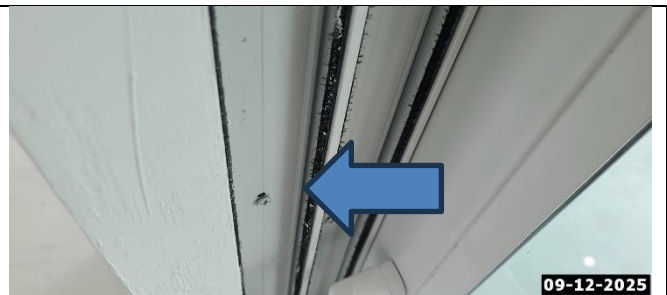
**Anchor Not Fully Seated**

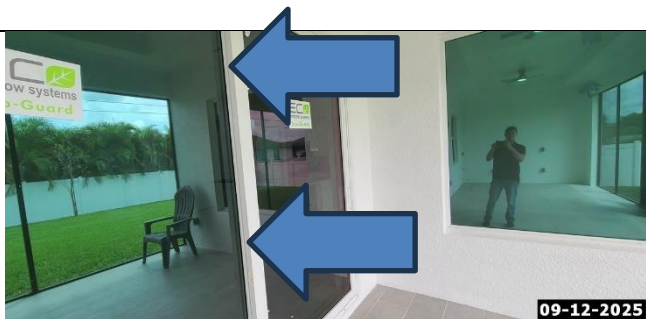
**Gaps Between Doors**

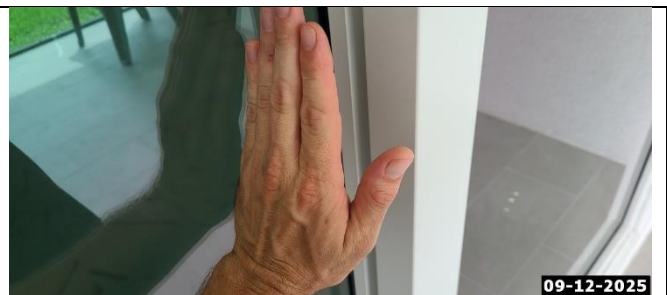
**Air Felt Escaping Home**

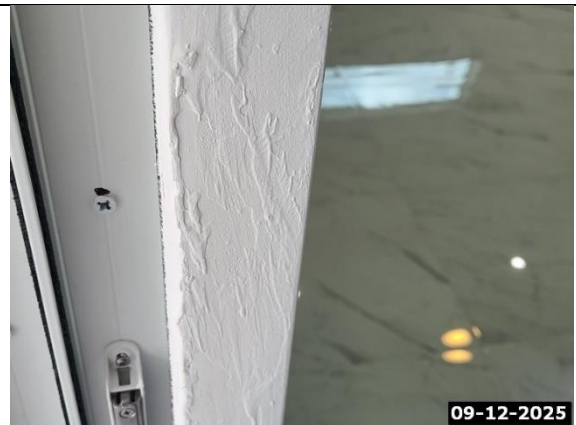
**Wall Around Sliding Patio Door  
Excessive Joint Compound  
Edges Not Straight**

**Repair Wall Coating / Paint**

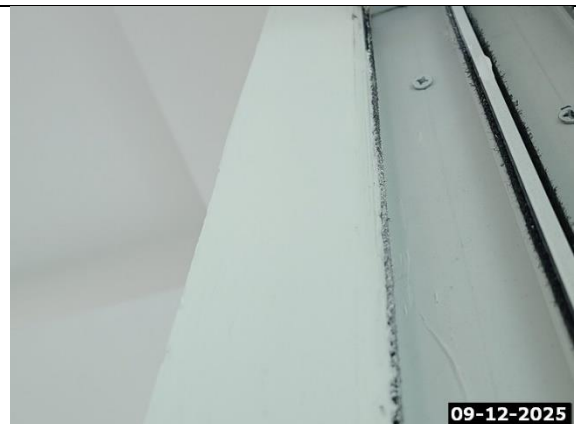
**Wall Around Sliding Patio Door  
Excessive Joint Compound  
Edges Not Straight**

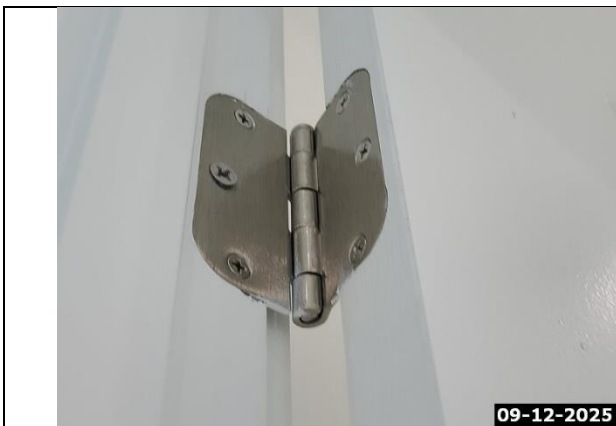
**Paint at Door Hinge**

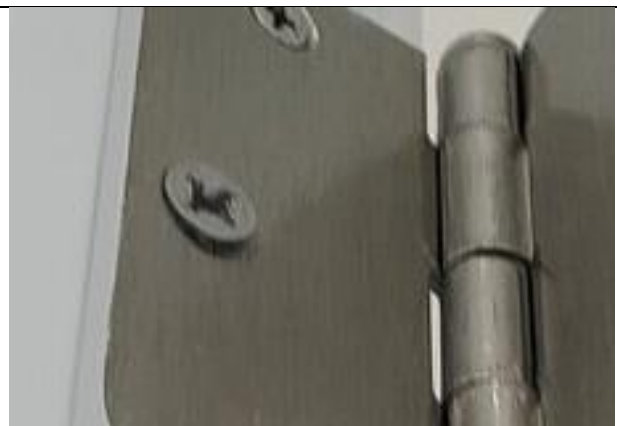
**Door Hinge Hardware Misaligned  
(Master Bedroom Door)**

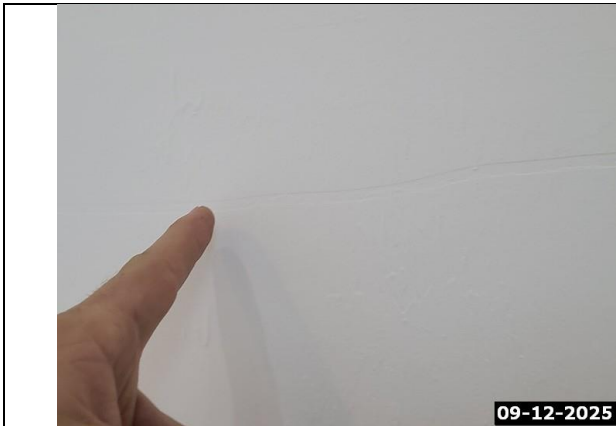
**Poor Wall Texturing**

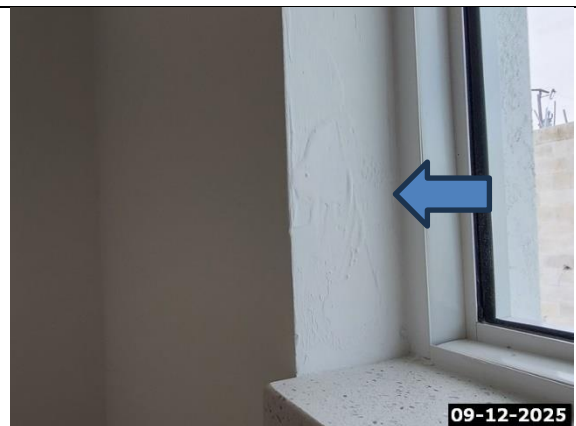
**Poor Wall Texturing**

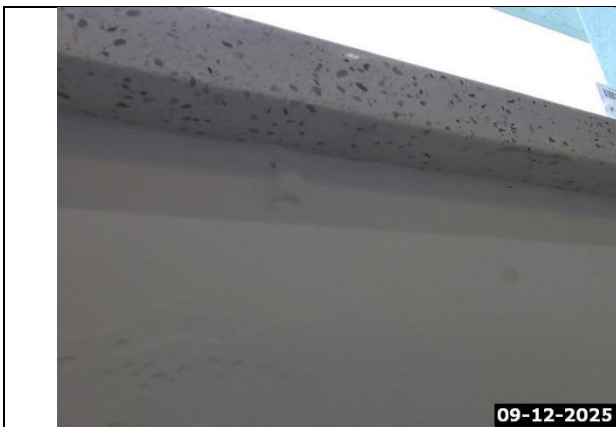
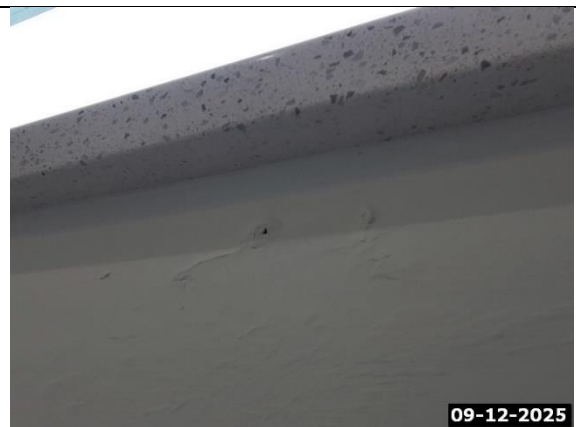
**Screw Visible at Wall**

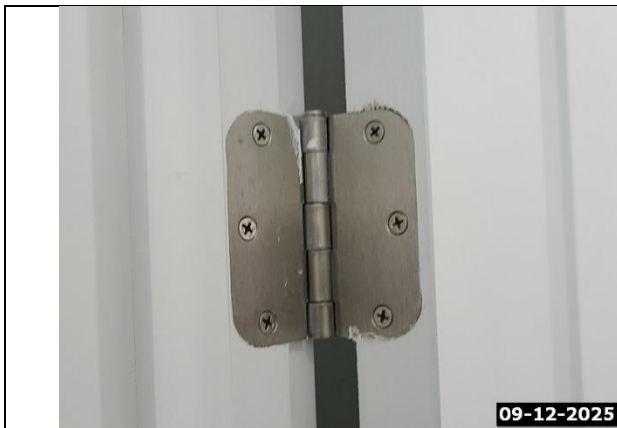
**Paint at Door Hinges**

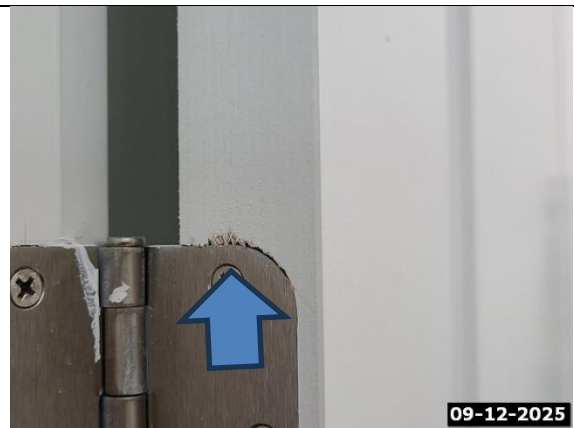
**Sand Splintered Wood  
at Hinge Bore**

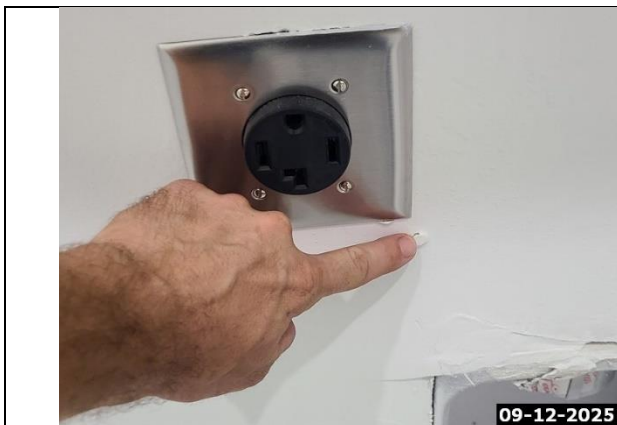
**Poorly Installed Wall Texture**

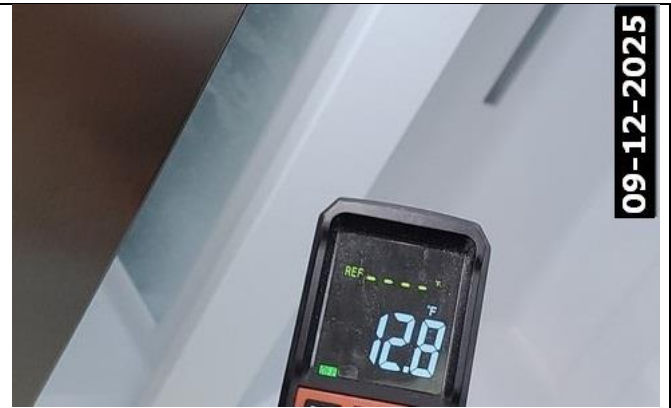
- **Unit is empty at time of inspection and true cooling capacity is not fully determinable.**
- **The freezer at the refrigerator is set to zero (0) degrees; measured low temperature at freezer is twelve (12) degrees at time of inspection. Cause of insufficient cooling is unknown; lack of items in freezer could be contributing to the temp being higher than the setting if the sensor is not working optimally in that condition (no items in freezer).**
- **Test if freezer can get down to temp with items stored inside freezer. Service will be required if freezer cannot get down to temp.**

**Freezer Temp**

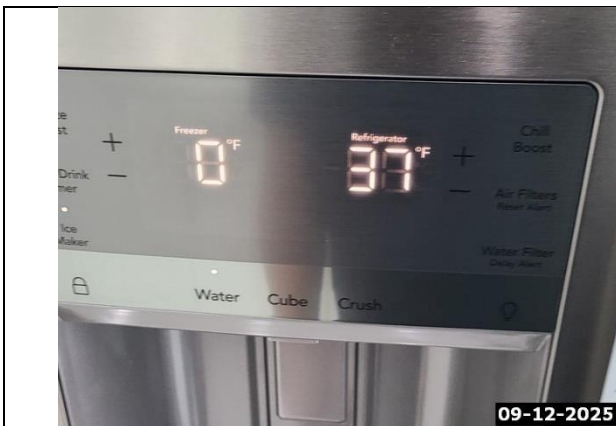
**Temp Settings (Freezer at 0)**

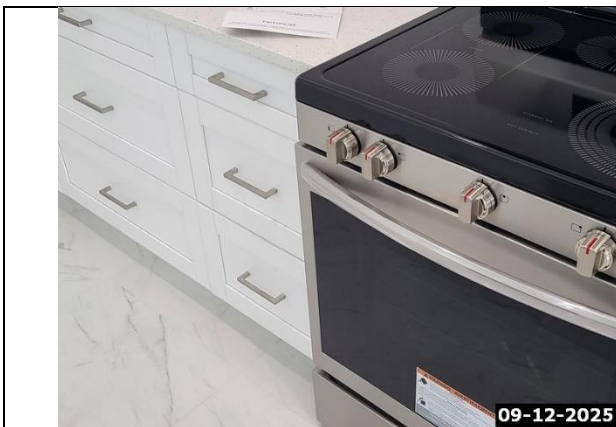
**Cabinet Drawer Hits Oven**

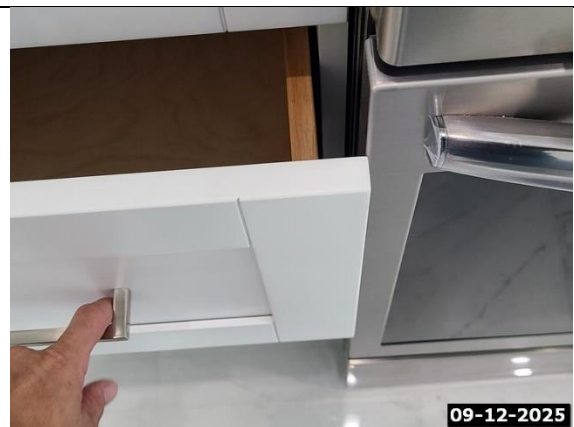
**Cabinet Drawer Hits Oven**

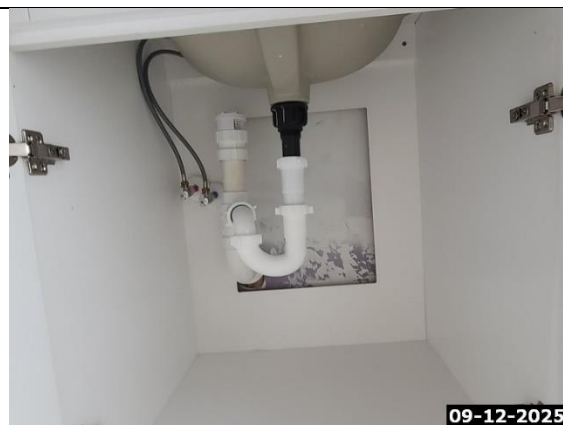
**Bathroom #2 Images****Bathroom #2 Sink Drain  
Gap In Wall Around Drain**

- **Wall under sink has gaps present between wallboard and sink drain; seal gaps to prevent pests.**  
**Seal Between Sink Drain and Wallboard**
- **The sink cabinet has a large section of the back removed for the plumbing components; this may be aesthetically unpleasing.**
- **Visible areas of wall through the opening in cabinet are not painted; the walls should be painted if the wall section is going to remain visible (if cabinet section is not replaced).**  
**Either Replace Missing Area of Cabinet, Paint Wall, or Both**
- **Gap visible between the right sink faucet and the countertop; install caulking to seal.**  
**Install Caulking Around Faucet**

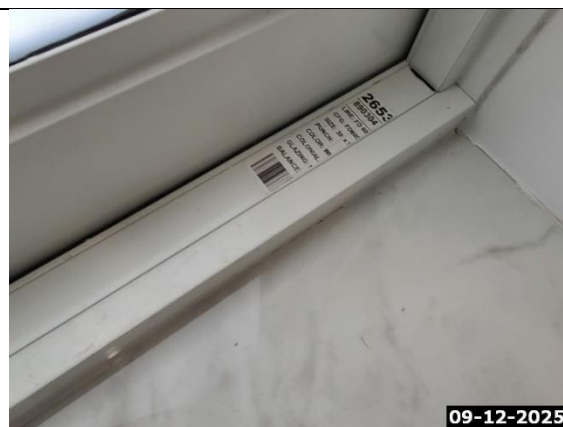
**Cracking at Wall Around Door  
Frame at Exterior Door****Sticker Remaining at Door**

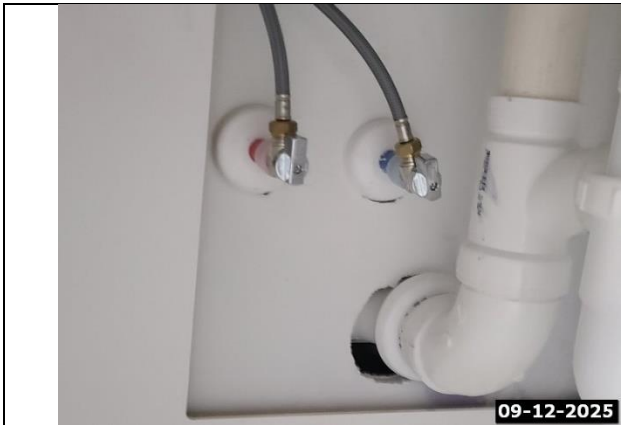
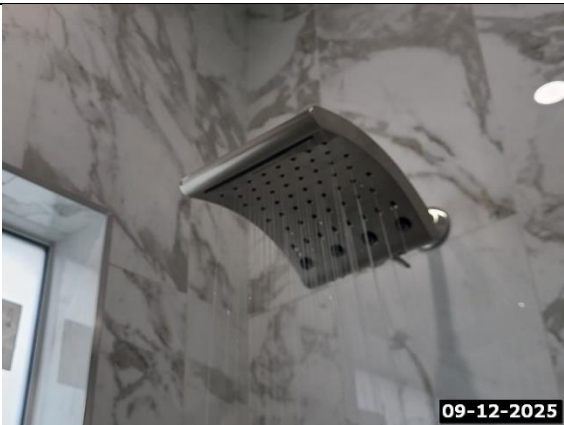
**Bathroom #3 Sink Drain  
Gap In Wall Around Drain**

- **Wall under sink has gaps present between wallboard and sink drain; seal gaps to prevent pests.**  
**Seal Between Sink Drain and Wallboard**
- **The sink cabinet has a large section of the back removed for the plumbing components; this may be aesthetically unpleasing.**
- **Visible areas of wall through the opening in cabinet are not painted; the walls should be painted if the wall section is going to remain visible (if cabinet section is not replaced).**  
**Either Replace Missing Area of Cabinet, Paint Wall, or Both**
- **Gap visible between the right sink faucet and the countertop; install caulking to seal.**  
**Install Caulking Around Faucet**

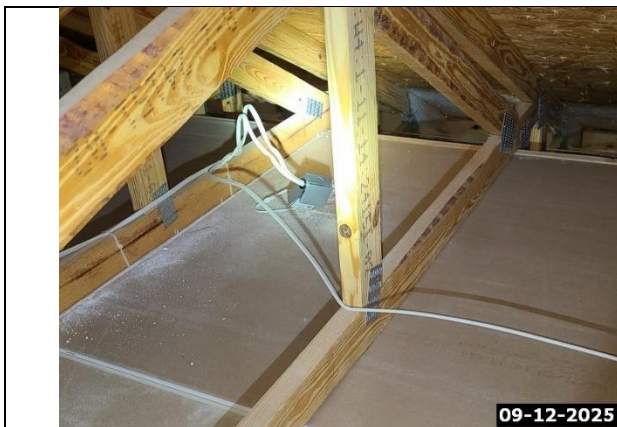
**Recessed Light Fixture Hardware  
Not Secured In Place at Attic - All**
